Lake Helena Drive – Preliminary Engineering Report

LEWIS & CLARK COUNTY
RPA PROJECT No. 09503.000

Lewis & Clark County

Robert Peccia & Associates

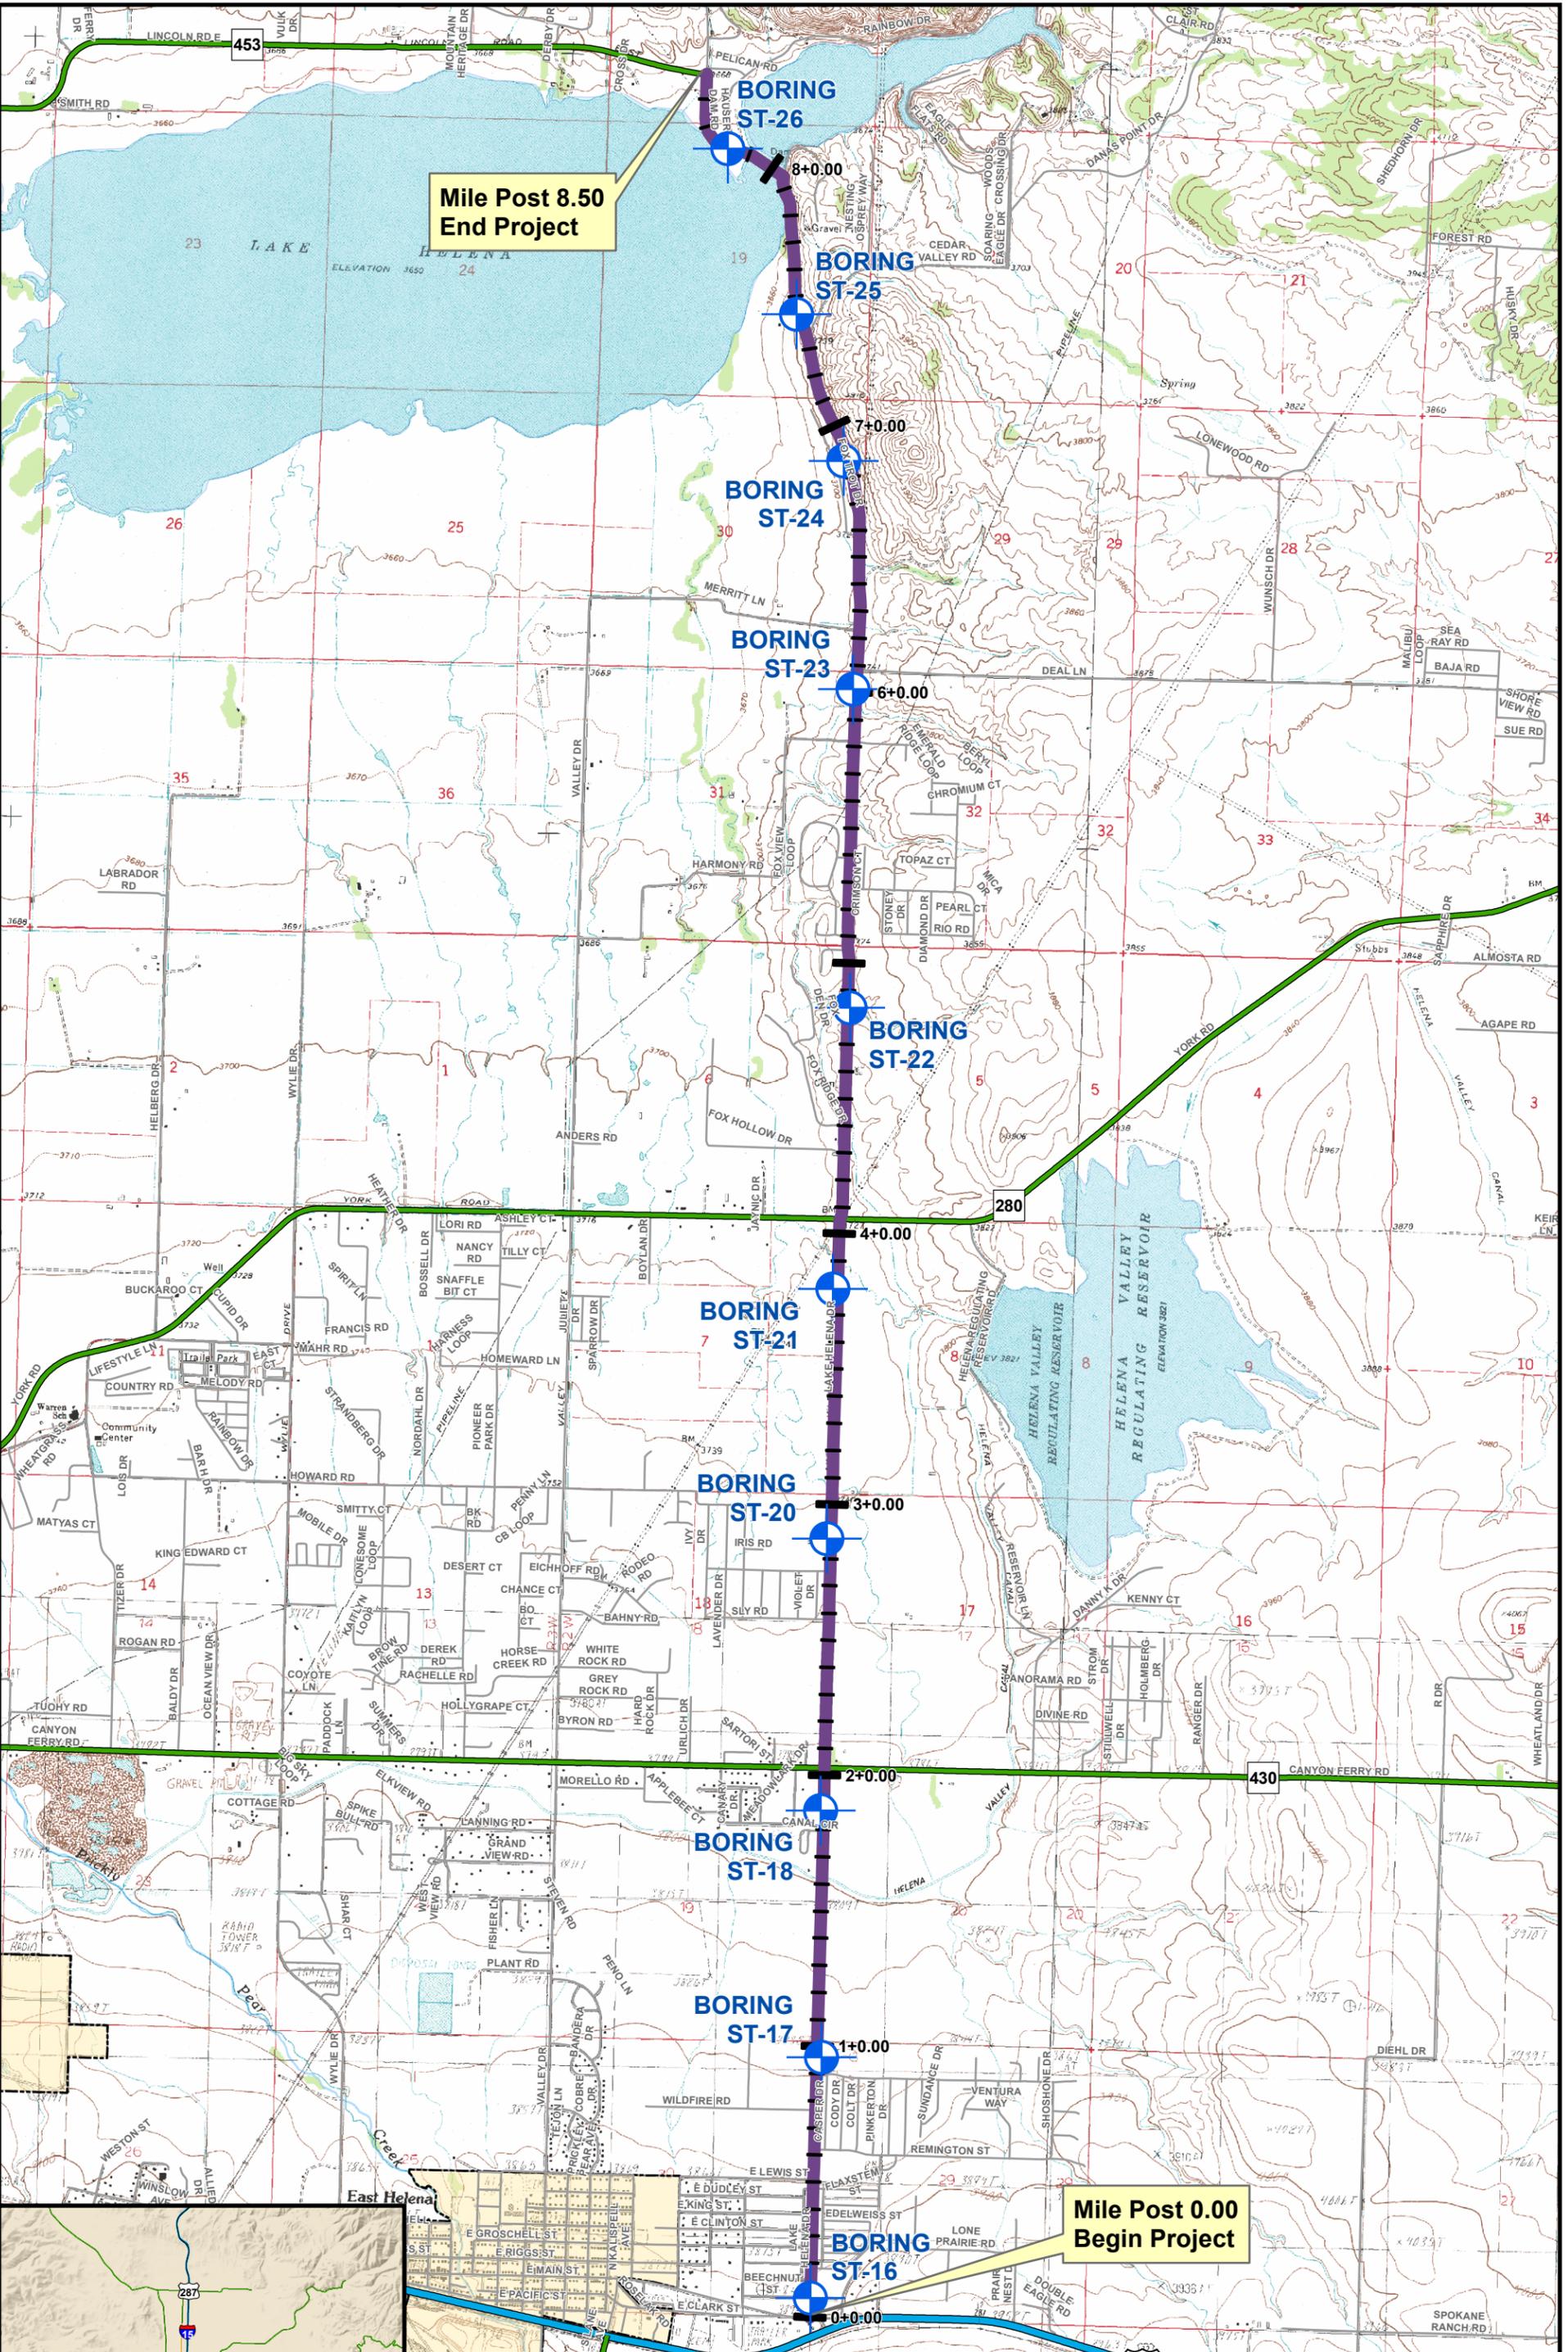
**LEWIS & CLARK COUNTY
PRELIMINARY ENGINEERING REPORT
FIGURE 1 - LAKE HELENA DRIVE**

**Mile Post 0.00
Begin Project**

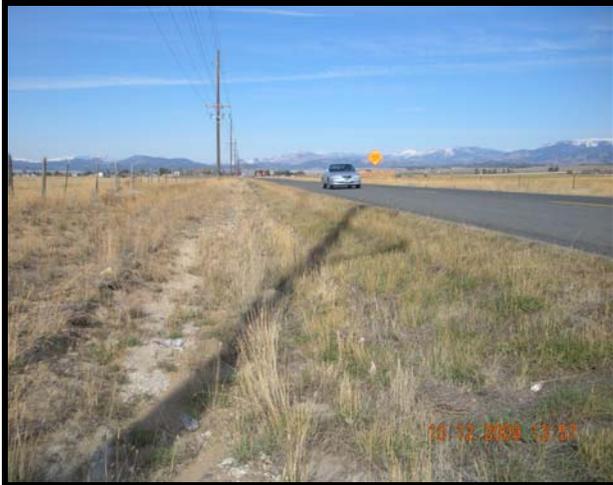
Photo 1: Looking north along the west roadside ditch between Boundary Street and Canyon Ferry Road. Note the overhead transmission lines dictate available room for roadside improvements.

The existing roadway's physical characteristics between Boundary Street and Canyon Ferry Road are very consistent as shown in **Photo 1**. This is primarily due to the level terrain. The following **Figure 2** is a representation of the road segment as shown in Photo 1, and is based on the composite field measurements described above.

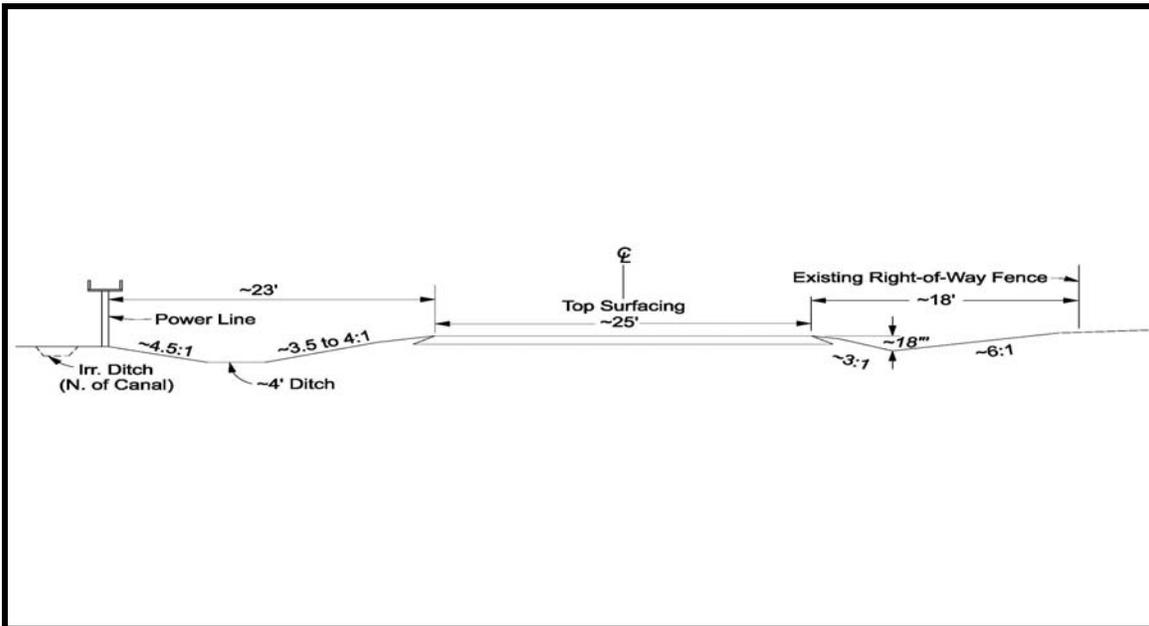
Figure 2: Existing Road Section Between Boundary St. and Canyon Ferry Road

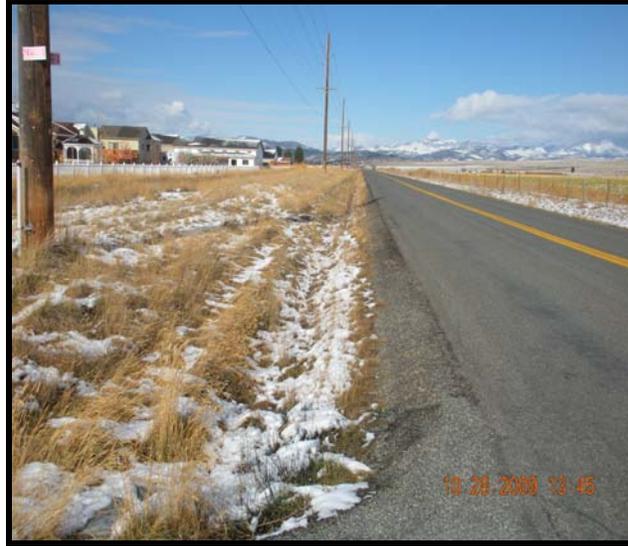
Photo 2: Looking north along Lake Helena Drive north of Canyon Ferry Road.

Lake Helena Drive between Canyon Ferry Road and York Road is very similar in aspects to the section south of Canyon Ferry Road. The primary exception is that both roadside ditches are very shallow, at about 18 inches deep. In this segment, the overhead transmission line and Helena Valley Irrigation Canal lateral running along the west side of the right-of-way are both a continuation of physical features that limit the opportunity for roadside improvements (unless each is relocated). The typical constraints and similarities of both segments are shown in **Photo 2** above, and **Figure 3**, below.

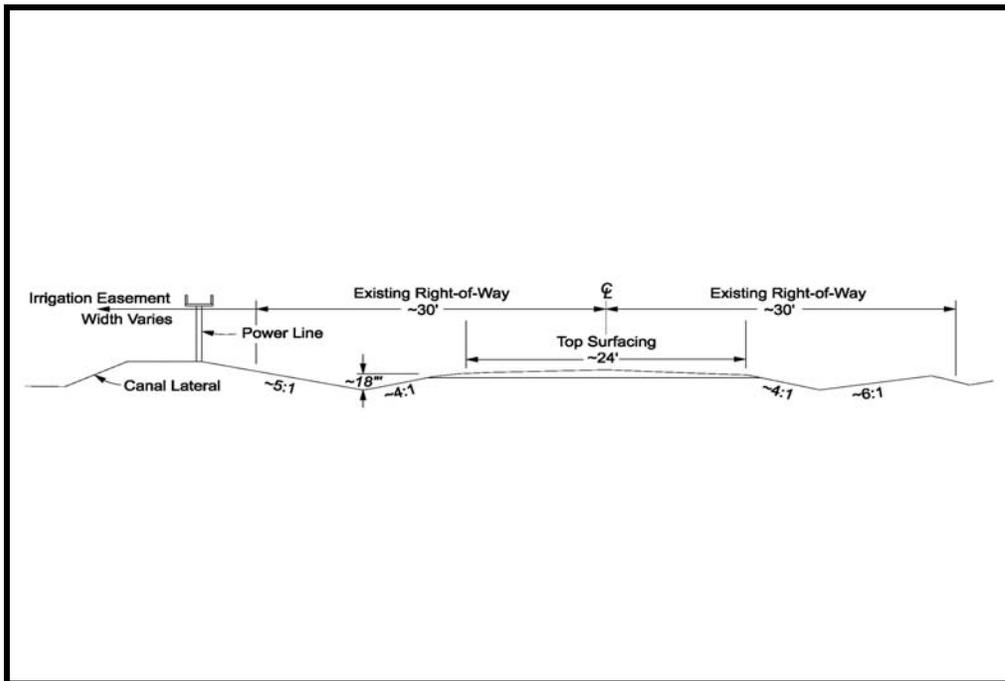
Figure 3: The Existing Section Between Canyon Ferry Road and York Road.

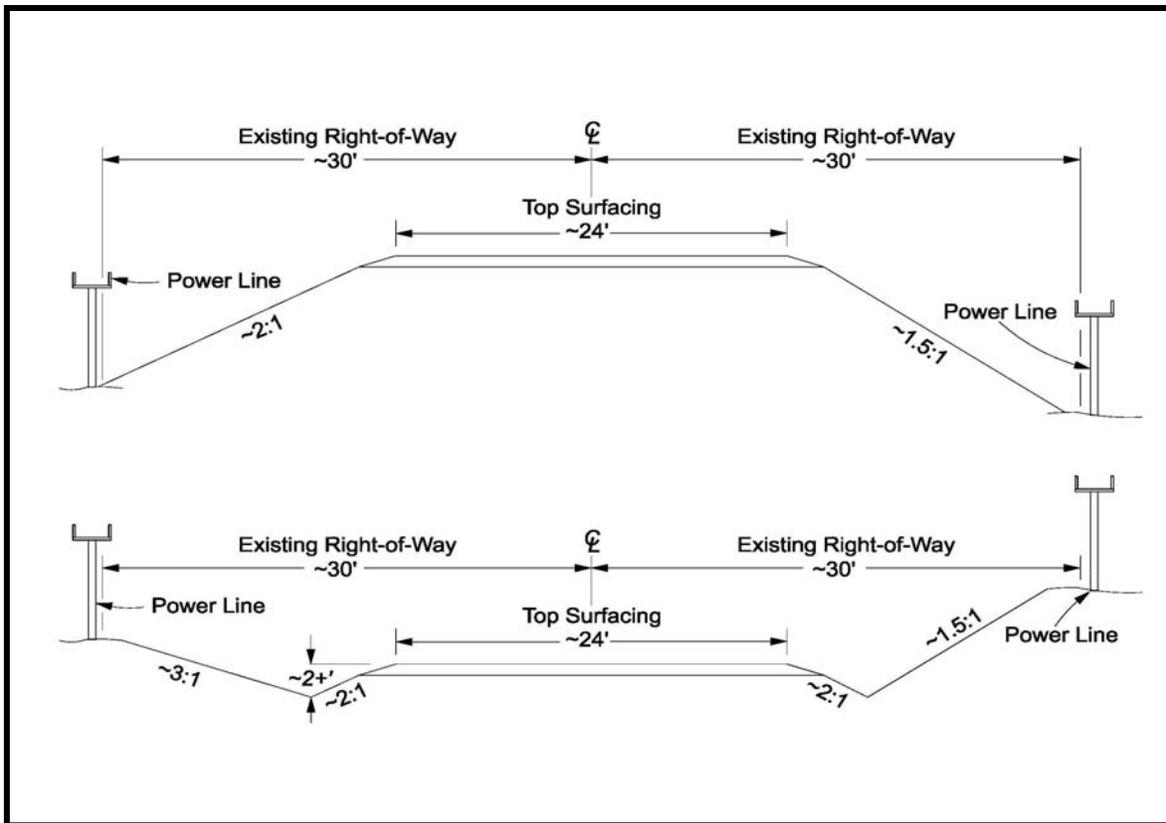
Figure 4 below is a composite diagram showing the typical road width, ditches and cut and fill slopes of the road segment between York Road and Deal Lane. The upper figure represents a typical fill section traversing a drainage, while the lower figure represents a typical section with the profile cutting through the crest of a hill. This portion of Lake Helena Drive is the only segment to have received somewhat recent reconstructive improvements. The reconstruction was completed in 1995 and included new surfacing, adjustments to the vertical profile to improve sight distance, and roadside slope flattening. The efforts completed by the County were to rehabilitate the road in preparation of receiving additional traffic in conjunction of constructing a new solid waste depository adjacent to Deal Lane. With the limited budget reconstruction, the County completed the work to improve the road surfacing while providing roadside safety improvements. As such, grades were improved, but the resultant action required increasing cut depths at the crest of vertical curves, and similarly increasing fill heights to improve sight distance through sag vertical curves. To limit cost, all work was completed to fit the road within the existing right-of-way and limit utility impacts, primarily to the overhead transmission lines running parallel on both sides of the highway. Since improvements were completed to fit within the width constraints of right-of-way and utilities, the cut and fill slope rates adjacent to the travel way, are relatively steep at about a 2:1 in locations, and therefore do not meet current County or AASHTO standards for safety relative to the amount of traffic and travel speeds using the facility. However, where feasible, safety was further improved over its pre-existing condition by installing guardrail barriers in the fill sections.

Figure 4: Representative Cut and Fill Sections of the Paved Section North of York Road

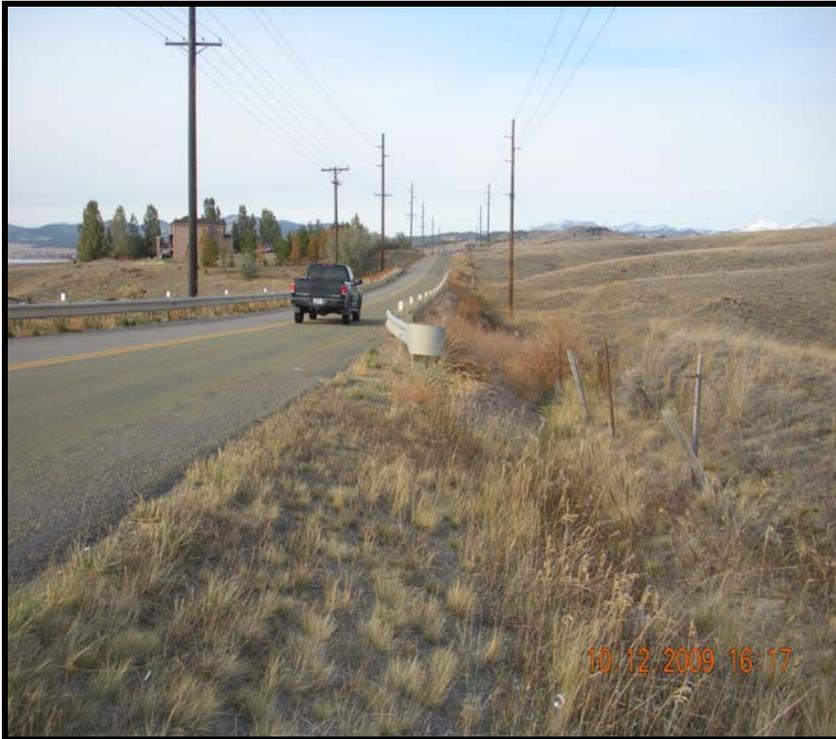
Photo 3: Photo of a cut section transitioning to a fill section through a drainage. Note the guardrail installed for safety. Roadside slopes are steepened to fit within utility and right-of-way limitations.

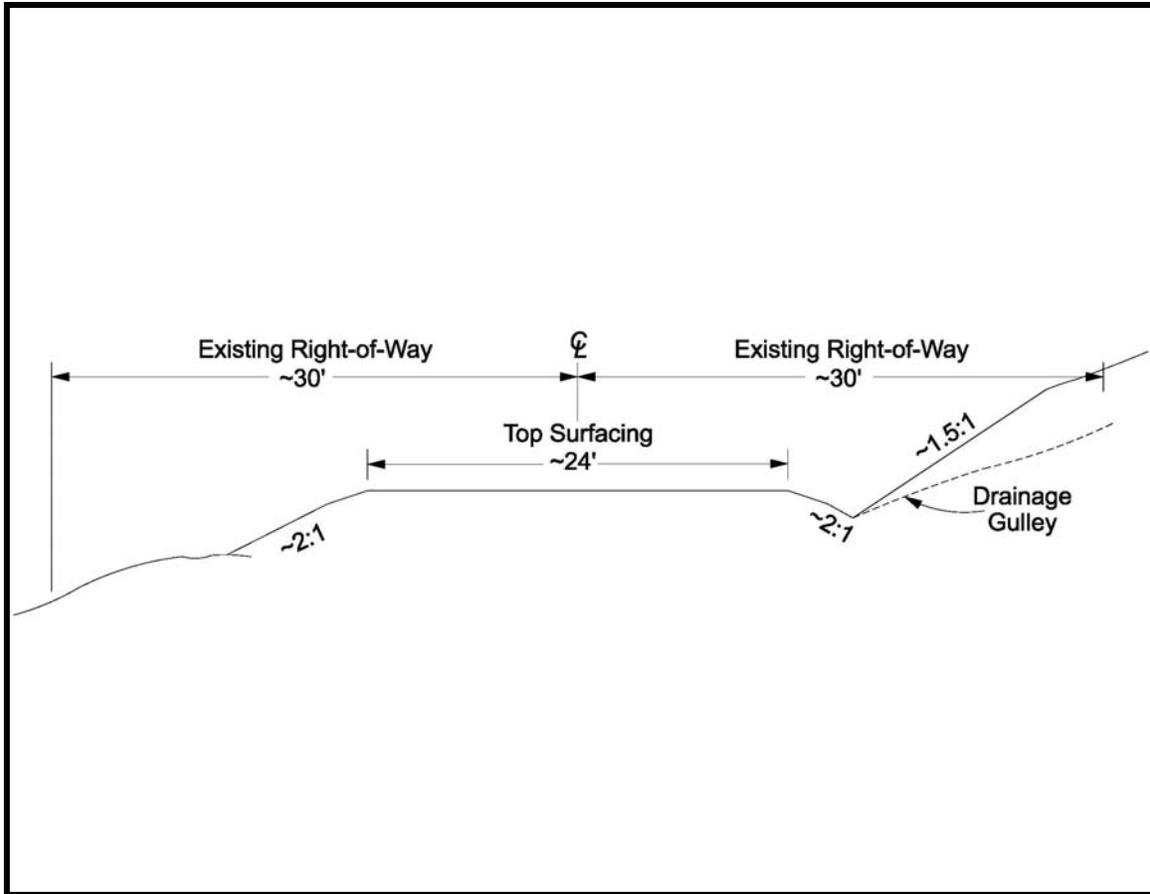
Figure 5: Typical Sectional Characteristics of the Gravel Road North of Deal Lane.

The gravel road is currently signed for a regulatory speed limit of 35 mph to account for the changing conditions that a driver can experience on a gravel road. The road for the most part is maintained to hold as wide as a surface width as attainable to fit within the hillside cut and fill slopes. However, in between surfacing blade and reshaping operations, the gravel surfacing displaces from the traveled way to the ditch or fill slopes. This creates what appears to be a wider road void of gravel surfacing. In its prime condition, the road is approximately 24 feet wide, with about 18-inch deep ditches. The cut slopes are generally characterized as steep at about 1.5:1. The cut slope is somewhat steeper in locations where the road traverses through exposed bedrock. Fill slopes are similarly steep compared to the County's current standards. The overall width of the road from the toe of fills to the top of cut sections is generally built to fit within the allowable right-of-way as shown in the **Figure 5** depiction, and it's accompanying representative **Photo 4**.

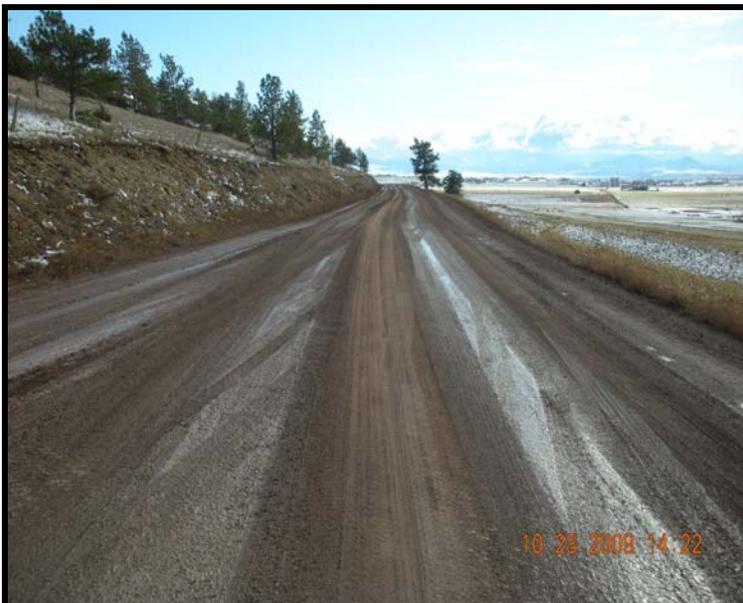
Photo 4: The width of the gravel road can vary depending on gravel displacement. Cut and fill slopes are steep relative to the proximity of the driver.

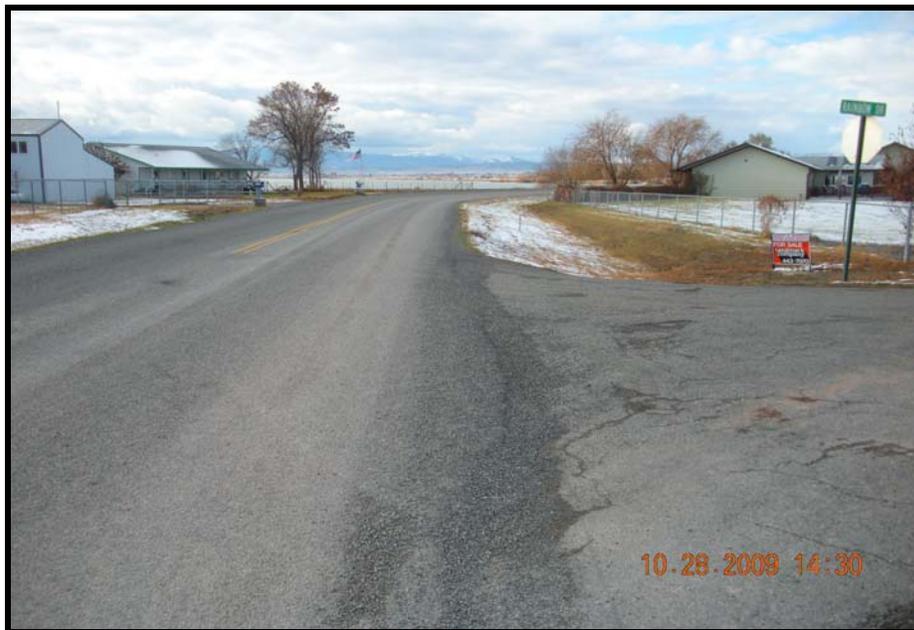
Photo 5: The segment of road north of the causeway exhibits some desirable roadside geometrics.

The short segment of road from the causeway north to the intersection of Lincoln Road is deteriorated having been blade patched numerous times. However, this segment contains some desirable roadside geometrics. As shown below in **Photo 5**, this section of the project exhibits the flattest ditch slopes throughout the study area even though it has the lowest posted regulatory speed limit of the project at 25 mph. Given the flat roadside slopes and low travel speeds, this segment generally provides the best opportunity for an errant vehicle leaving the road to make a safe recovery. Although the ditch slope rates are favorable, the depth of the ditch would desirably be increased which would provide good cover depth over approach drains. However, there is little opportunity to do so due to the built up housing and Lake Helena limiting the potential to widen the right-of-way. As such, for the purpose of this study, given the very low operating speed and relatively good roadside recovery area, we believe the reconstructive effort in this segment would be focused on reconstructing the road surfacing, and not on the geometrics of the road.

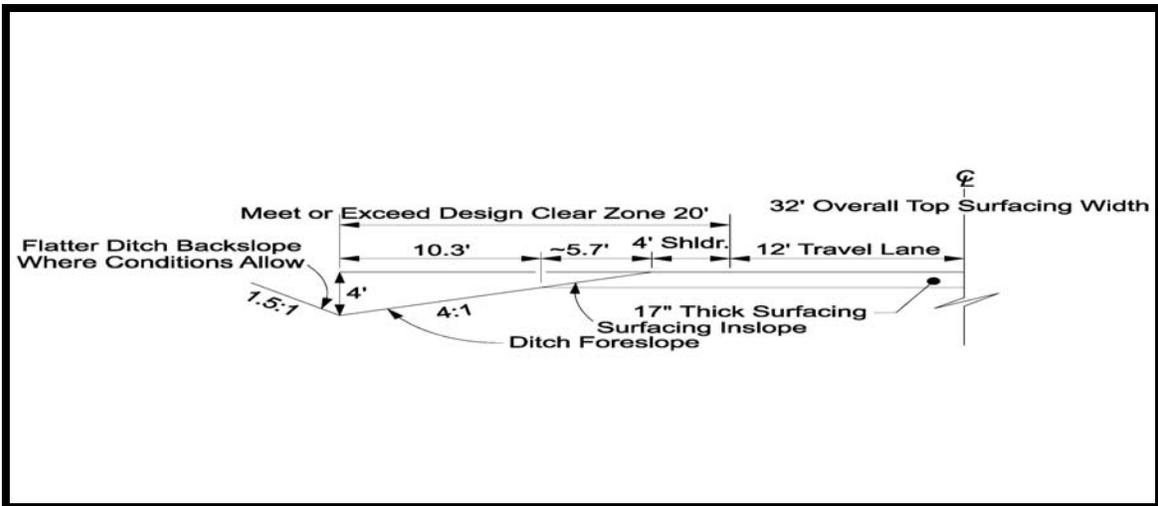
Figure 6: Proposed Road Template for Lake Helena Drive South of York Road

The following **Figures 6 and 7** display the recommended road design typical sections to reconstruct Lake Helena Drive north of the Eastgate subdivisions. Figure 6 is representative of Lake Helena Drive south of York Road, and Figure 7 is the road section north of York Road. Each typical section is based on the design methodology previously discussed in which the County Road Standards served as the basis supplemented by AASHTO guidance as needed. They are very similar with equal travel lane and shoulder widths. The most notable difference is the greater clear zone required for a 50 mph design speed as compared to a 40 mph design speed.

To estimate earthwork and miscellaneous other feature impacts to reconstruct the roadway, we applied the design typical sections, shown in Figures 6 and 7 over the existing road templates as shown in previous Figures 2 through 5. The superimposed design placed over the existing road yielded **Figure 8**, below. The estimate is based on the reconstruction closely following the existing horizontal and vertical alignments.

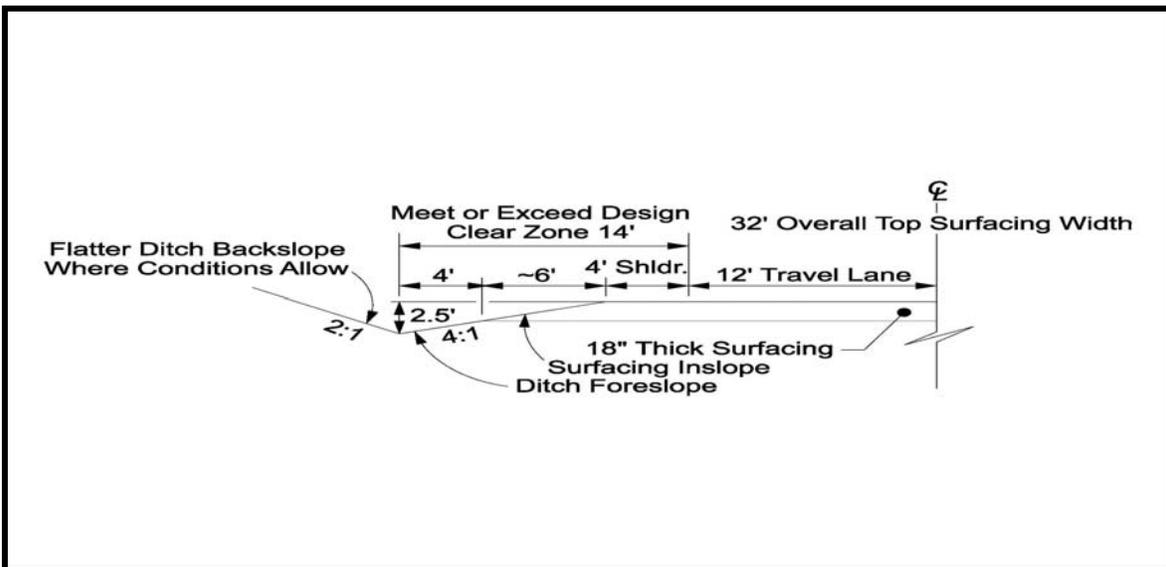
Figure 7: Proposed Road Template for Lake Helena Drive North of York Road.

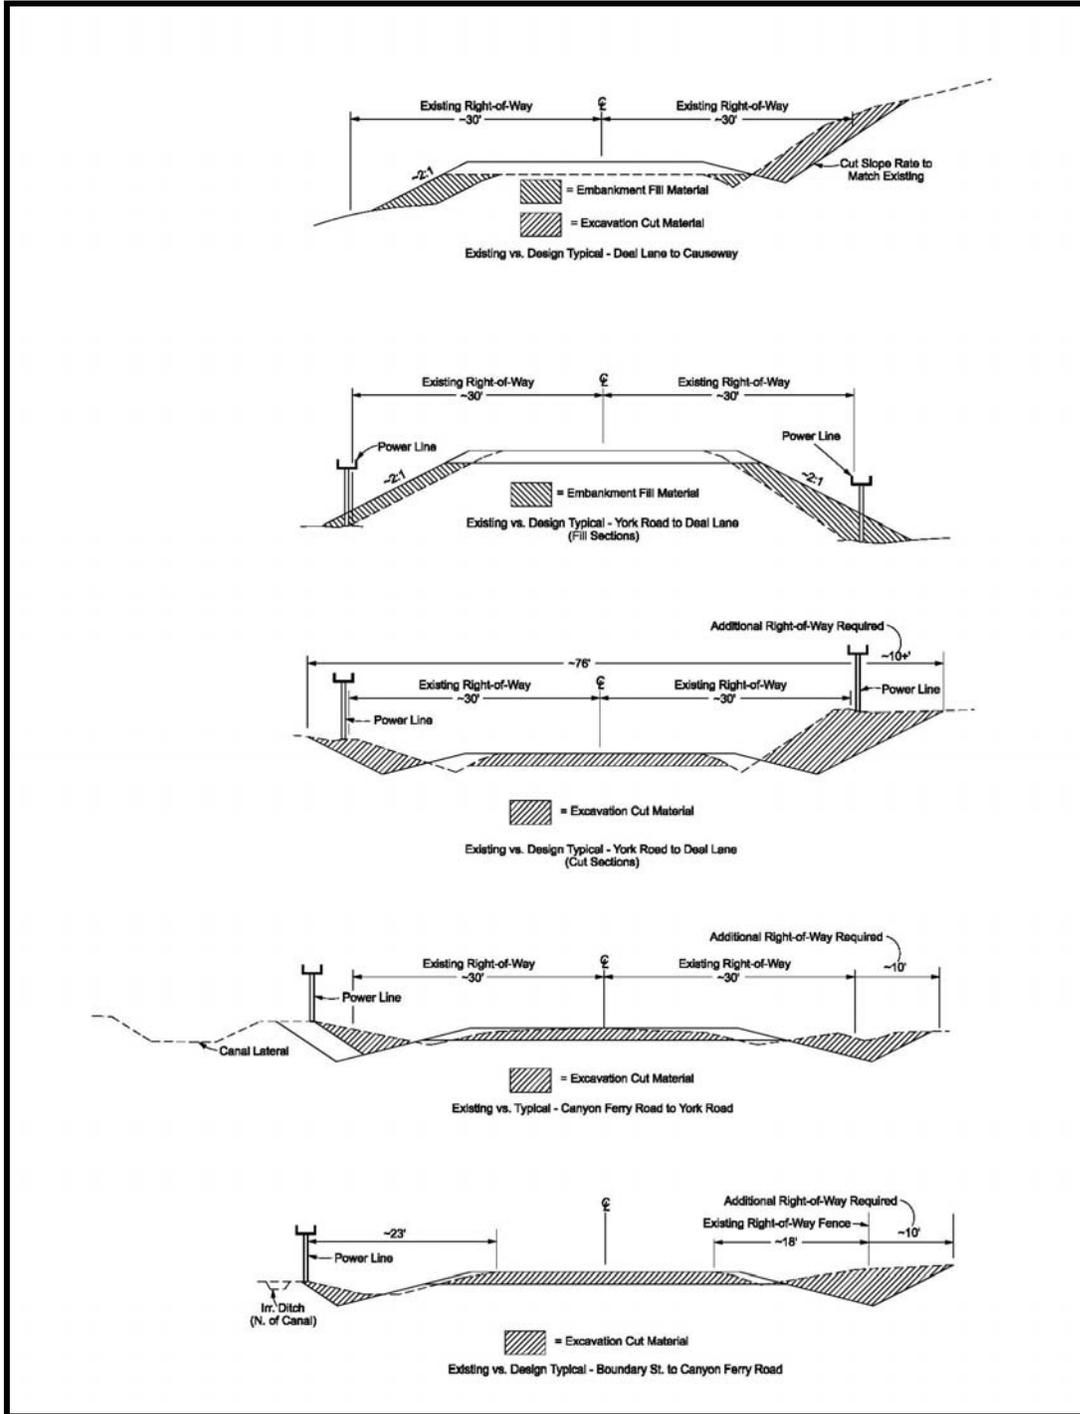
Figure 8: Estimated Cut/Fill Impacts to Reconstruct Lake Helena Drive

Figure 8 shows representative cut and fill impacts anticipated to reconstruct Lake Helena Drive from south (shown on the bottom) to north (shown at the top) to minimum standards.

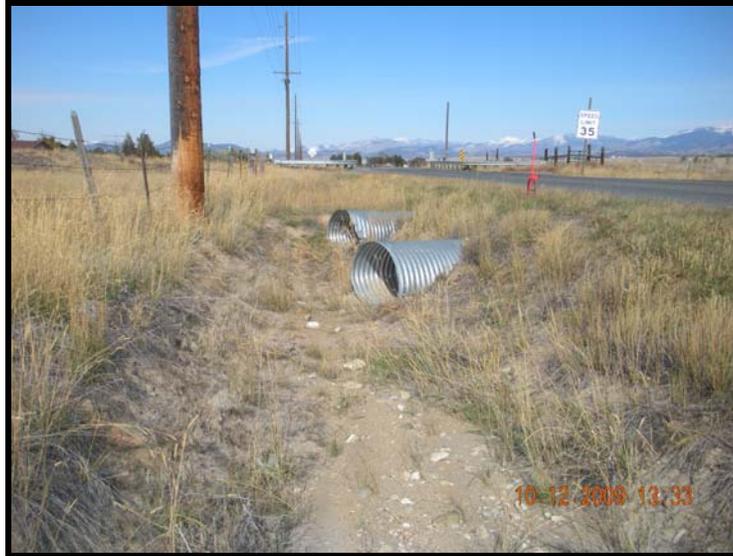
Photo 6: Double culverts installed just south of the Helena Valley Canal, MP 1.6.

From the beginning of the project to York Road, MP 0.0 to 4.0, the existing road traverses level terrain following the direction of the south-to-north natural drainage patterns. As such, the primary hydraulic conveyance feature in the more urbanized area within the Eastgate subdivision, from MP 0.0 to MP 0.5, consists of sheet flow along the edge of the sidewalk. There is no curb and gutter or storm drain system in this location. The sidewalks end north of MP 0.5 and the runoff enters roadside ditches at this point. Flowing northerly, the County installed a cross-draining culvert at approximate MP 1.2, and double culverts nearer to the Helena Valley Canal at about MP 1.6. These three culverts are 42" x 28 ½" corrugated metal arch pipes; each about 56 feet in length. These drains divert the runoff approaching the canal to the east under the road to drain into the agricultural fields.

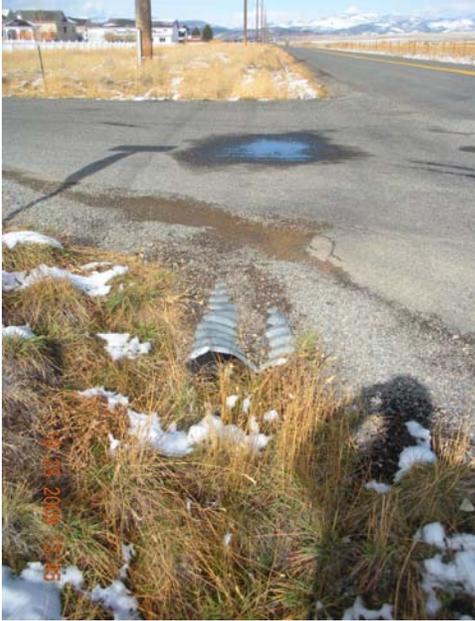
Photo 7: Shallow ditch with a crushed pipe.

There are few cross-drains under the road between Canyon Ferry Road and York Road (MP 2.0 to MP 4.0). Similarly, runoff picked up in this area is therefore conveyed primarily along the roadside, crossing under roads that intersect Lake Helena Drive by the means of small-diameter approach drains. As previously discussed, the roadside ditches in this segment are very shallow with issues of not having adequate cover between the top of the pipe and the approach surfacing. Widening the roadside ditch in this area will provide not only an improved clear recovery area for motorists, but will also increase the ditch depth to allow for improved installation of culverts. Culverts with adequate depth of cover will experience less structural damage from vehicles crossing over the culvert, and lessen crushing the ends of the pipes due to running over the inlets and outlets while turning in or out of approaches.

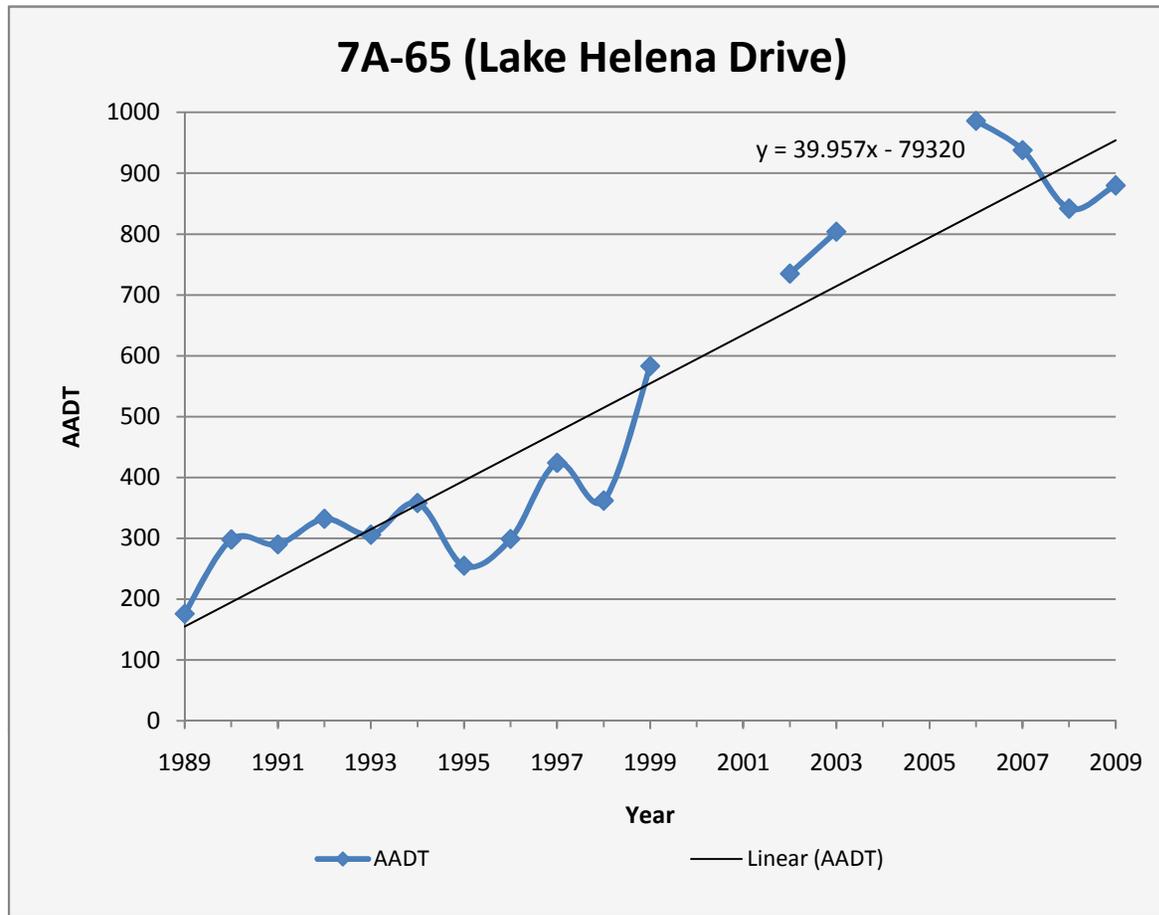
7A-65 (Lake Helena Drive - North of Deal Lane)

Year	AADT
1989	176
1990	298
1991	290
1992	332
1993	306
1994	358
1995	255
1996	299
1997	424
1998	362
1999	583
2000	
2001	
2002	735
2003	804
2004	
2005	
2006	986
2007	938
2008	842
2009	880
2029	1753

2009	954
2029	1753
Yearly Growth Rate	3.09%

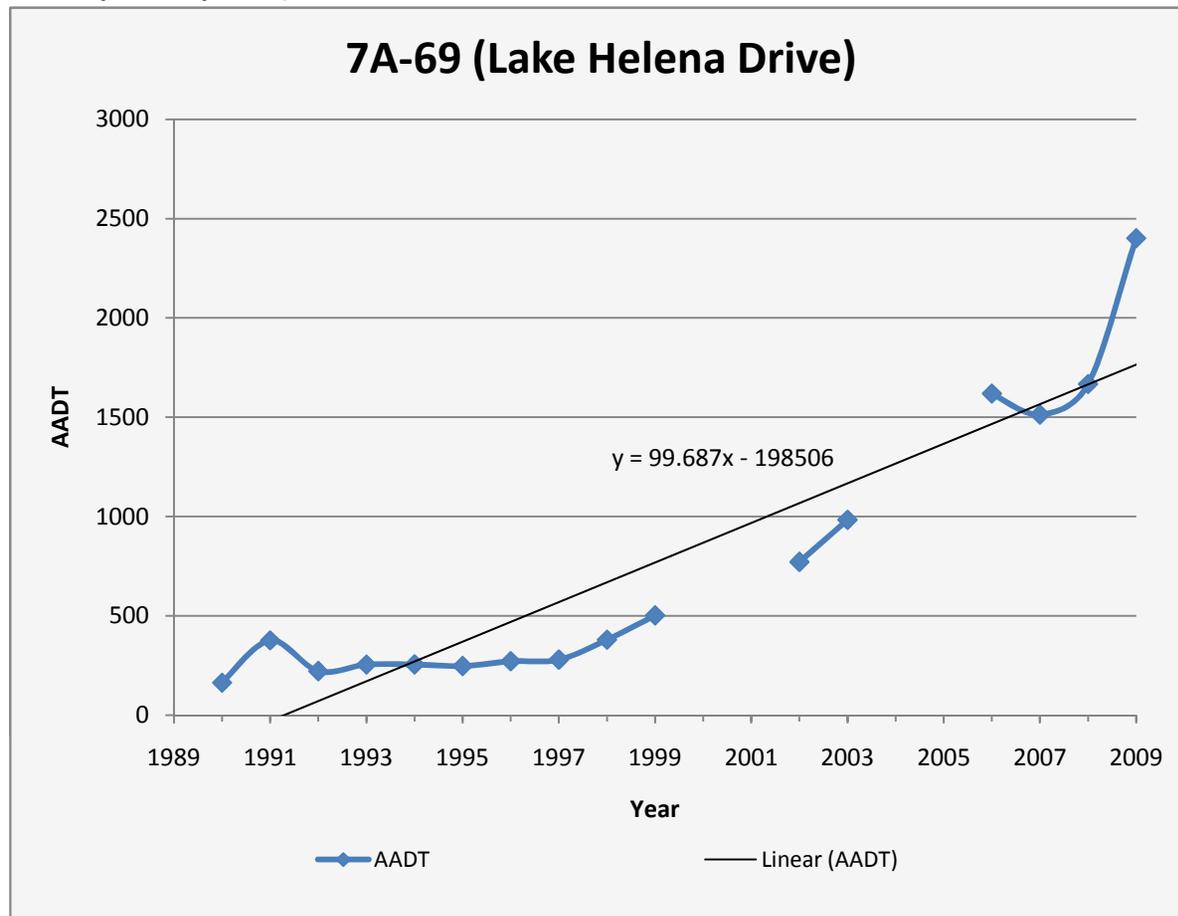
7A-69 (Lake Helena Drive - North of Canyon Ferry Road)

Year	AADT
1989	
1990	163
1991	376
1992	221
1993	254
1994	255
1995	247
1996	271
1997	279
1998	379
1999	502
2000	
2001	
2002	771
2003	983
2004	
2005	
2006	1619
2007	1513
2008	1667
2009	2401
2029	3759

2009	1765
2029	3759
Yearly Growth Rate	3.85%

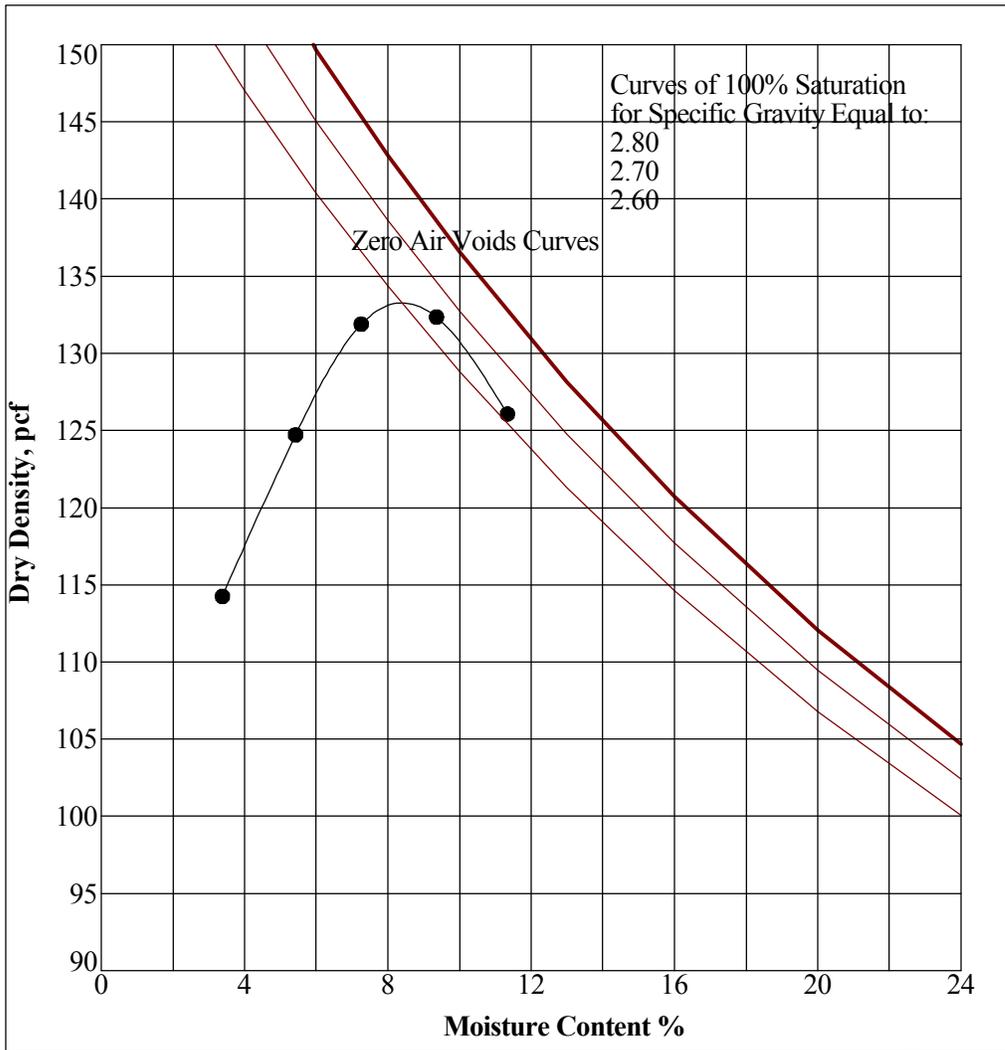
Laboratory Compaction Characteristics of Soil (Proctor)

ASTM D 698 Method C

Maximum Dry Density, pcf	Optimum Moisture Content %
133.2	8.5
Rammer Type:	Mechanical
Preparation Method:	Moist

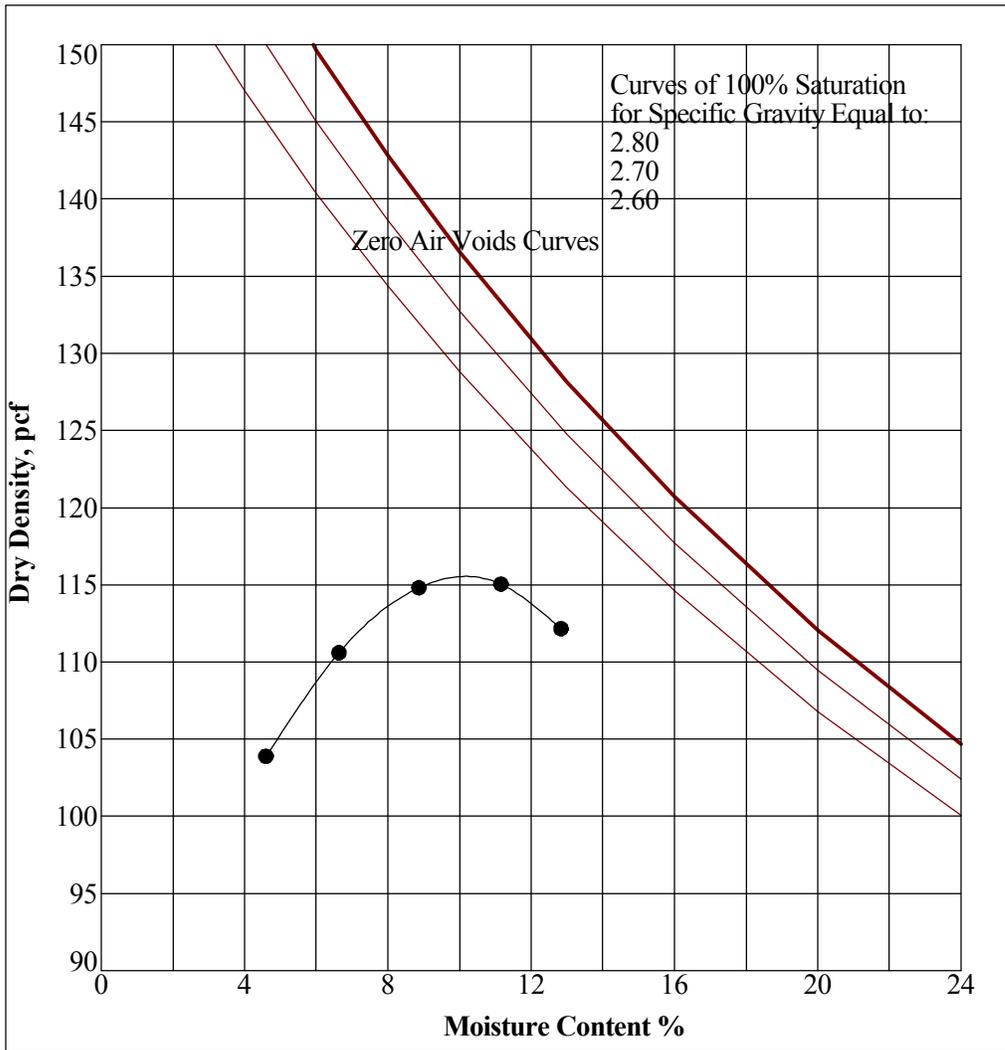
Laboratory Compaction Characteristics of Soil (Proctor)

ASTM D 698 Method C

Maximum Dry Density, pcf	Optimum Moisture Content %
115.8	10.1

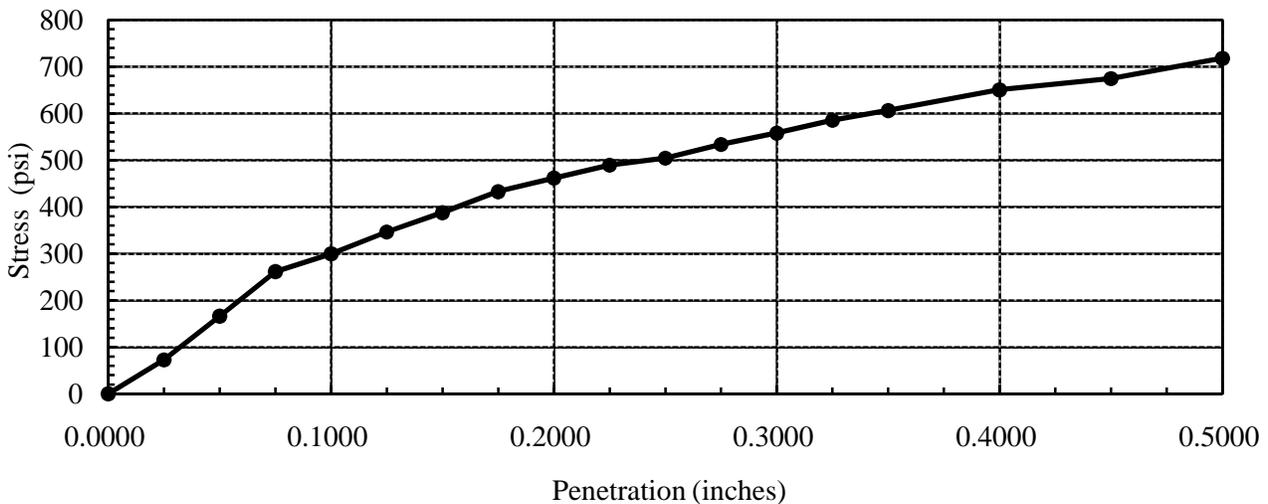
California Bearing Ratio Test

Surcharge Weight 22.5 lbs Surcharge Pressure 128.1 psf
 CBR @ 0.1 in. **30.0** CBR @ 0.2 in **30.8**
