East Helena Superfund Site Agricultural Lands Field Inspection

August 2003

Prepared by
CH2MHILL

East Helena Agricultural Lands Field Inspection

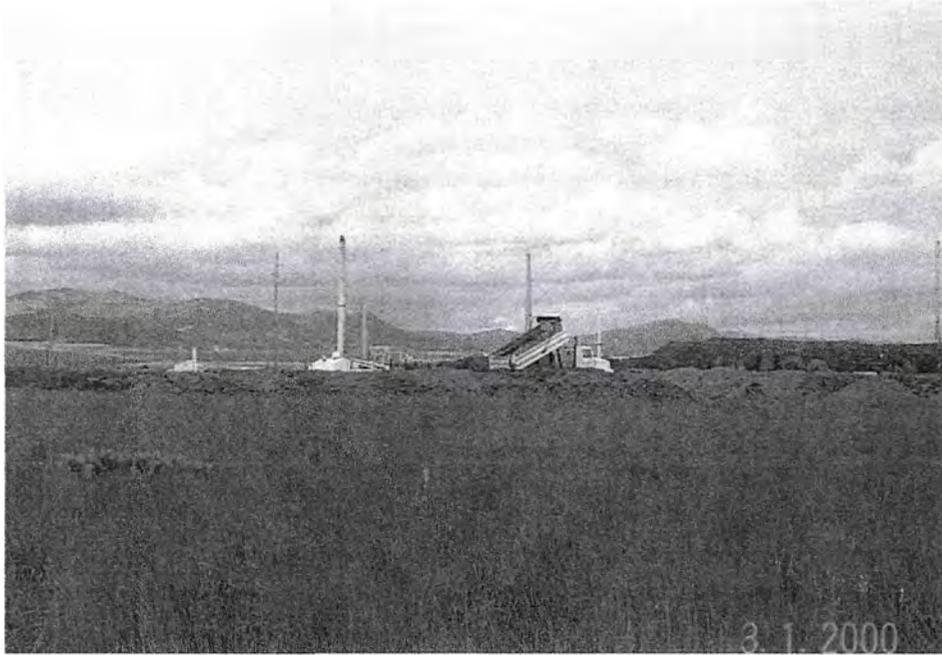
- The grasses throughout the east fields are healthy and ground cover is good to excellent. They consist mostly of crested wheatgrass. The vegetative cover inhibits blowing dust. Toadflax and whitetop weeds appear to be a minor problem.

Figure 1 East Fields - looking west

- Dr. Mosley, MSU recommended that grazing by either horses, sheep, or cattle would benefit the vegetative community and promote growth, though water and fencing would need to be provided. He recommended that Asarco contact Rodney Kott, MSU, to see if an arrangement can be made to allow sheep to graze.

- Dr. Mosely recommended winter grazing, (October through January) to reduce the existing dead-fall. Supplemental protein would need to be provided for winter grazing. Sheep could be introduced into the property in the spring (May and June) to control weeds, and then horses, cattle or sheep in the summer. Horses may be considered for aesthetic reasons. Dairy cows are not recommended. He recommended approximately 25 head of cattle (or their equivalent) for the 200 acres (1 animal unit per 1½ acres per month for a 6 month grazing season).

- Chemicals (spraying) could also be used for weed control.
- Stormwater ponding may present a livestock arsenic exposure in some low lying areas.

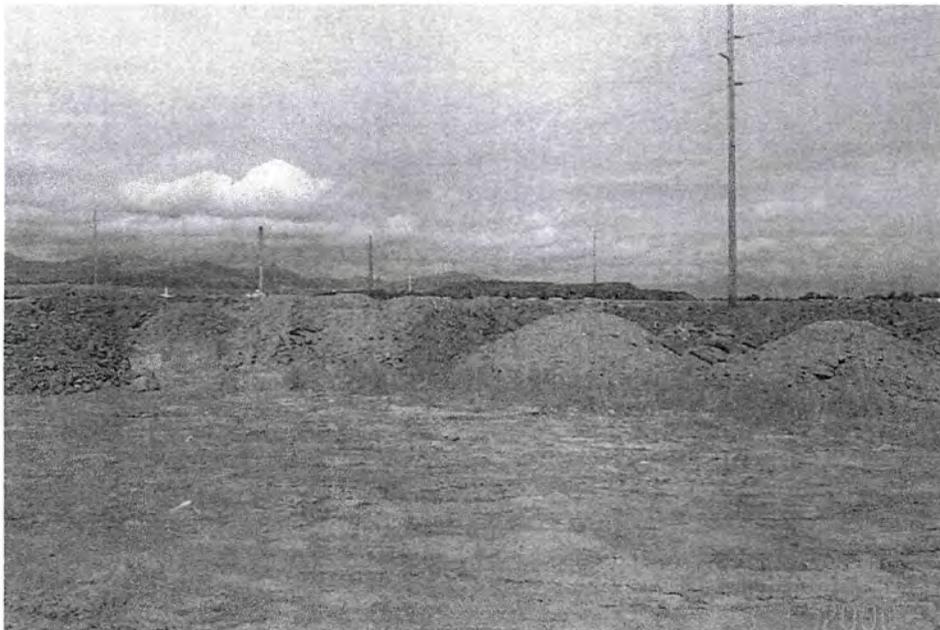
Figure 2 East Fields - looking west (East Fields continue to receive spoils from ongoing removals)

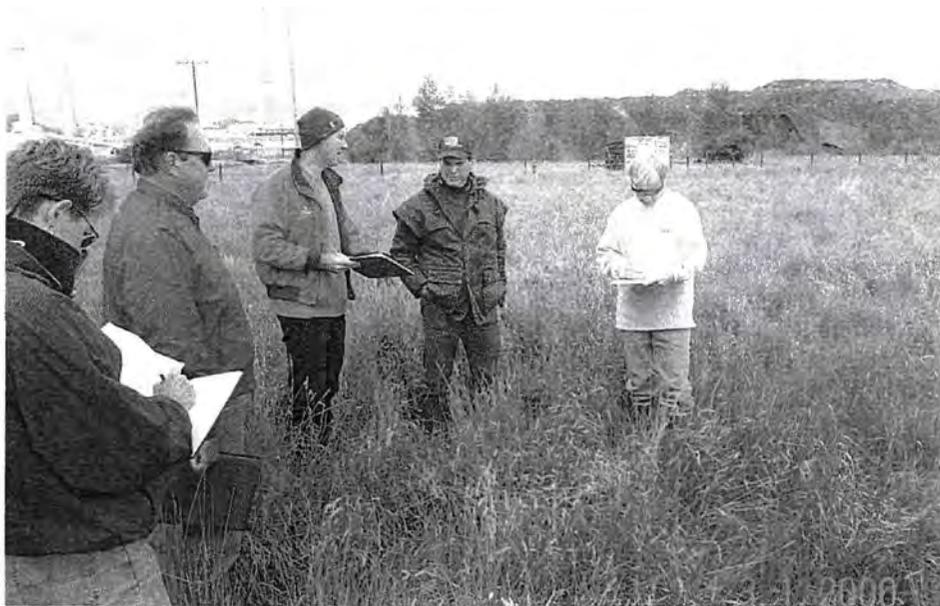
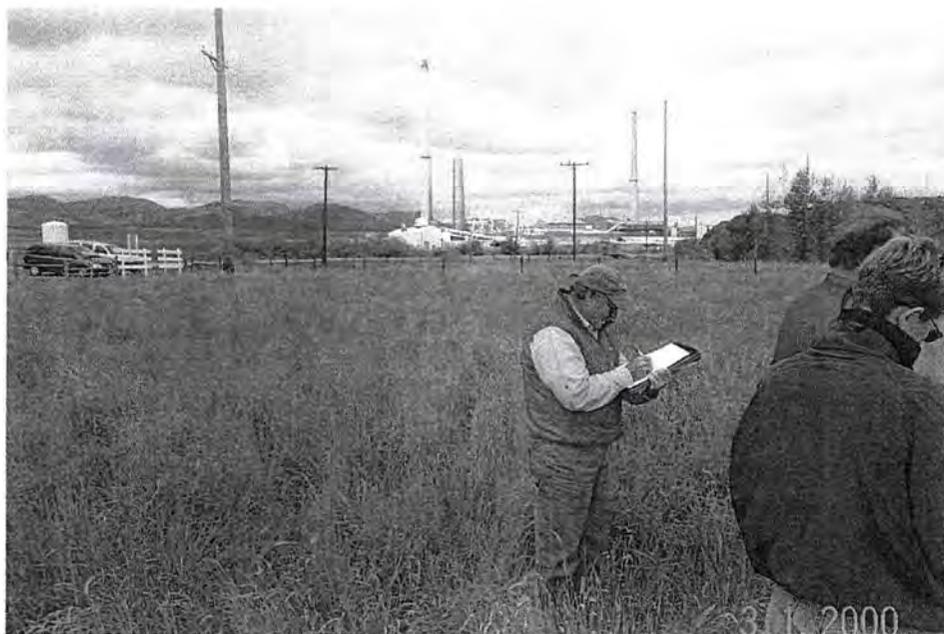
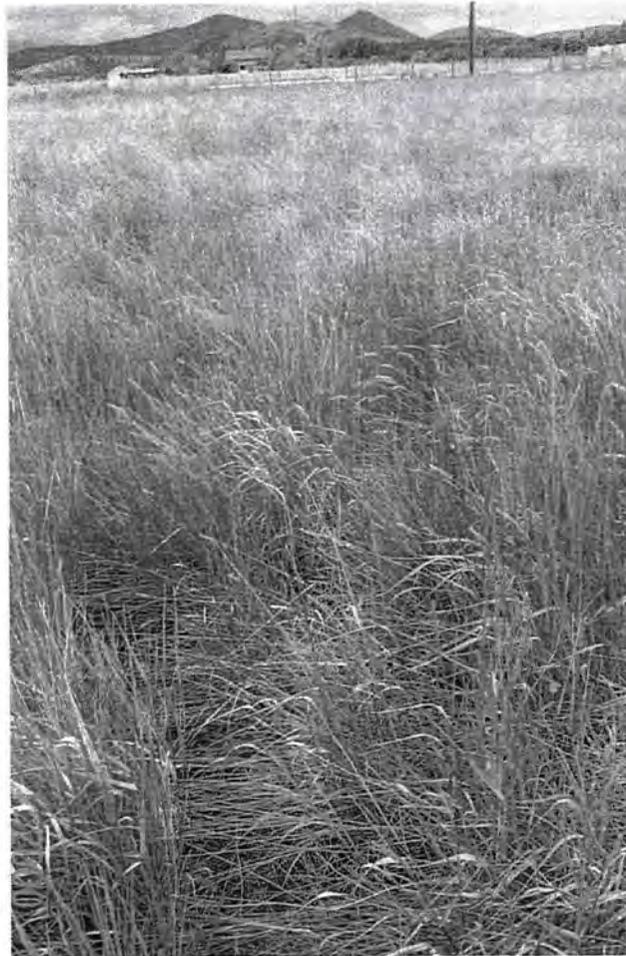
- The 35 acres of Asarco land, located immediately east of the smelter, have a good to excellent stand of drought resistant grasses and vegetation (mostly crested wheatgrass). The area was sprayed and seeded in 2001. Weed controls by Asarco, since the inspection of 2001, show success in reducing Kochia. A map showing the location of the West Portion of the East Fields is included in Appendix B.

Figure 3 West Portion of the East Fields - looking southwest

Figure 4 West Portion of the East Fields - looking southwest

Figure 5 West Portion of the East Fields -
looking north

- The dead growth may be more palatable to livestock after the existing vegetation has been "knocked down". Burning, mowing and grazing are "knockdown" options. Burning would not likely be desirable because of close proximity to residences, and mowing would be difficult due to rough terrain. The most economical option would be to allow grazing.
- Both the east and west portions will require some new fencing and fence repair by the producer if grazed. Grazing will in time improve the palatability of wheatgrasses.
- Livestock (cattle, sheep, or horses) could be initially introduced in the fall and then in the spring of subsequent years.

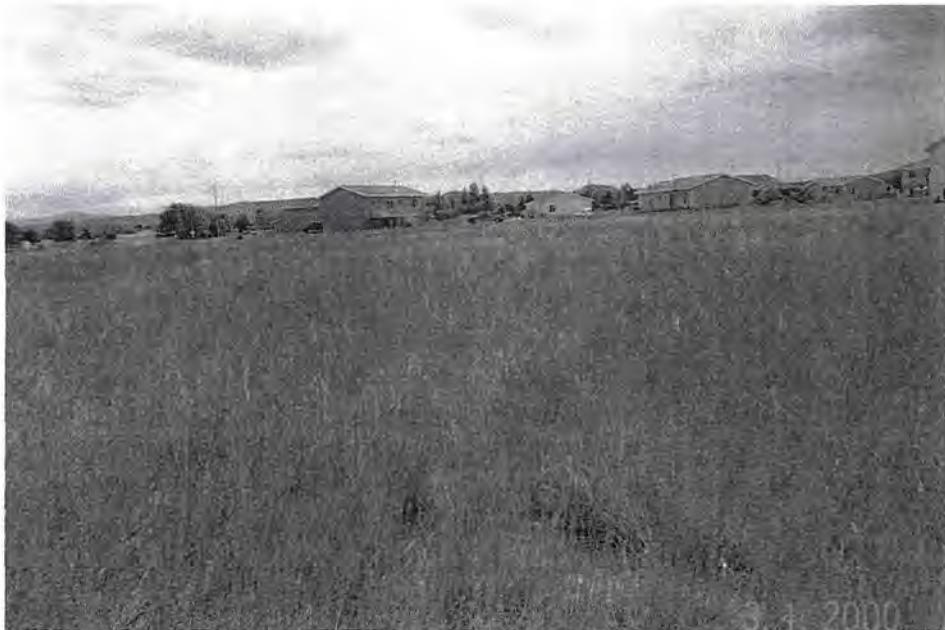
- The Diehl property was deep tilled to a depth of 24-30 inches in 1993. Original lead concentrations were within the range of 1,000 to 1,800 mg/kg. After four or more passes with the deep tiller, concentrations throughout the tilled soil profile were reduced to about 300 to 500 mg/kg. A map of the Diehl Property and associated soil sampling results are included in Appendix B.
- Lime was added as needed to raise the pH to greater than 7.
- The property is currently being developed for residential homes and some limited commercial development. A middle school was constructed shortly after the response action was taken.
- See existing Hydrometrics reports for additional pre- and post- sampling and tillage and liming rates.

Figure 6 Diehl Property - Looking east

- The development looked good. Remediation of the property was successful. No changes were recommended. Although weeds are present.

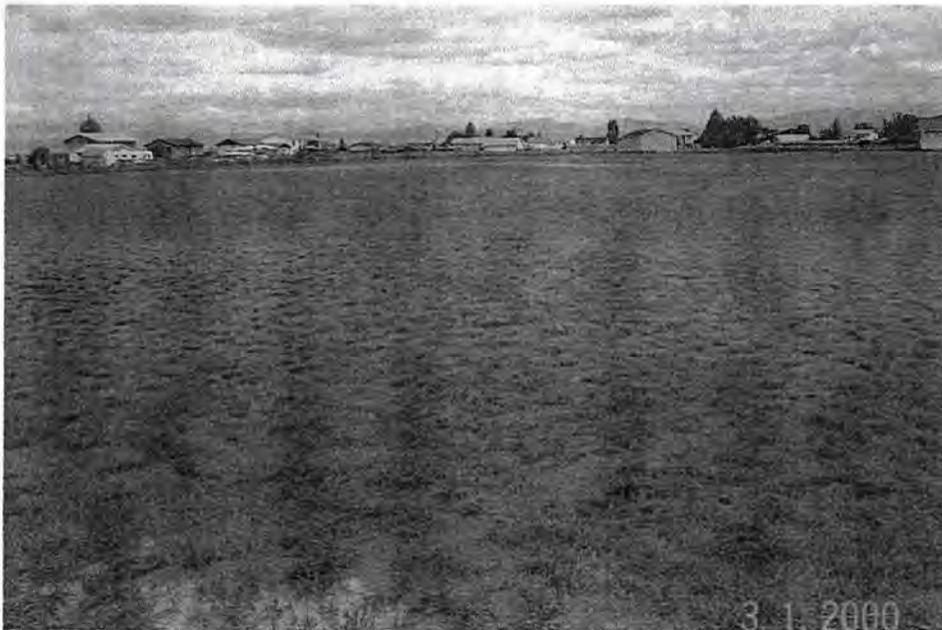
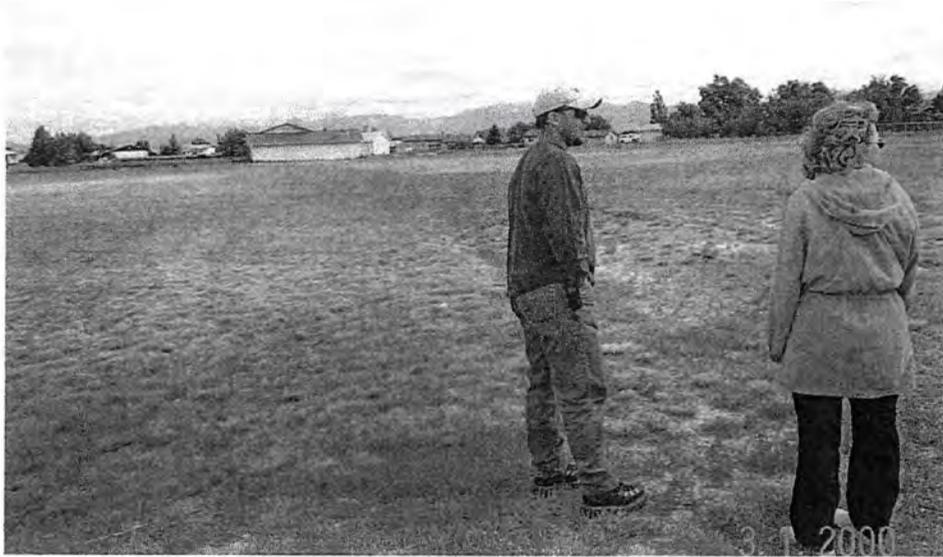
- The 2.8 acre La Casa Grande Park is located in a 250 lot subdivision. The park had surface soil lead concentrations ranging from 297 mg/kg to 2,166 mg/kg. It was tilled to a depth of approximately 10 inches. Lime was added for neutralization. Surface soil lead levels are now less than 500 mg/kg. A map and soil sampling results are included in Appendix B.
- A sprinkler system has been installed by the homeowners association (contact Richard Wilson). They broadcast seeded turf grass, but it did not take.
- Ground cover is good to excellent, though weeds have established in the baseball diamonds.

Figure 7 La Casa Grande Park - looking northwest

Figure 8 La Casa Grande Park - looking northeast

- More involvement from other homeowners in the subdivision would help to reduce the burden of maintenance costs for the few homeowners who contribute.

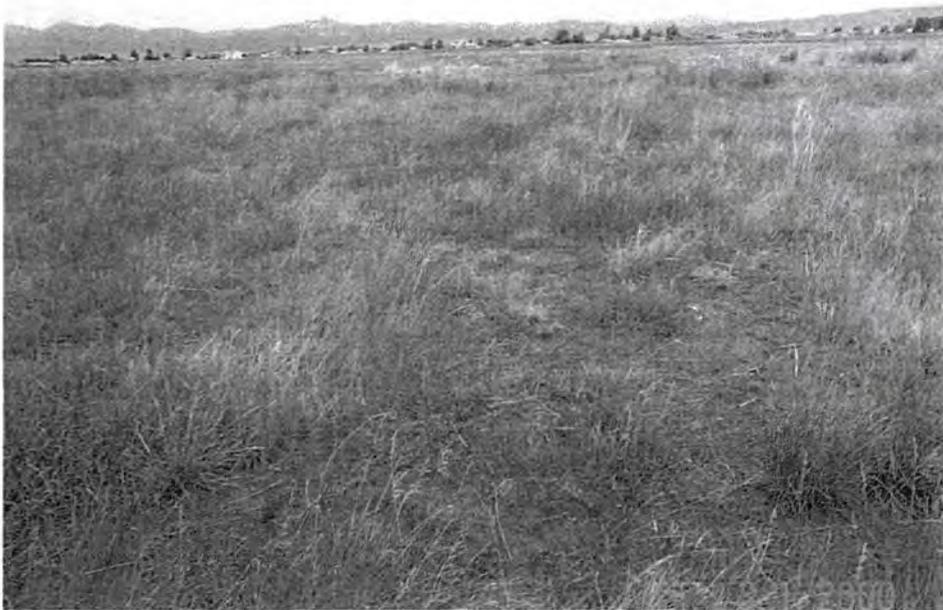
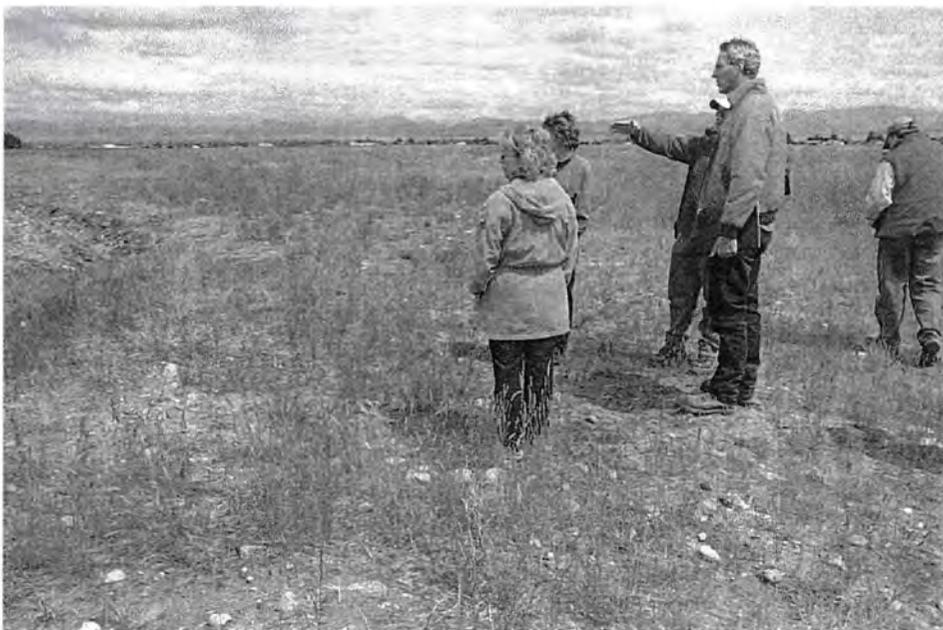
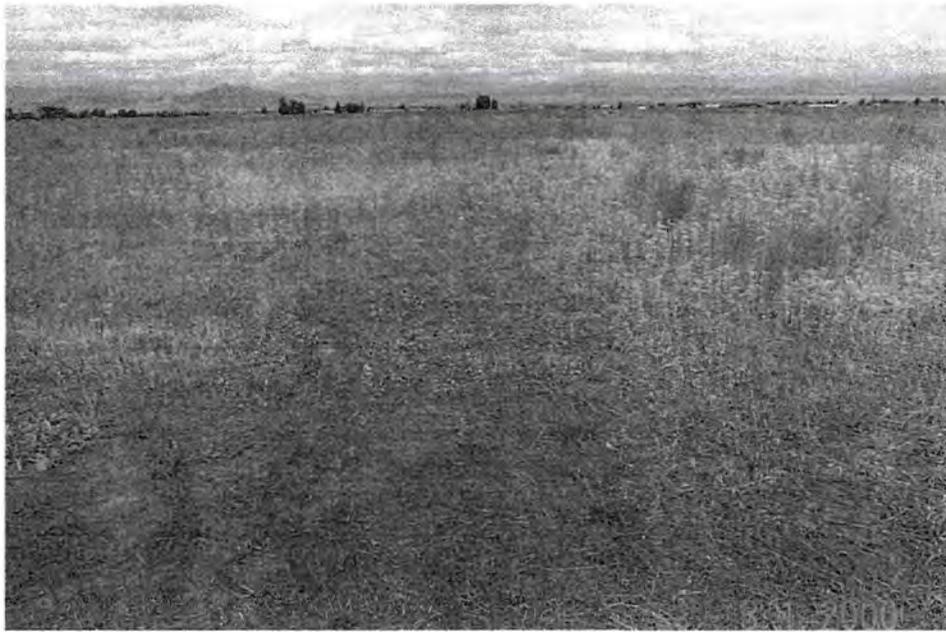
- A marked improvement in vegetative cover was noted, in contrast to the severely over-grazed condition of these fields observed just two years ago. Few bare areas remain and the grasses are good to excellent. Some weed problems were noted although the lessee has initiated weed control.

Figure 9 Dartman Fields - looking east

Figure 10 Dartman Fields - looking north

Figure 11 Dartman Fields - looking west

- A total of 23 cows and calves have been allowed to graze the area from May through October. Though this number is below the fields grazing capacity, no increase was recommended.
- Encourage the use of all 200 acres for uniform grazing, to prevent over-use in selected areas.
- It was recommended that some of the less vegetated areas be seeded.
- It was the opinion of the MSU scientists that vegetative cover was as good as it would get without additional work and that the absence of grazing cattle would not have an appreciable impact in reducing the dust generation from the pasture.
- However, if dust generation is a problem, Dr. Mosley recommended that no grazing will improve ground cover, bare areas should be seeded, and irrigation and fertilizer should be applied.

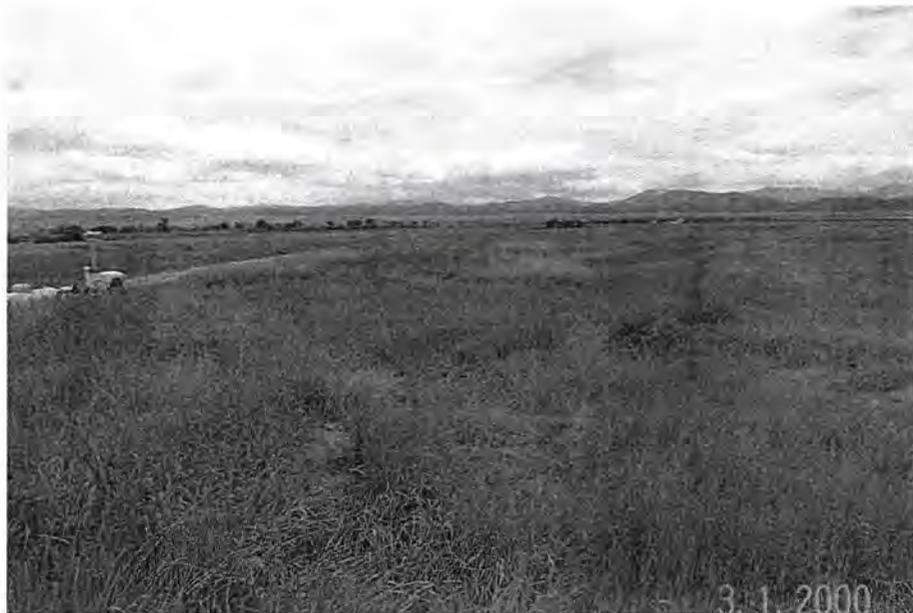
- This area is one of three areas in the Helena Valley from which replacement soils were strip-mined during the height of the removal action. Located immediately east of the former Girls' Reform School off Sierra Road, this area provided the majority of replacement soils. A map showing the location of the permitted mining locations is included in Appendix B.
- Approximately 12 inches of topsoil were mined from the approximately 150 acre parcel.
- The land has been seeded with alfalfa and grasses, and has been irrigated. Mustard is common throughout the alfalfa. The vegetation is excellent.
- The other 2 sources of topsoil are located off Arrowhead Lane and at Merritts farm near Lake Helena. Scott Brown inspected the site at Merritts farm and it is in excellent condition, as only 4 to 6 inches of topsoil were removed from a source that is at least 3 to 4 feet deep.

Figure 12 Menthe - Bahnny Borrow Area - looking northwest

- It was recommended that the borrow site located off Arrowhead Drive near the Masonic Home, where nearly all of the topsoil was removed in 1991 and 1992, be inspected. See attached maps for borrow site locations.

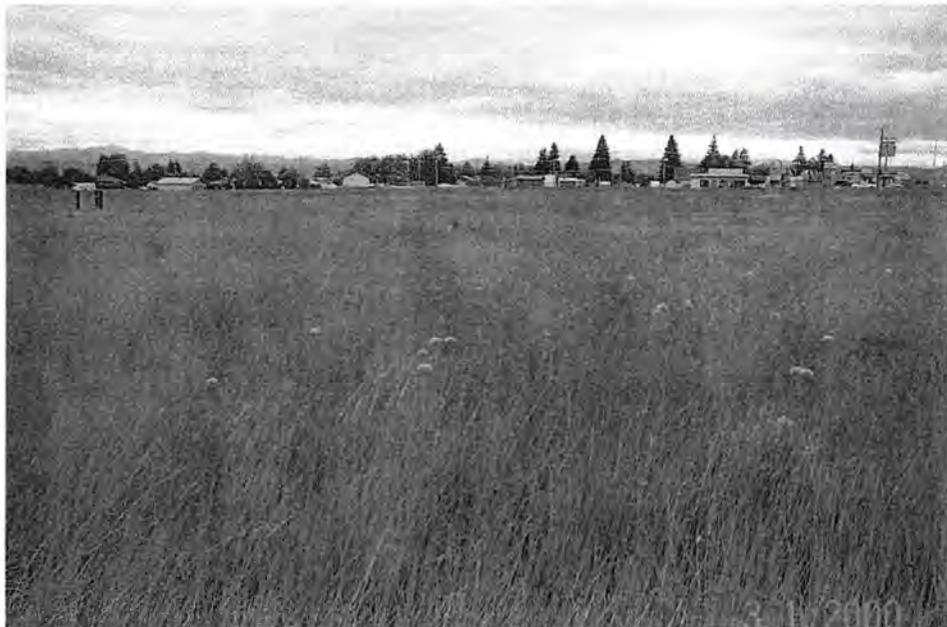
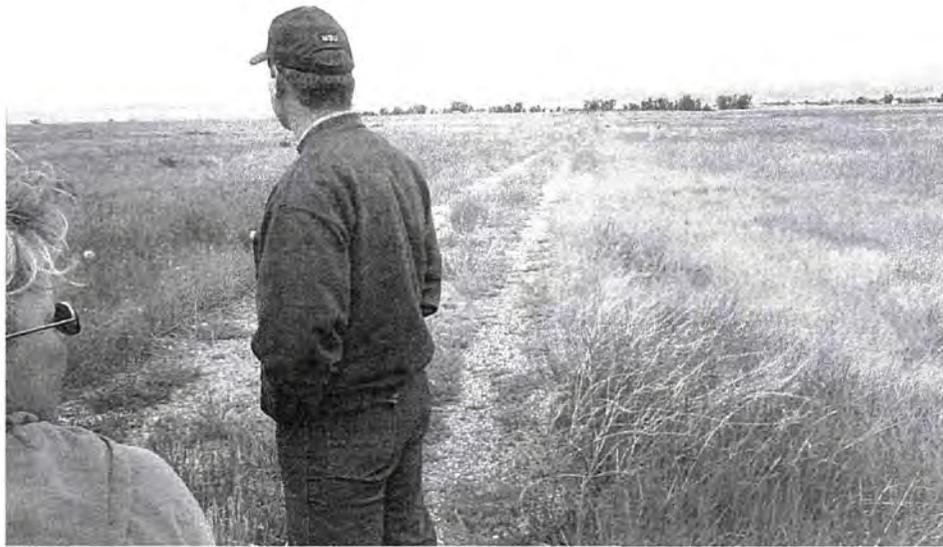
- This 330 acre parcel located west of Wiley Drive is owned by Asarco. The field has improved remarkably since 2001 and years prior, when it was severely overgrazed.
- The area was sampled in 2001. The fields were broken into one-acre sections and 16-spot composite samples (0-1 inch depth) were collected from each section. The lead levels ranged from 229 mg/kg in the northwest area to 4,042 mg/kg in the southeast area. A map showing the Lamping fields sampling sections is included in Appendix B. The fields are a portion of the area labeled Areas 2 and 3 on the map in Appendix C.
- Thirty pairs of Angus cattle graze May through October. The producer rotates his cows (cross-fencing), and the vegetation is good to excellent.

Figure 13 Lamping Fields - looking east

Figure 14 Lamping Fields - looking north

- The current management of the pasture should continue.

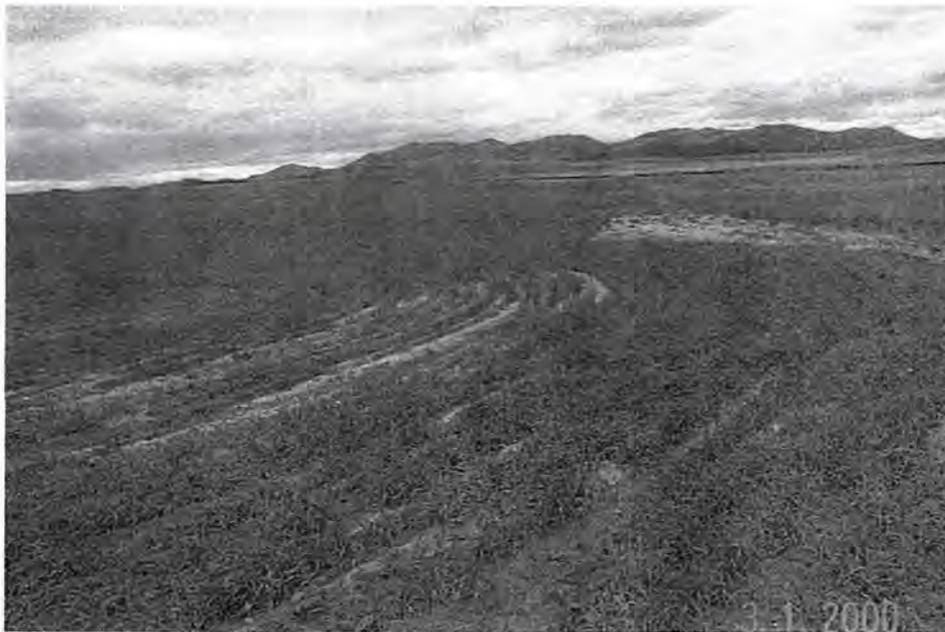
- The approximately 160-200 acre field located south of the smelter, is being leased from Asarco for wheat. This land has been repeatedly plowed and returned to wheat. This appears to be the best use of this land, although when in fallow, wind-blown dust may be a slight problem. Several miles of agricultural fields exist down-wind.

Figure 15 Southern Agricultural Fields - looking southwest

- The current management of the pasture should continue.

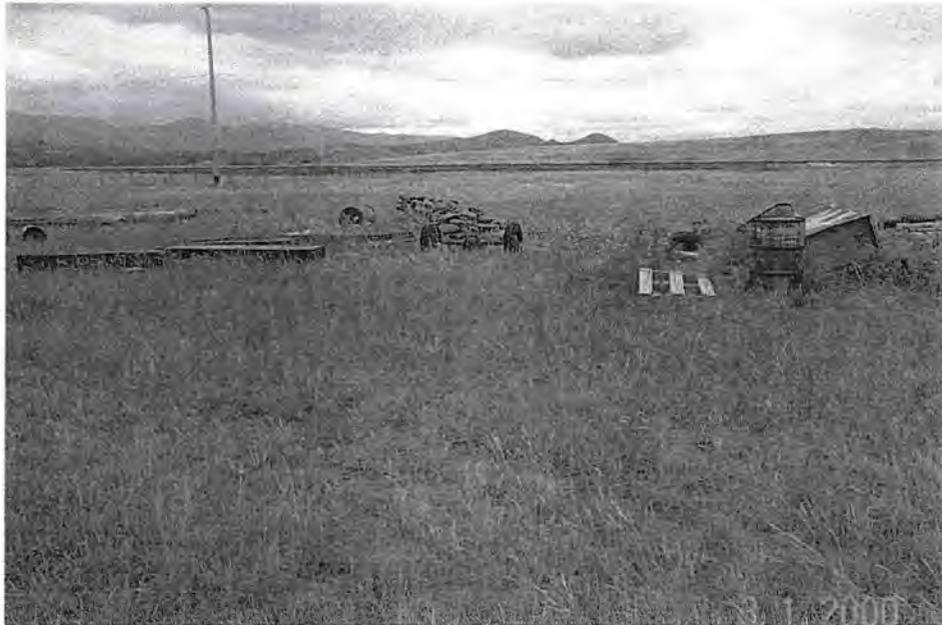
- The fields, owned by Asarco, are located south of the Manlove Addition and west of the rodeo grounds. The fields are located in the area labeled as Area 15 on the map in Appendix C.
- Ground cover—dryland grasses and the like—is good, but repeated foot traffic would likely render areas barren.
- The surface soils in this area are contaminated with lead (levels of 1,000-2,000 mg/kg). The area remains in native condition and bare areas exist. Limited sampling data exist but are not available.
- A proposal to establish a paint ball course here is being considered by Asarco.

Figure 16 Fields south of Manlove Addition - looking south

- Potential recreational health risks must be clarified prior to approval of paint ball course.

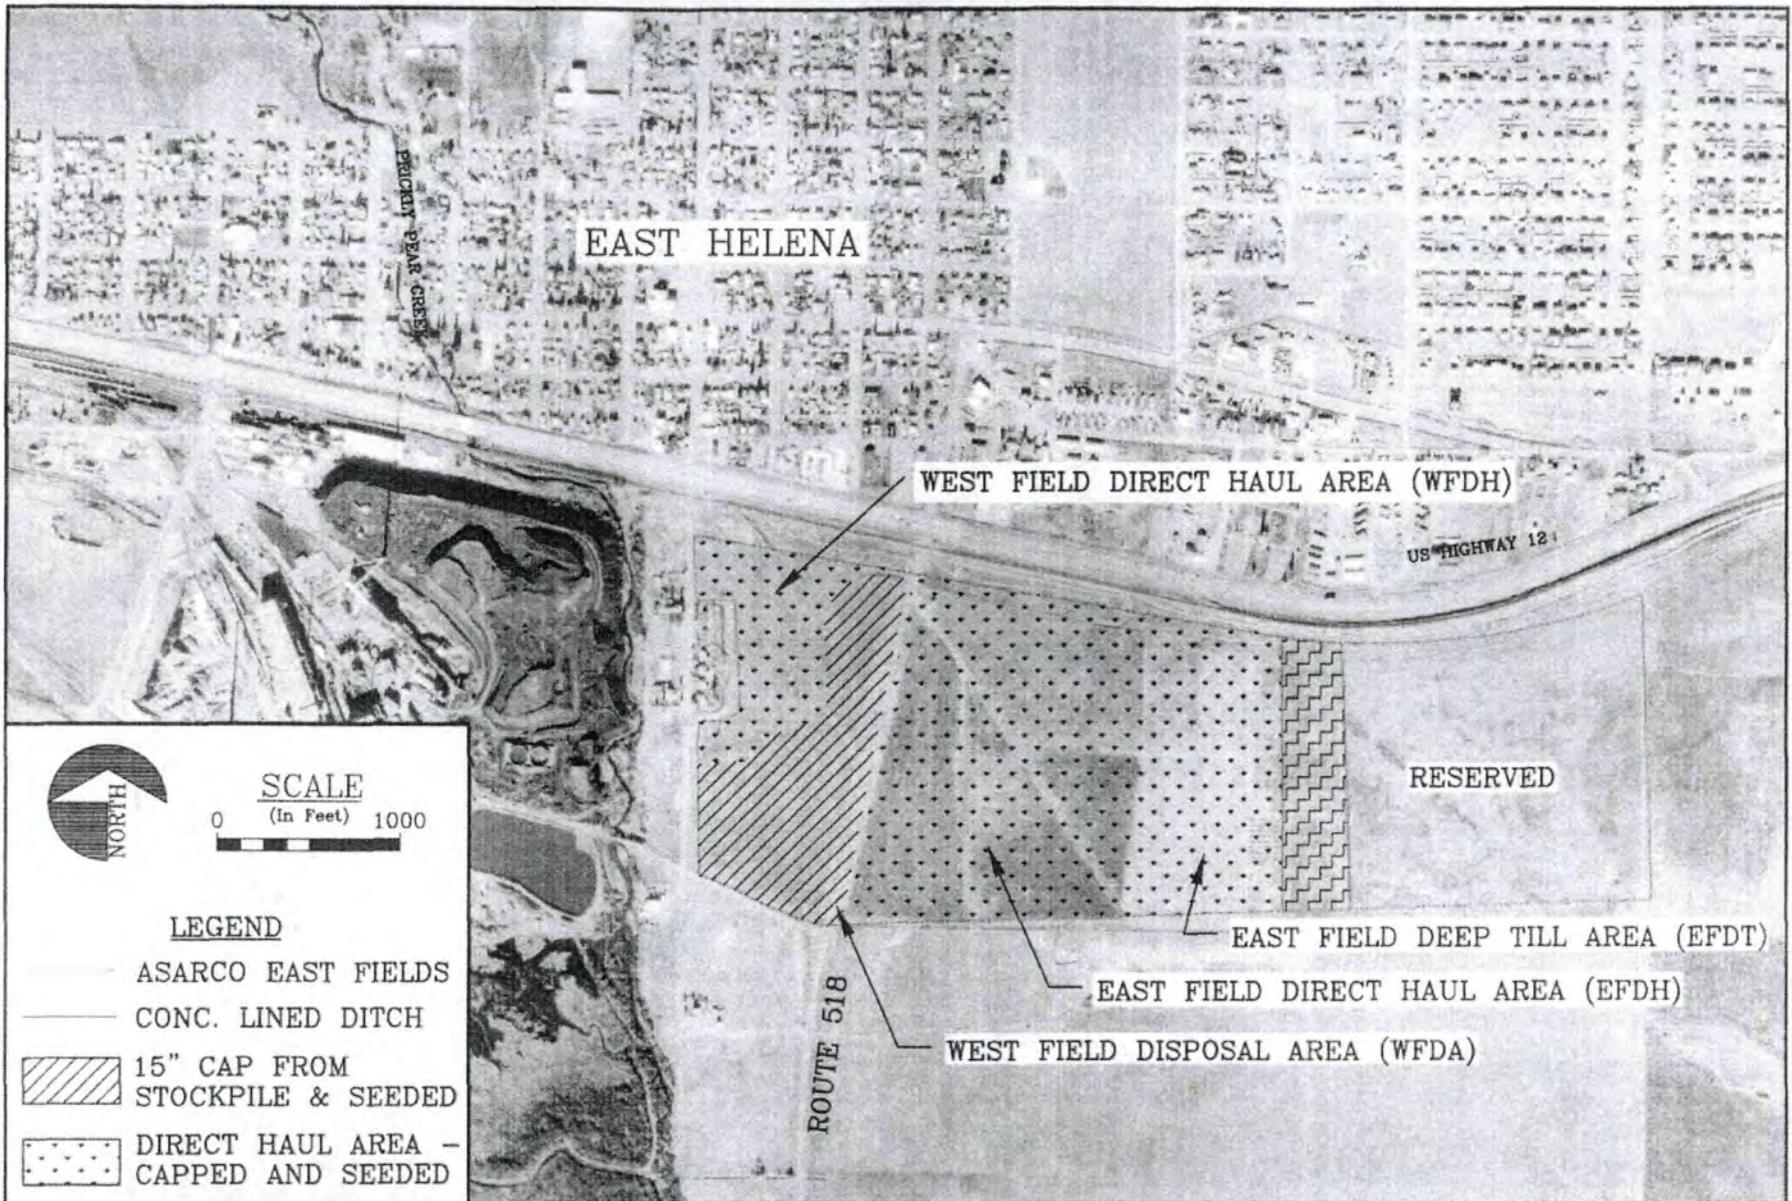
**FIGURE
 4-1**

**EAST FIELDS
 RESIDENTIAL SOIL DISPOSAL AREA**

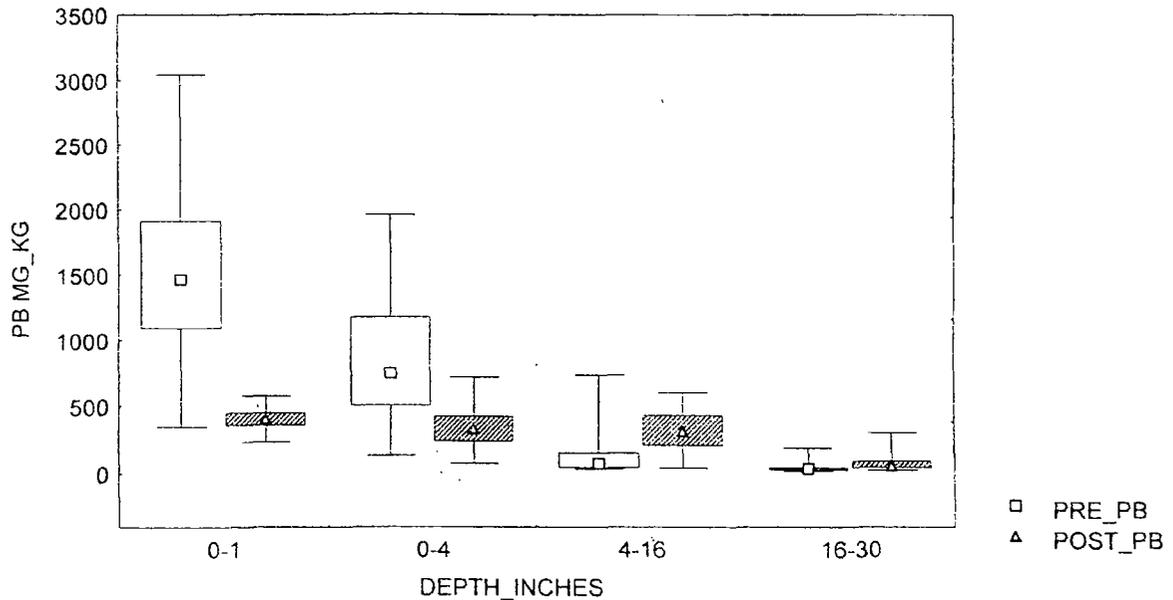
FIGURE 2-8. POST PROFILE LEAD CONCENTRATIONS

Median; Box: 25%, 75%; Whisker: Min, Max
Pre and Post Samples

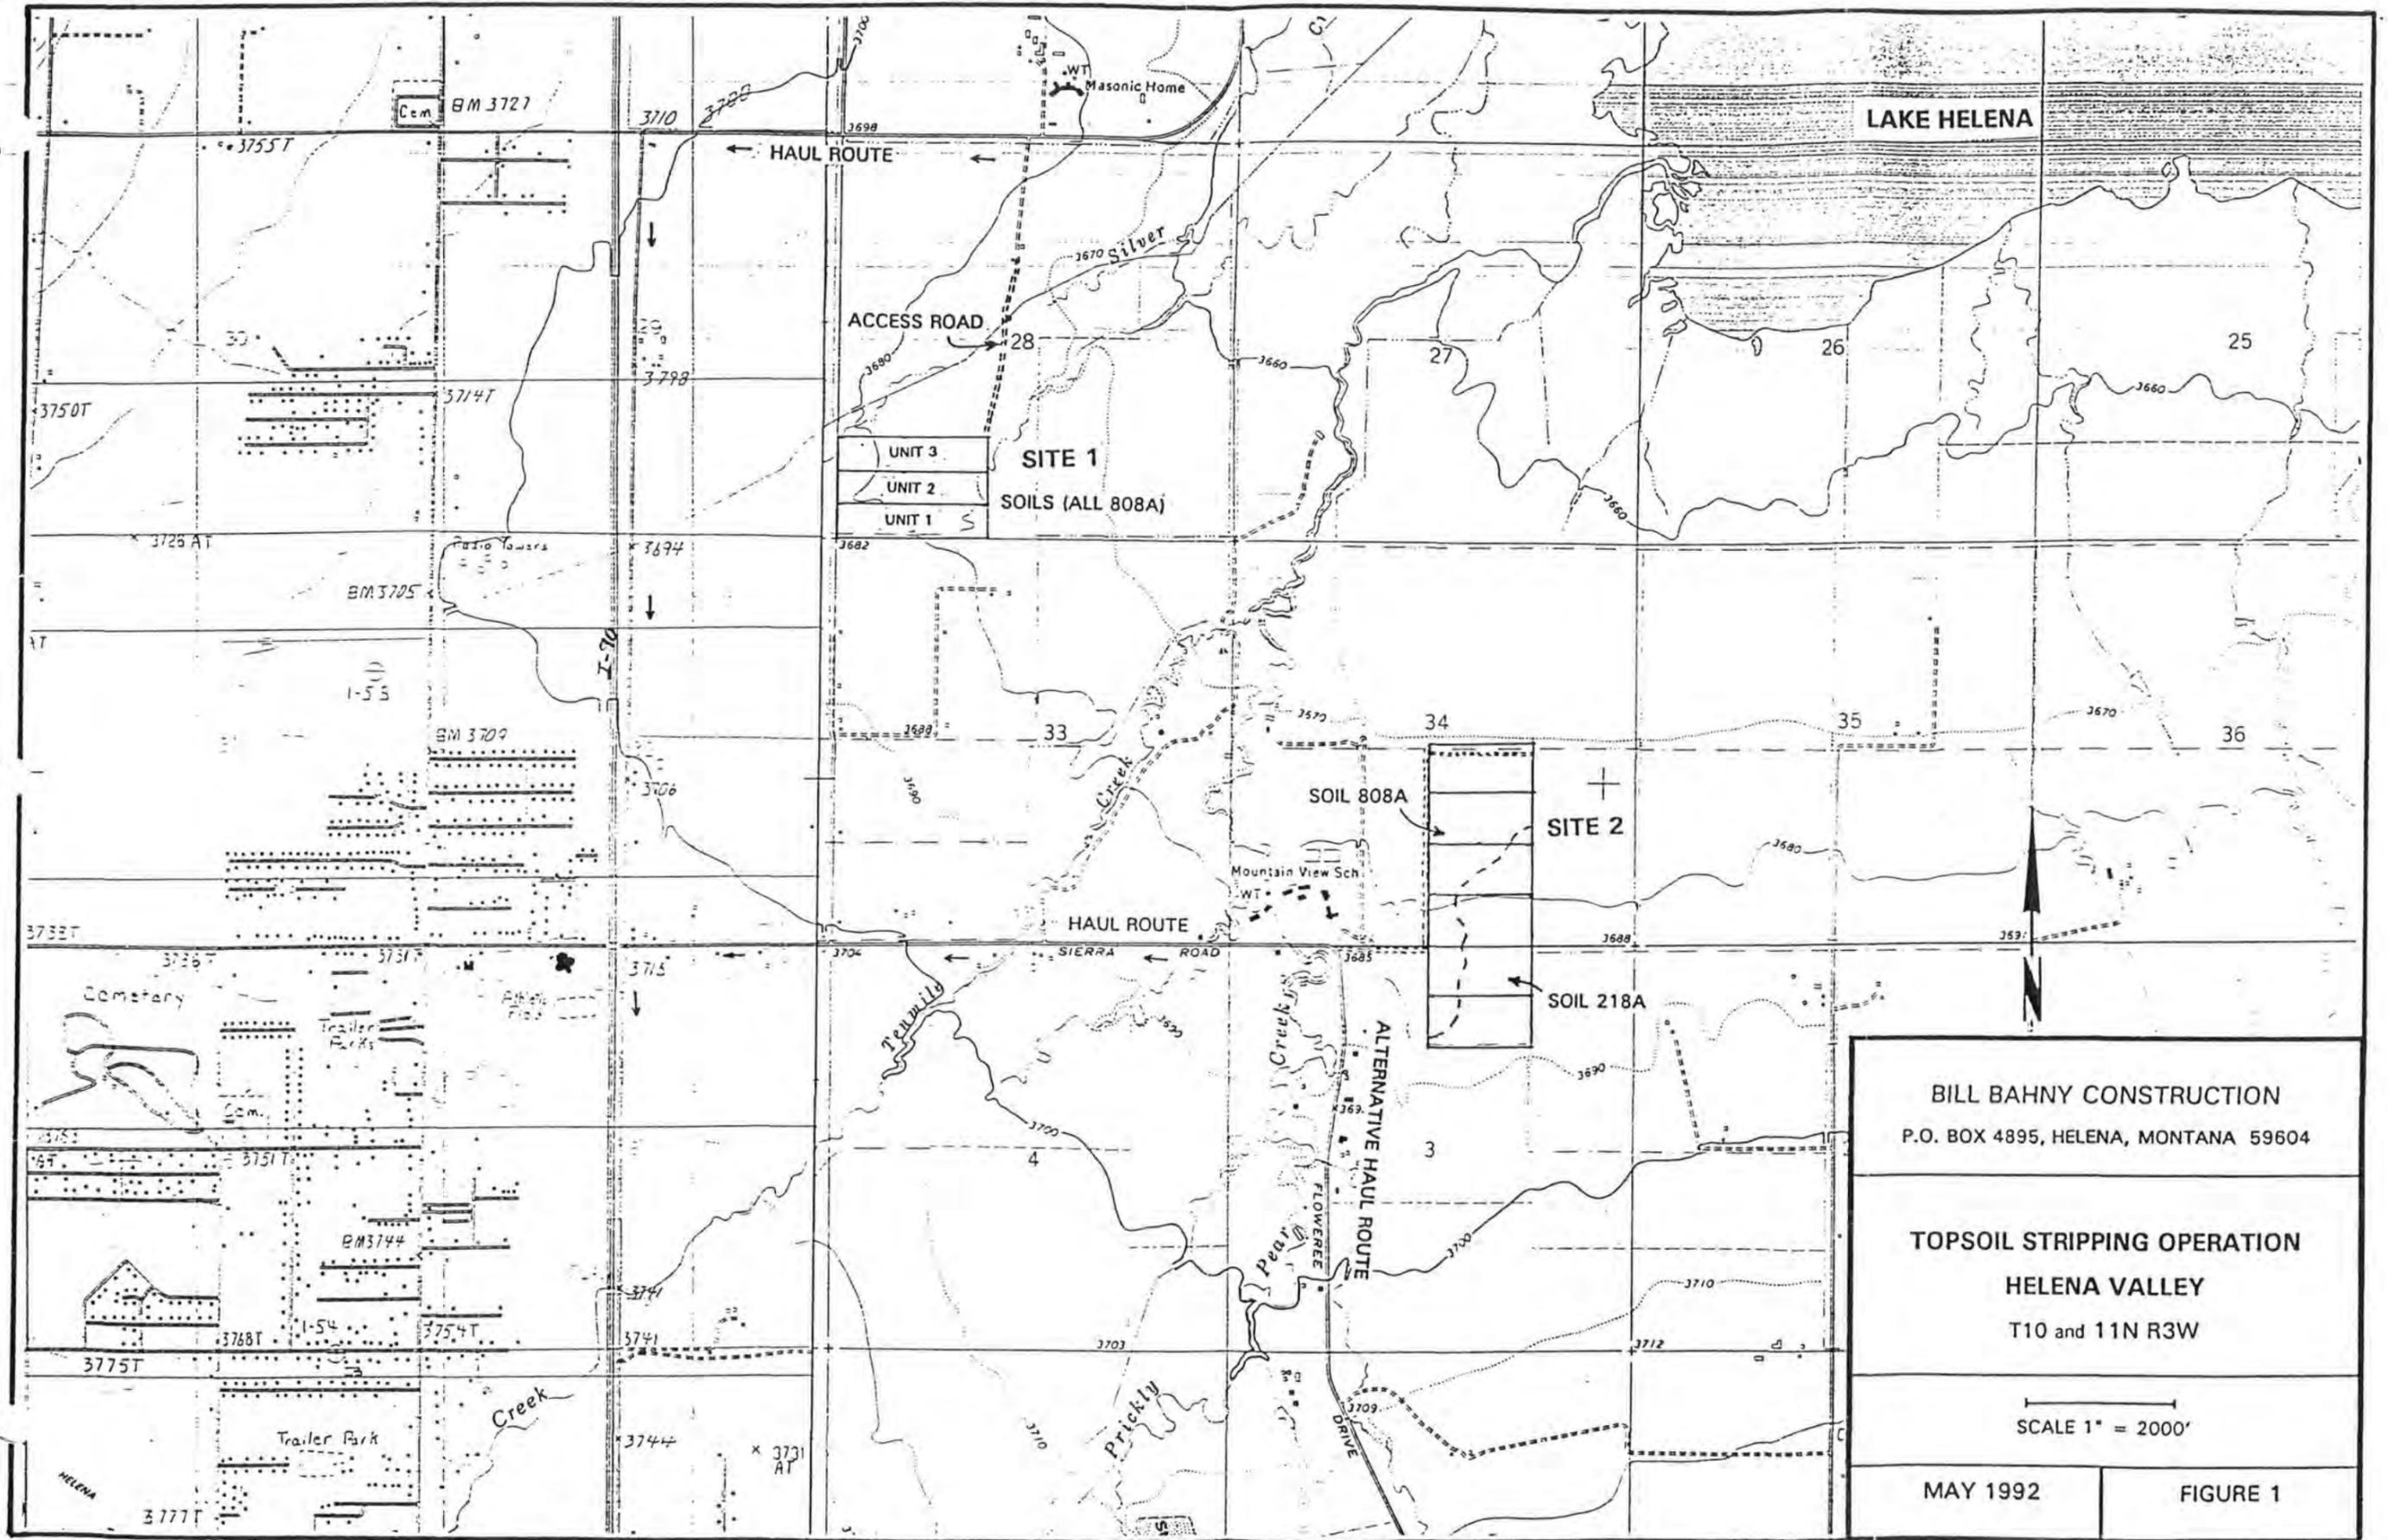
MAY 1992	FIGURE 1
----------	----------

TOPSOIL STRIPPING OPERATION
 HELENA VALLEY
 T10 and 11N R3W

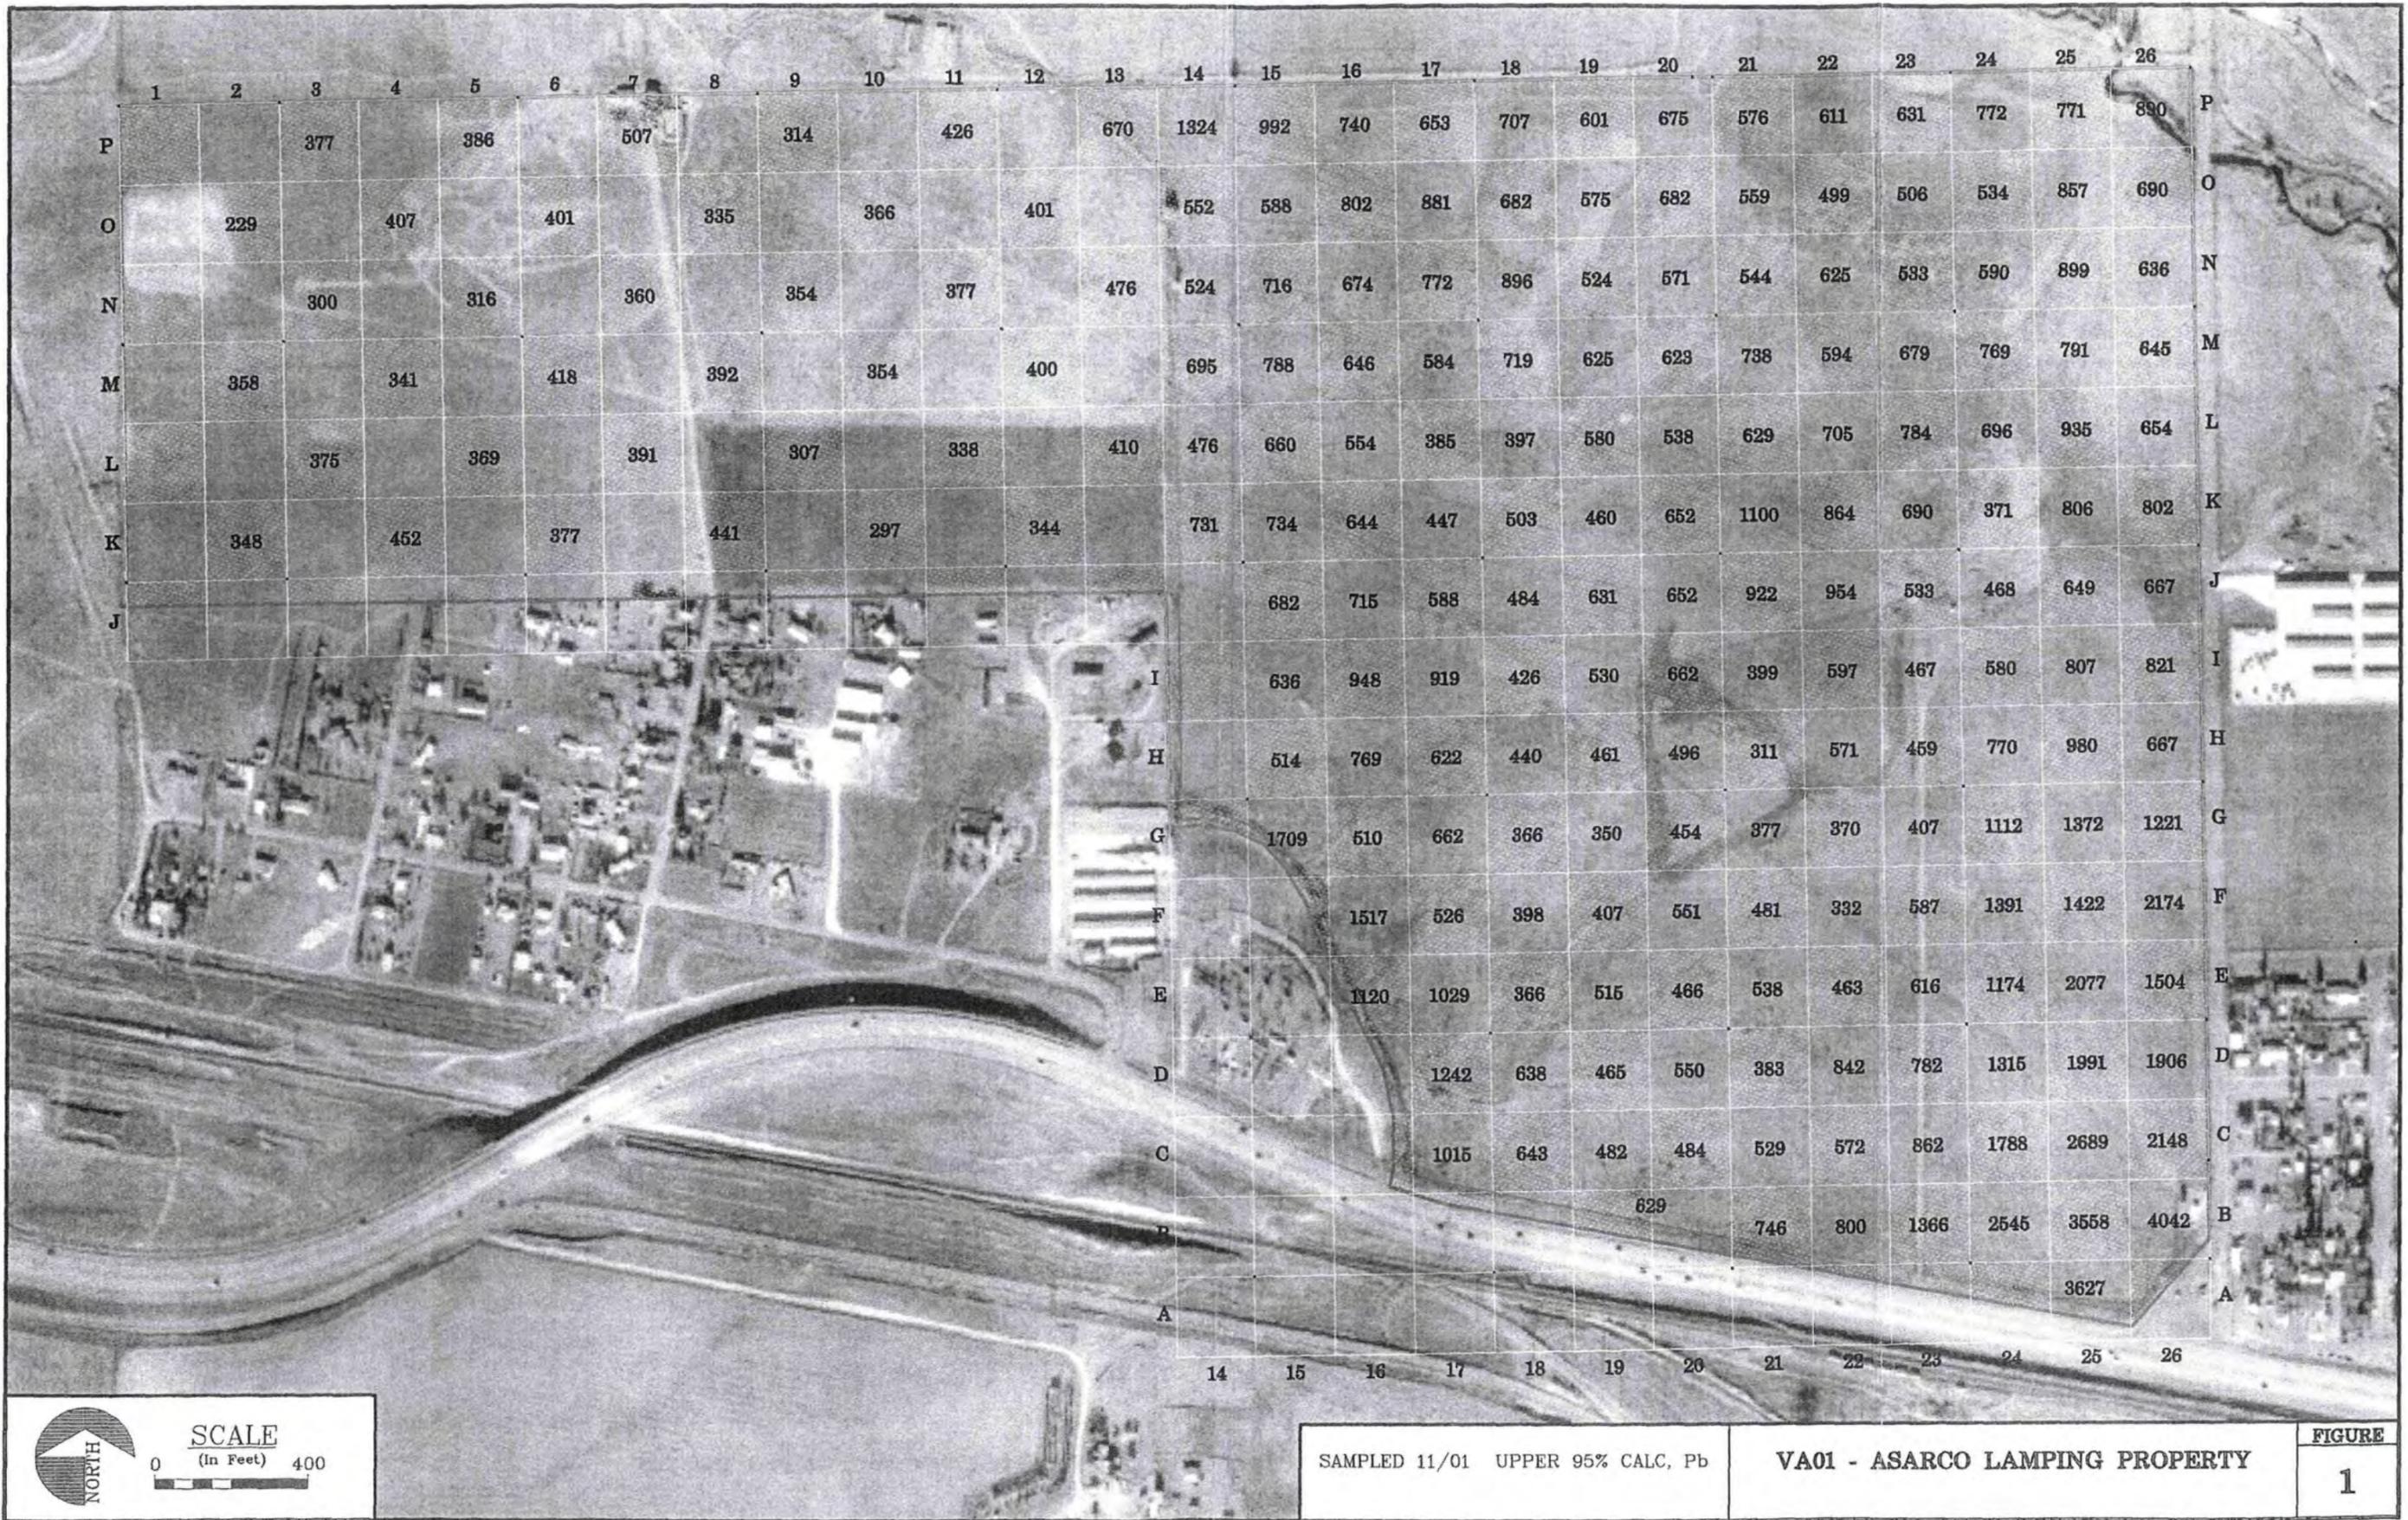
VA01 - ASARCO LAMPING PROPERTY

SAMPLED 11/01 UPPER 95% CALC, Pb
