2018 Helena Valley Flooding

Inputs and Outputs

A Presentation to the Helena Valley Flood Committee

Peter Schade
Lewis & Clark County
Water Quality Protection District

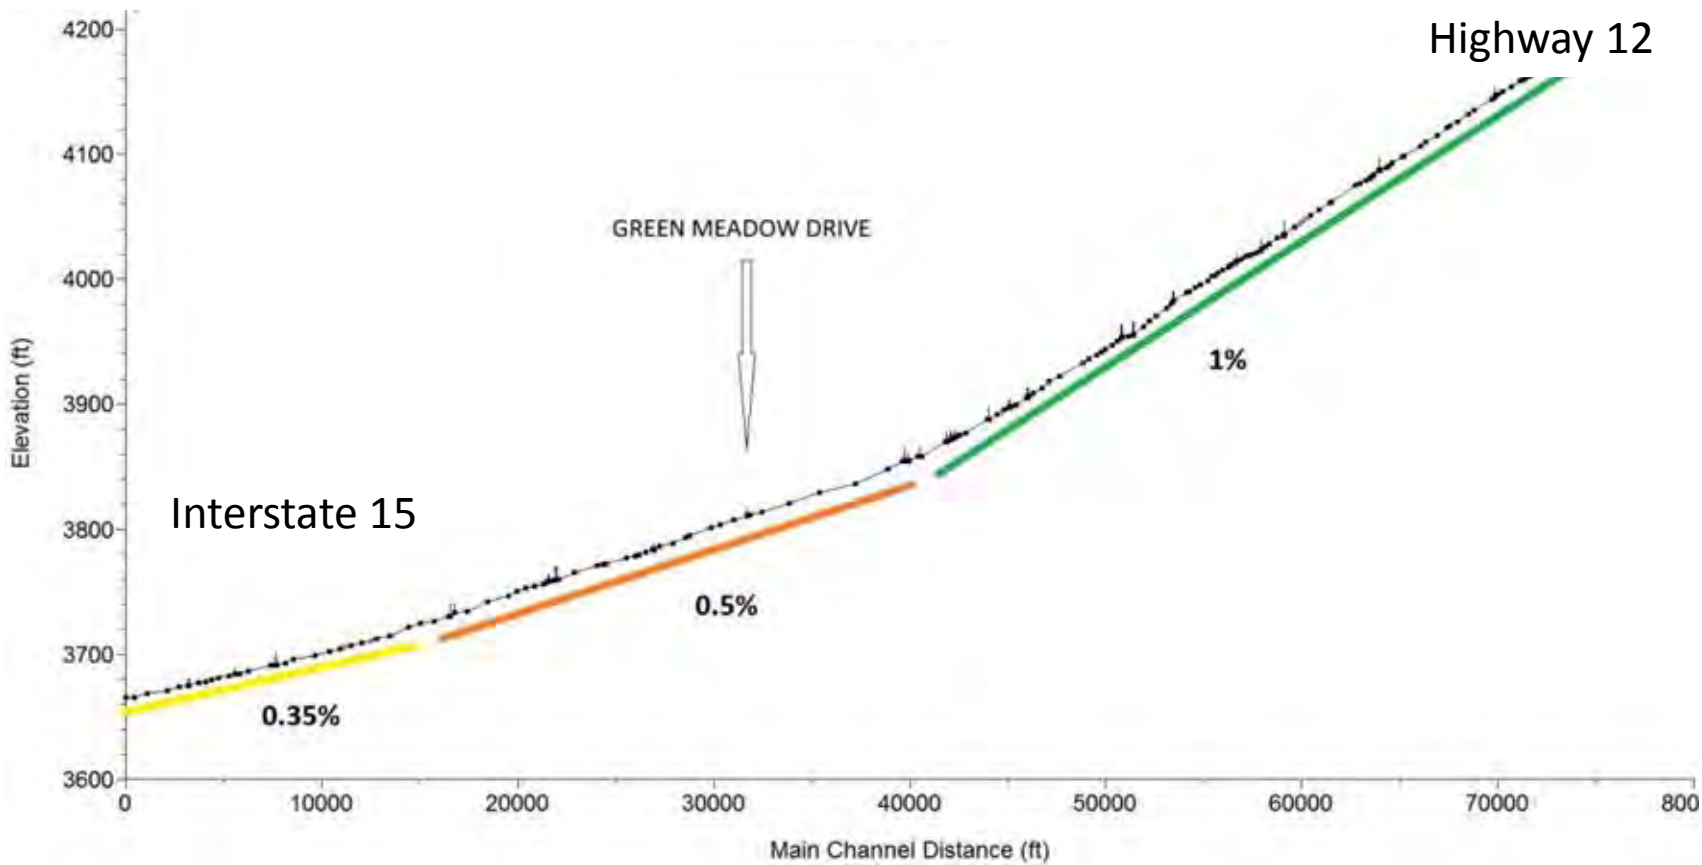
Streambed profile illustrating grade break just upstream of Green Meadow Drive.

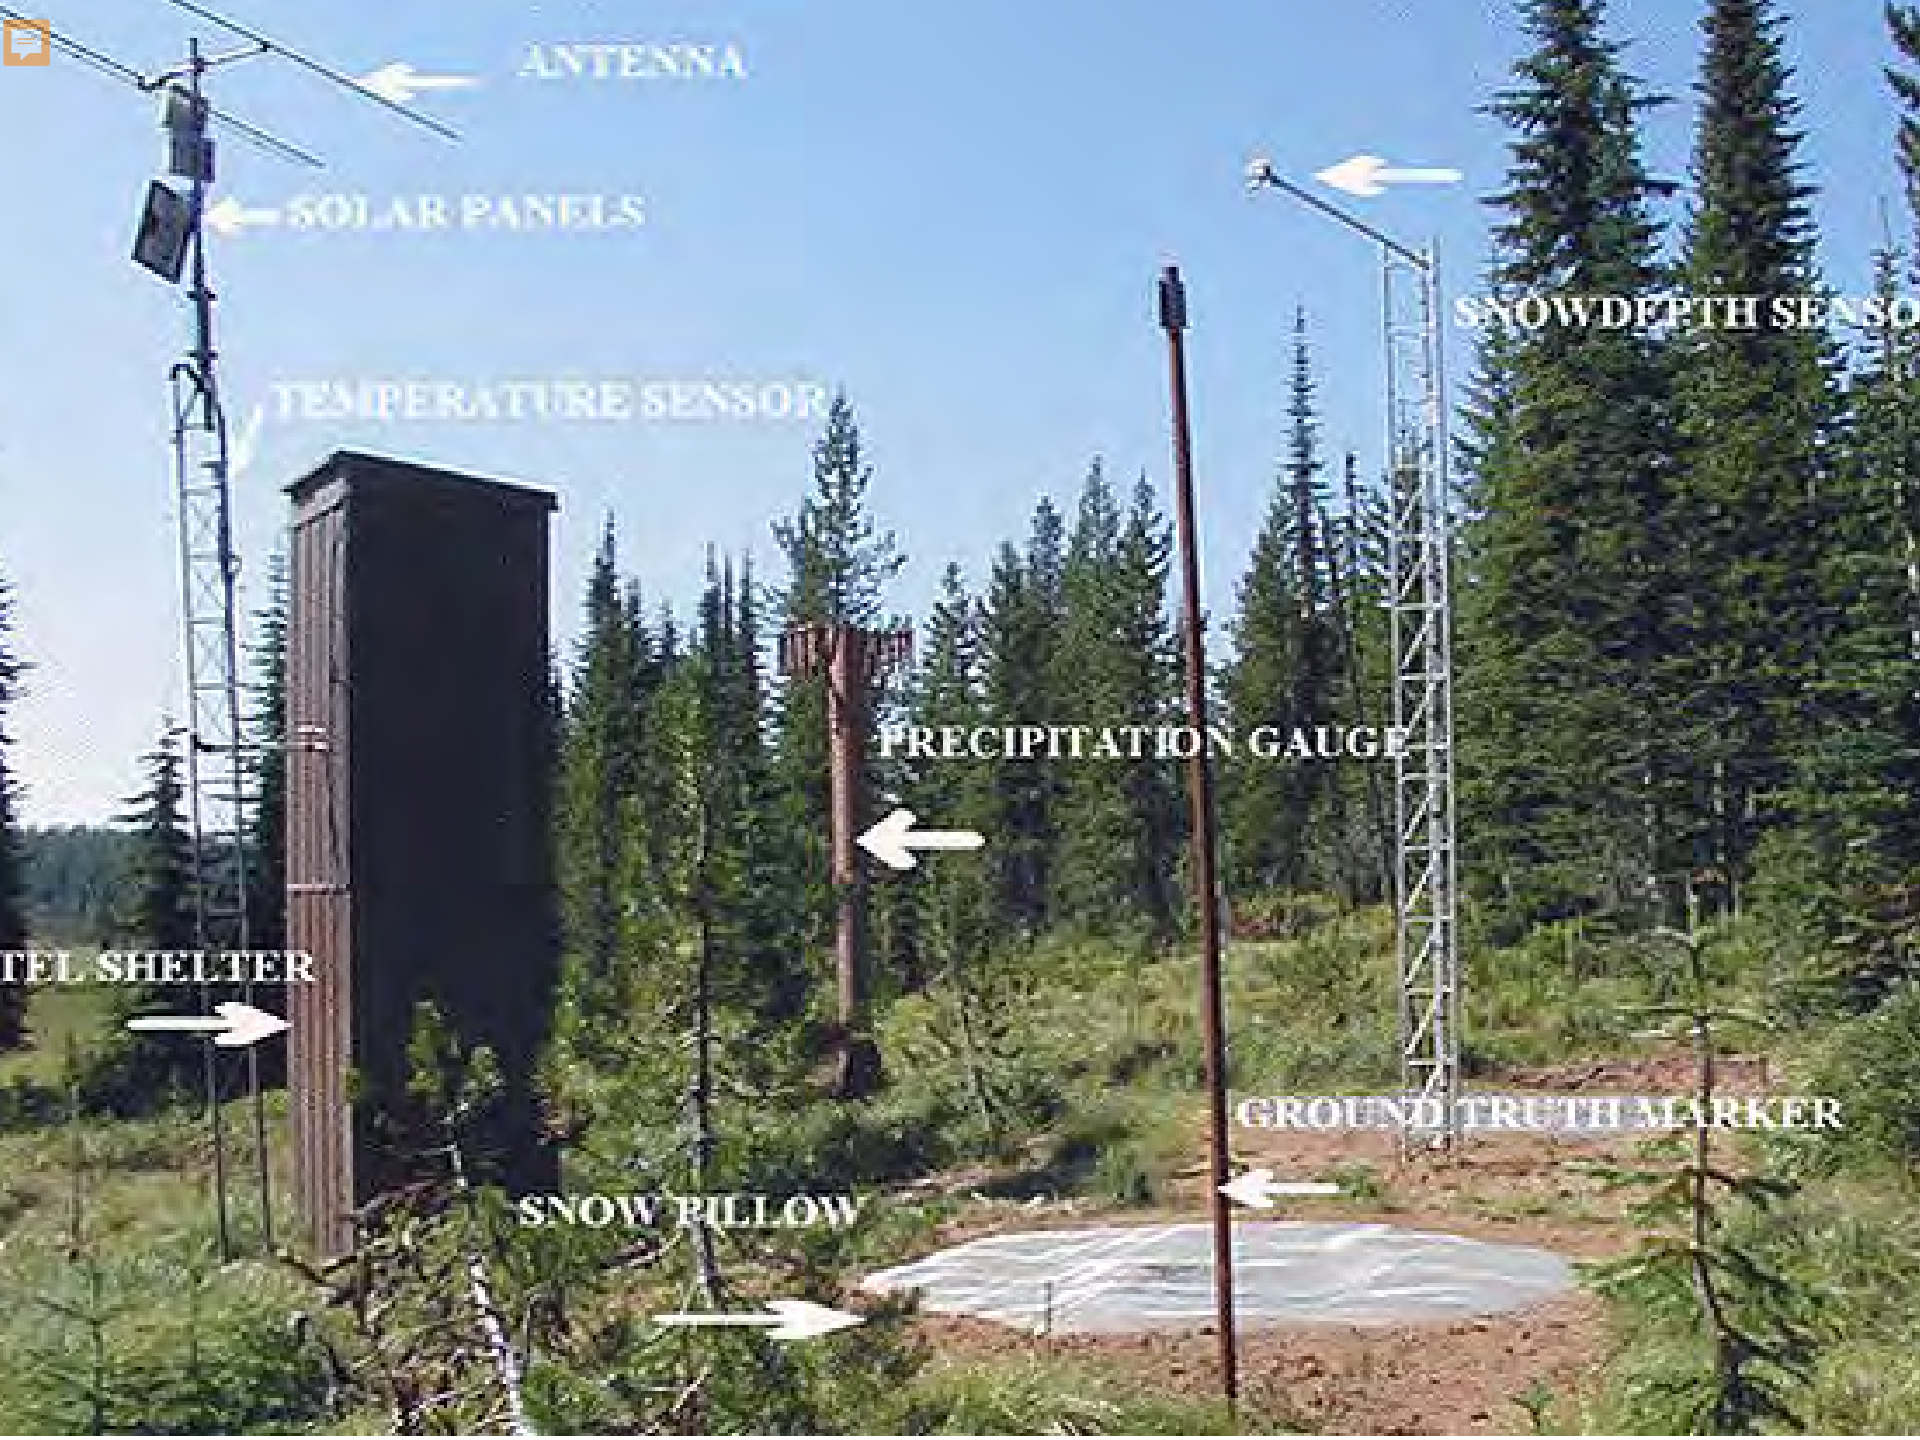
ANTENNA

SOLAR PANELS

TEMPERATURE SENSOR

SNOWDEPTH SENSOR

PRECIPITATION GAUGE

TEL SHELTER

GROUND TRUTH MARKER

SNOW PILLOW

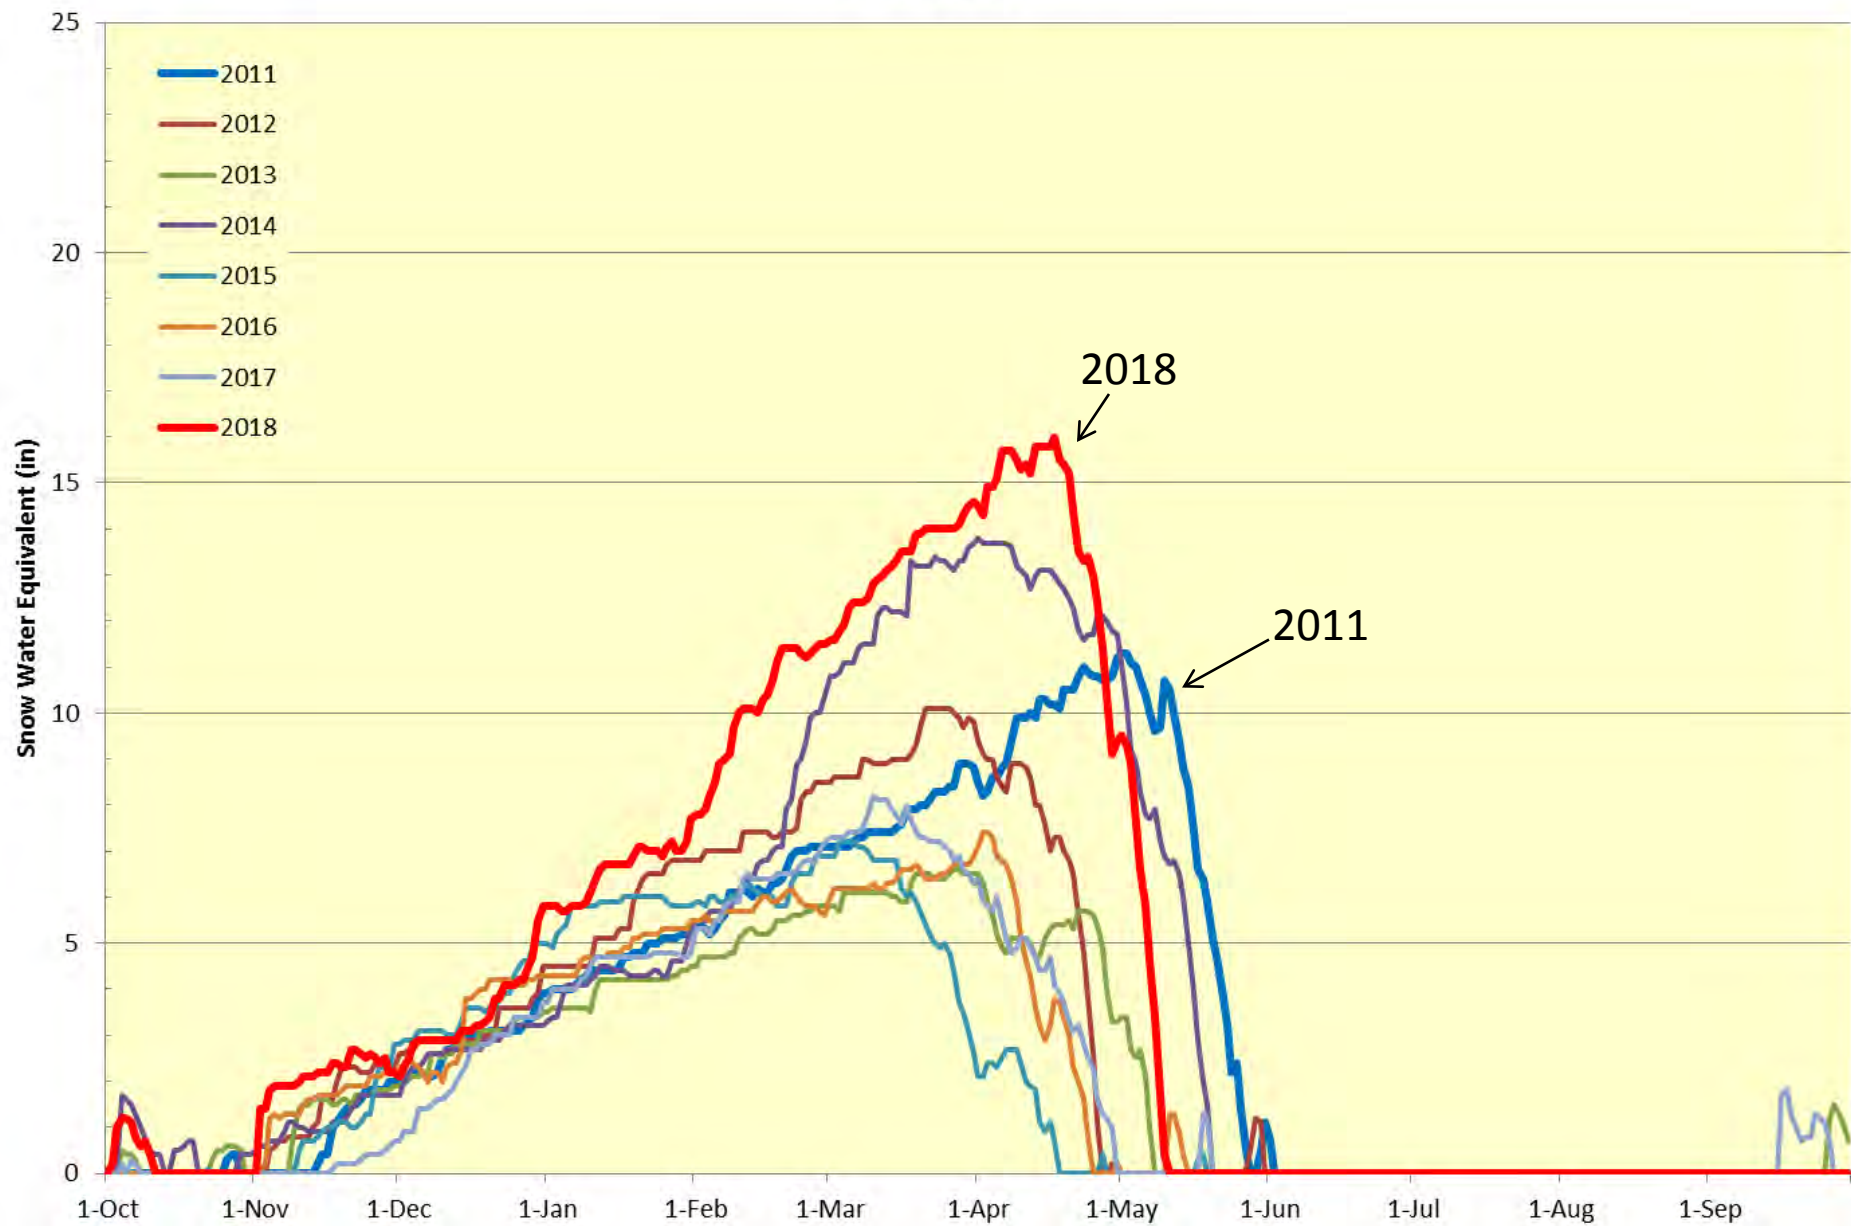
Frohner Meadows Snotel Data

2011-2018

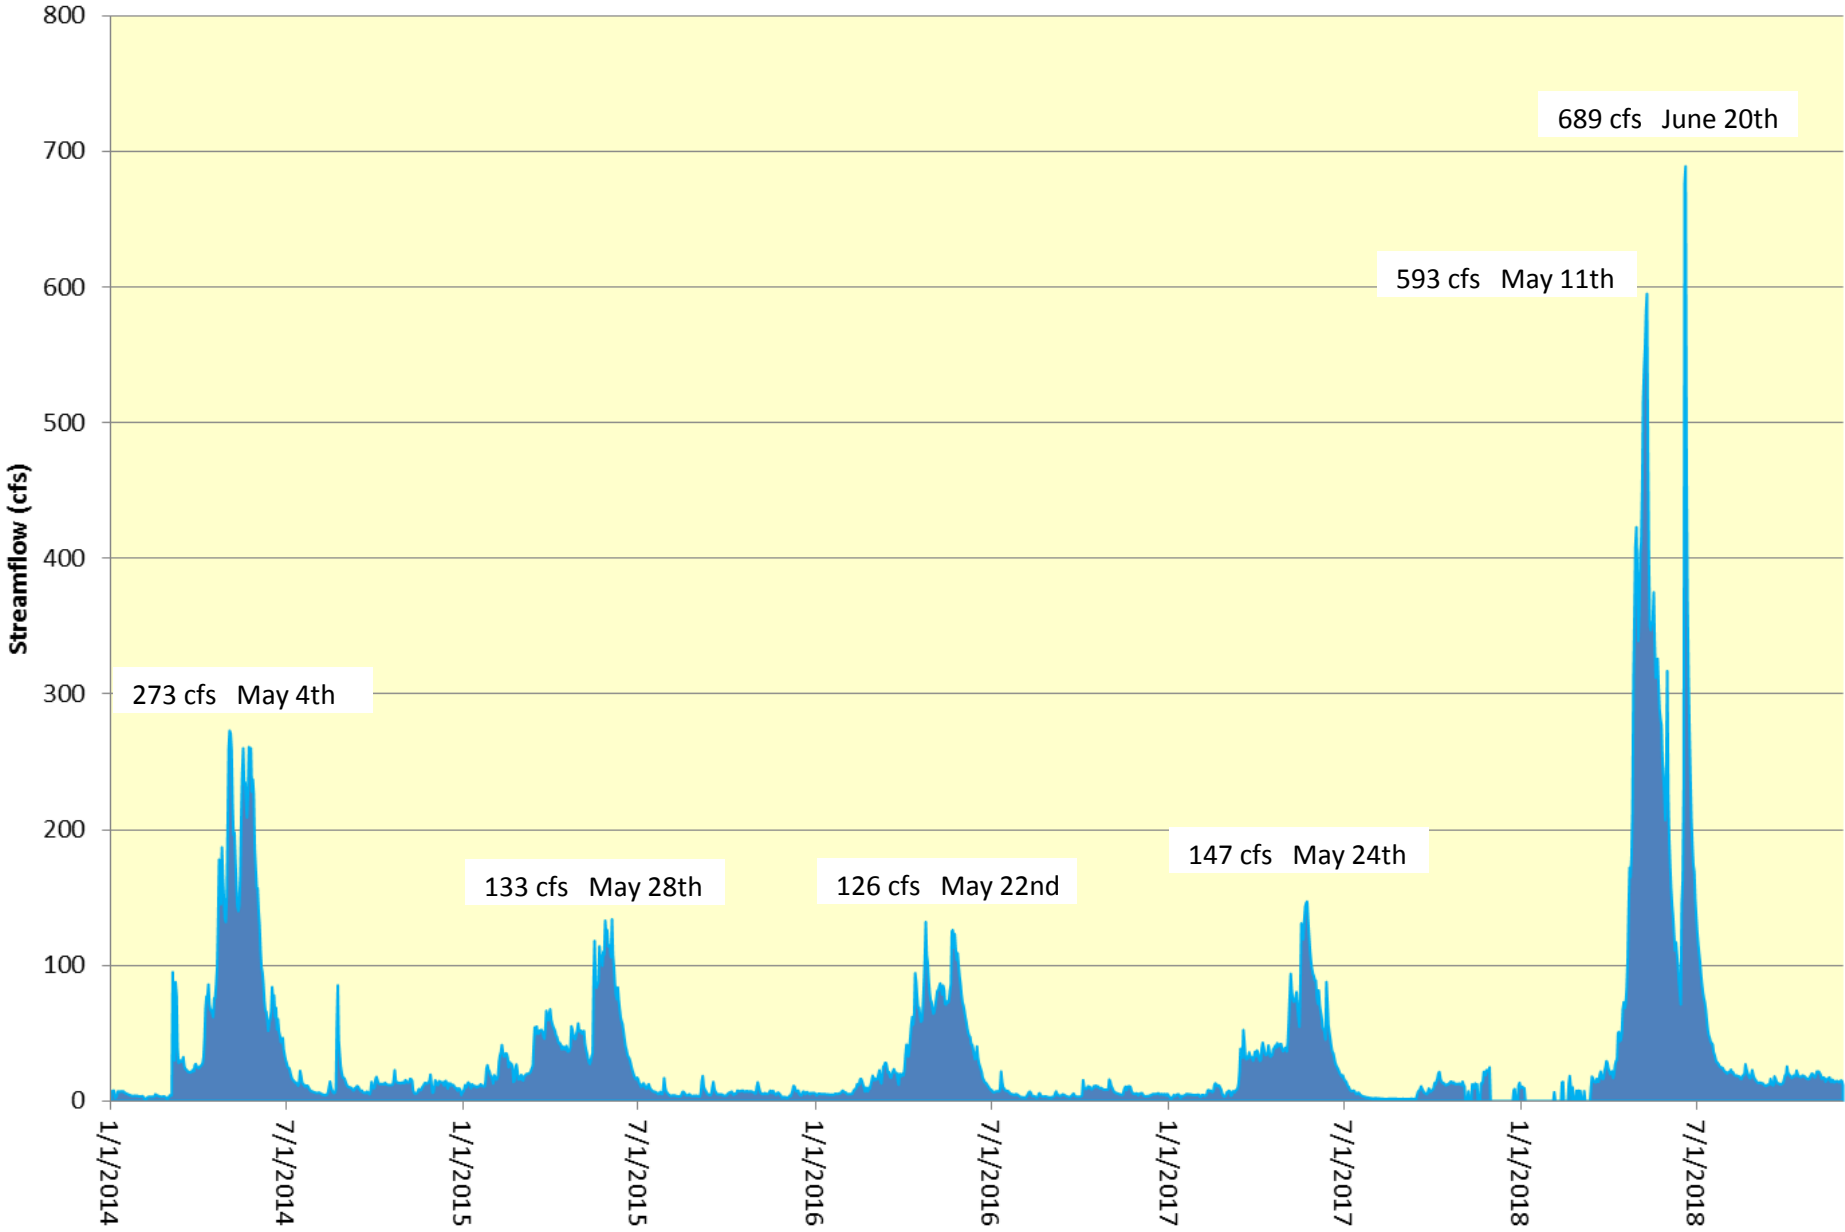
Tenmile Creek Streamflow

USGS Williams St Gauge 6063000 2014-2018

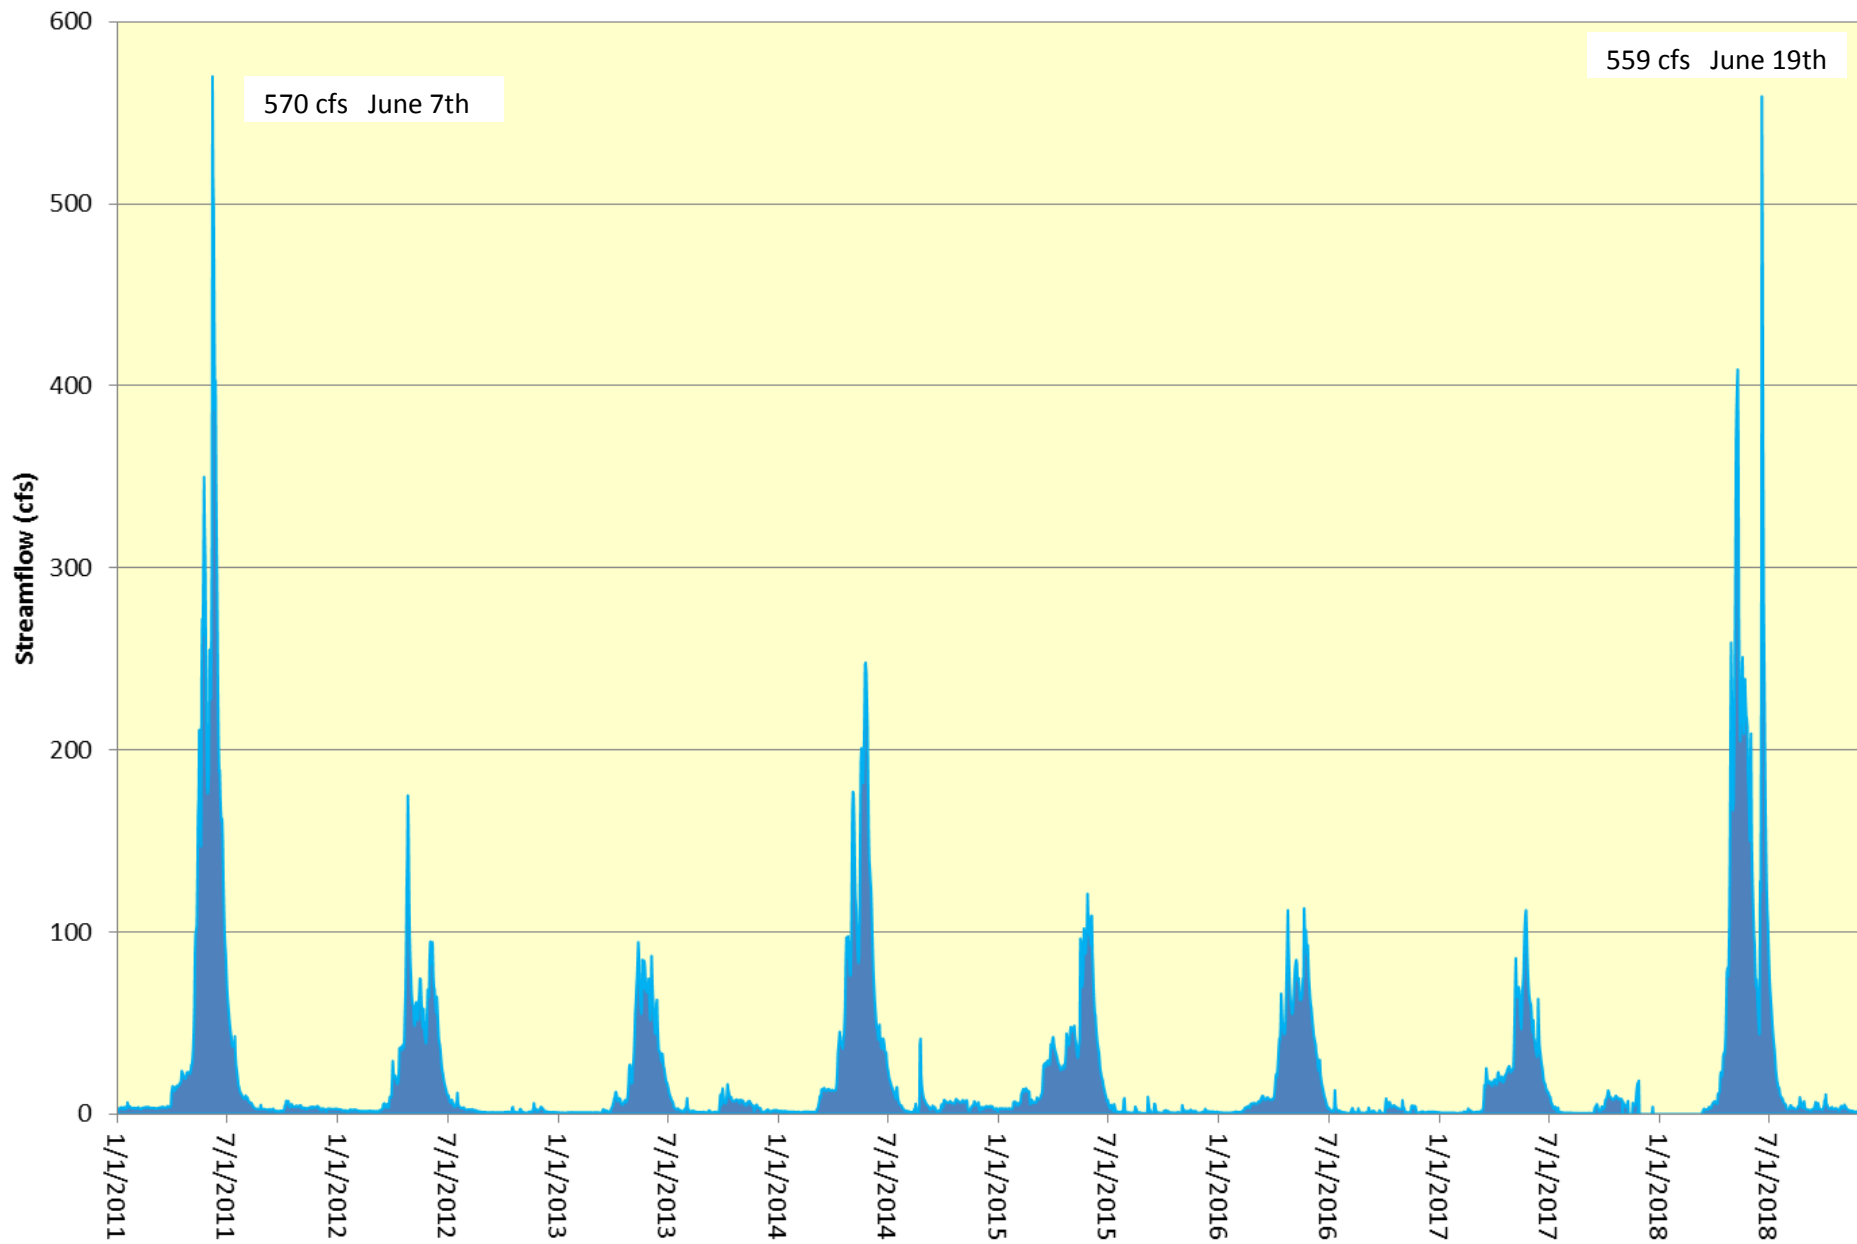
Tenmile Creek Streamflow

USGS Rimini Gauge 6062500 2011-2018

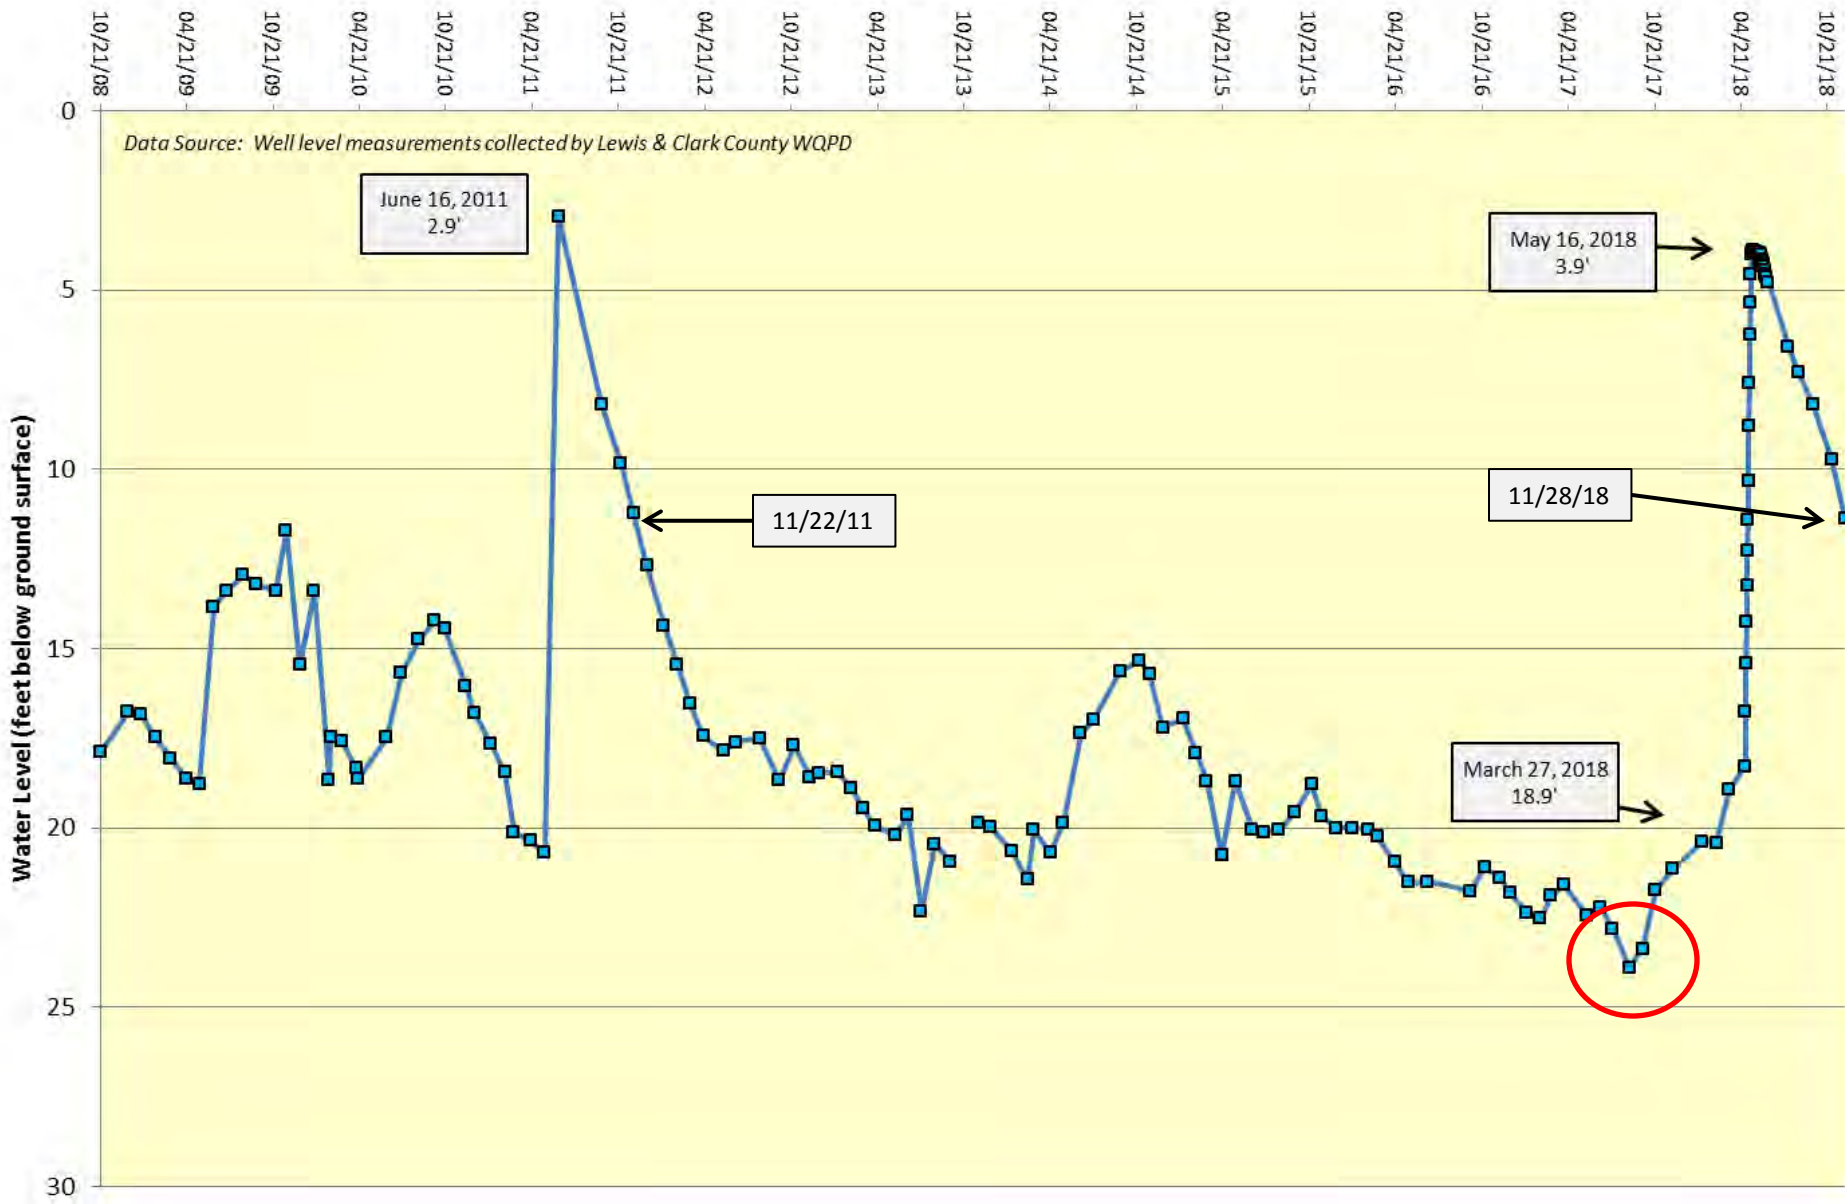
Residential Well Hydrograph

Motsiff Rd

GWIC ID 61368

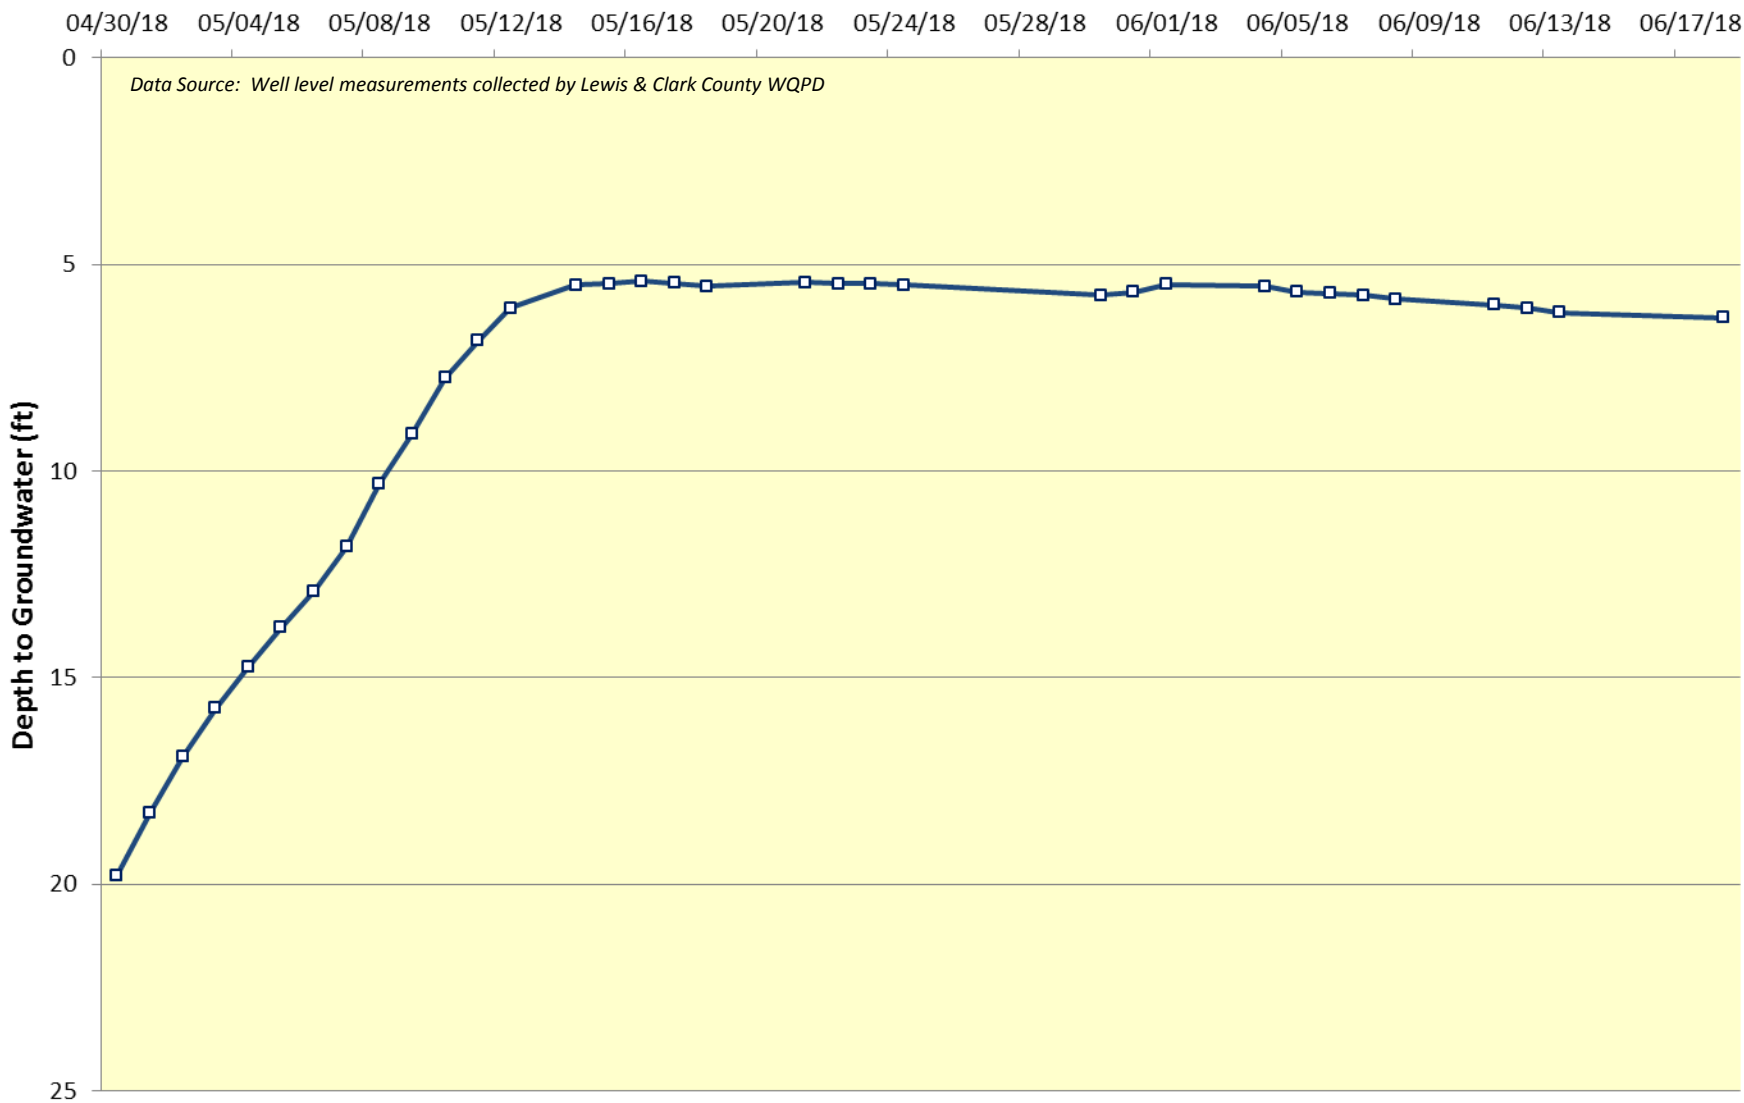
Groundwater Levels on Motsiff Rd

April - June 2018

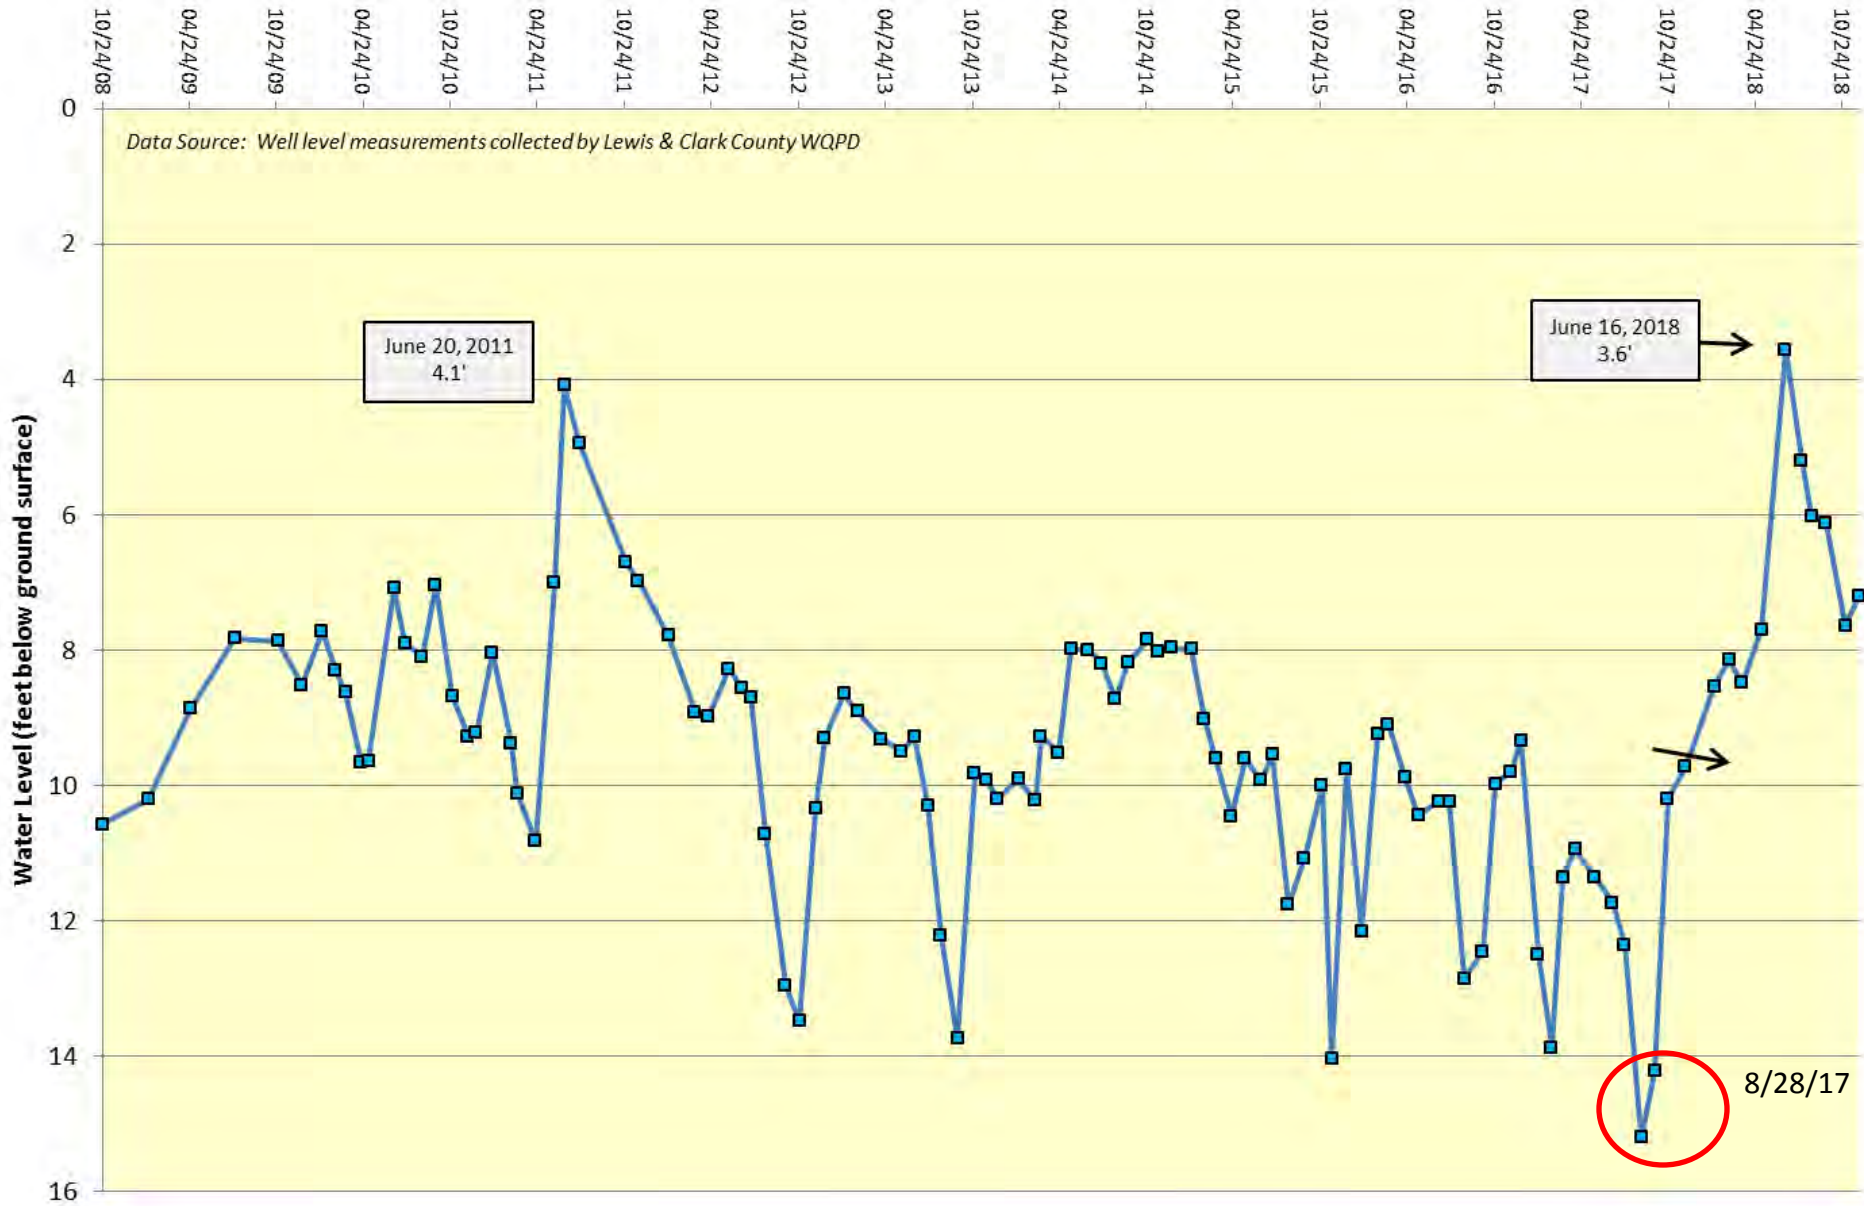
USGS Well Hydrograph

Mill Rd

GWIC ID 82195

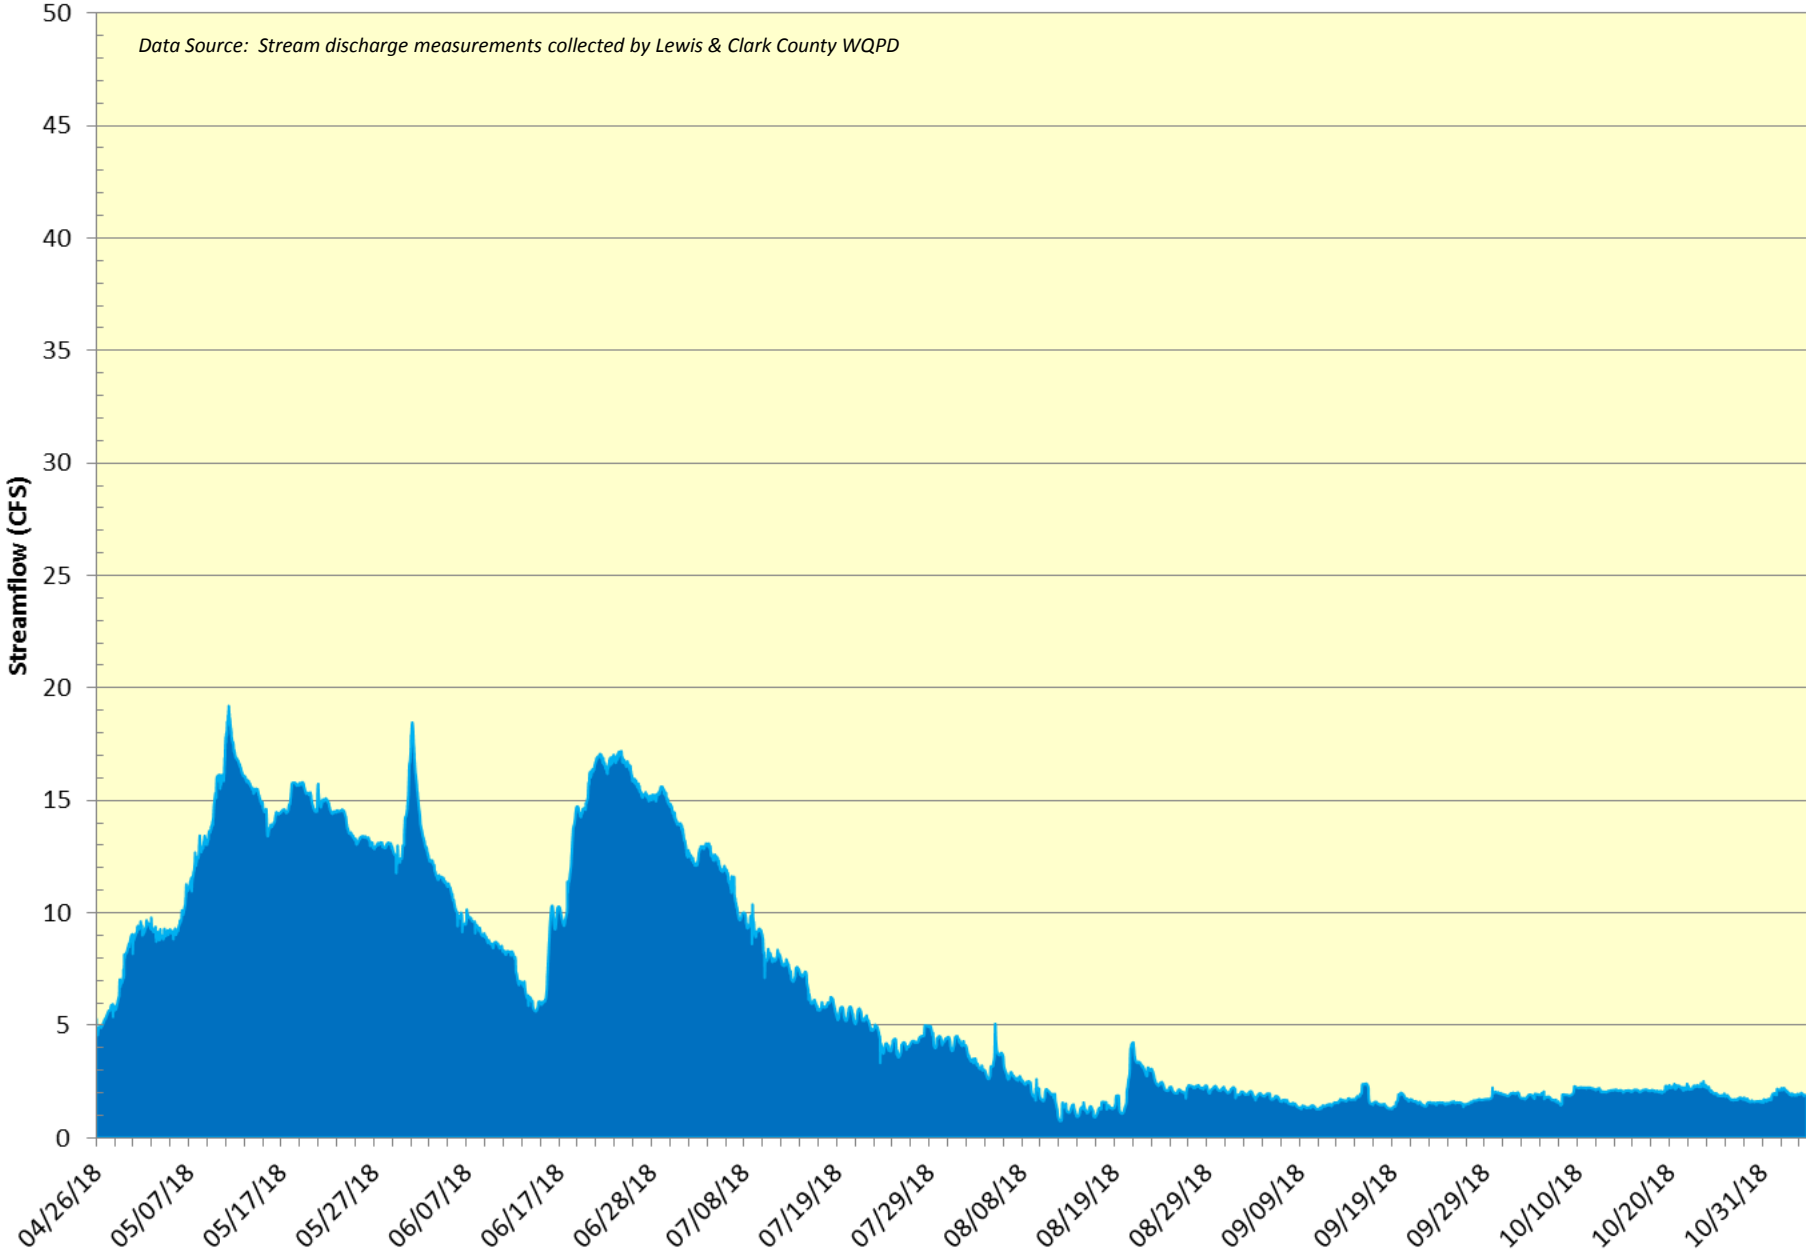
Silver Creek 2018 Estimated Streamflow

Data Source: Stream discharge measurements collected by Lewis & Clark County WQPD

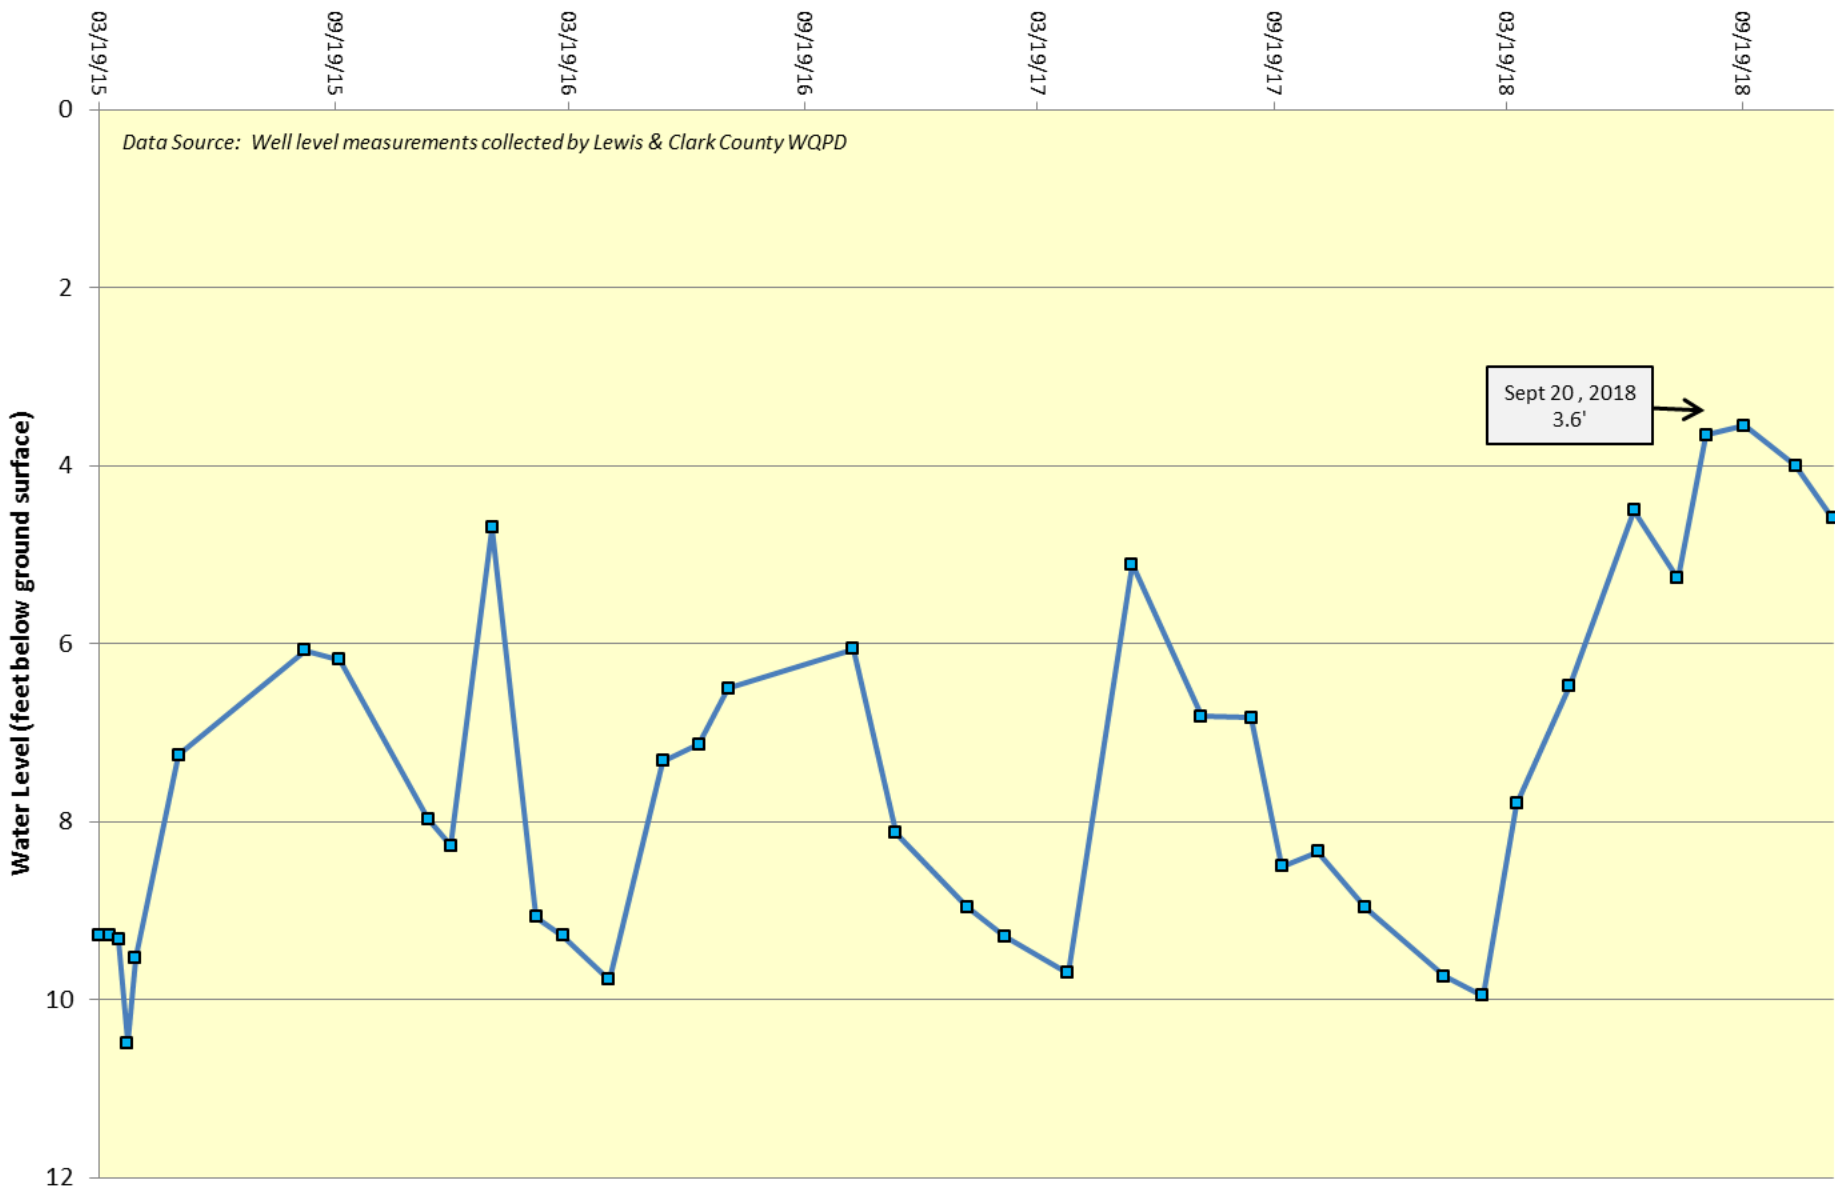
Residential Well Hydrograph

North Montana

GWIC ID 278687
