AUGUSTA FLOOD MITIGATION ENGINEERING RECOMMENDATIONS REPORT LEWIS AND CLARK COUNTY, MONTANA

JUNE 2022

RESPEC Company LLC
3810 Valley Commons Drive, Suite 4
Bozeman, MT 5971

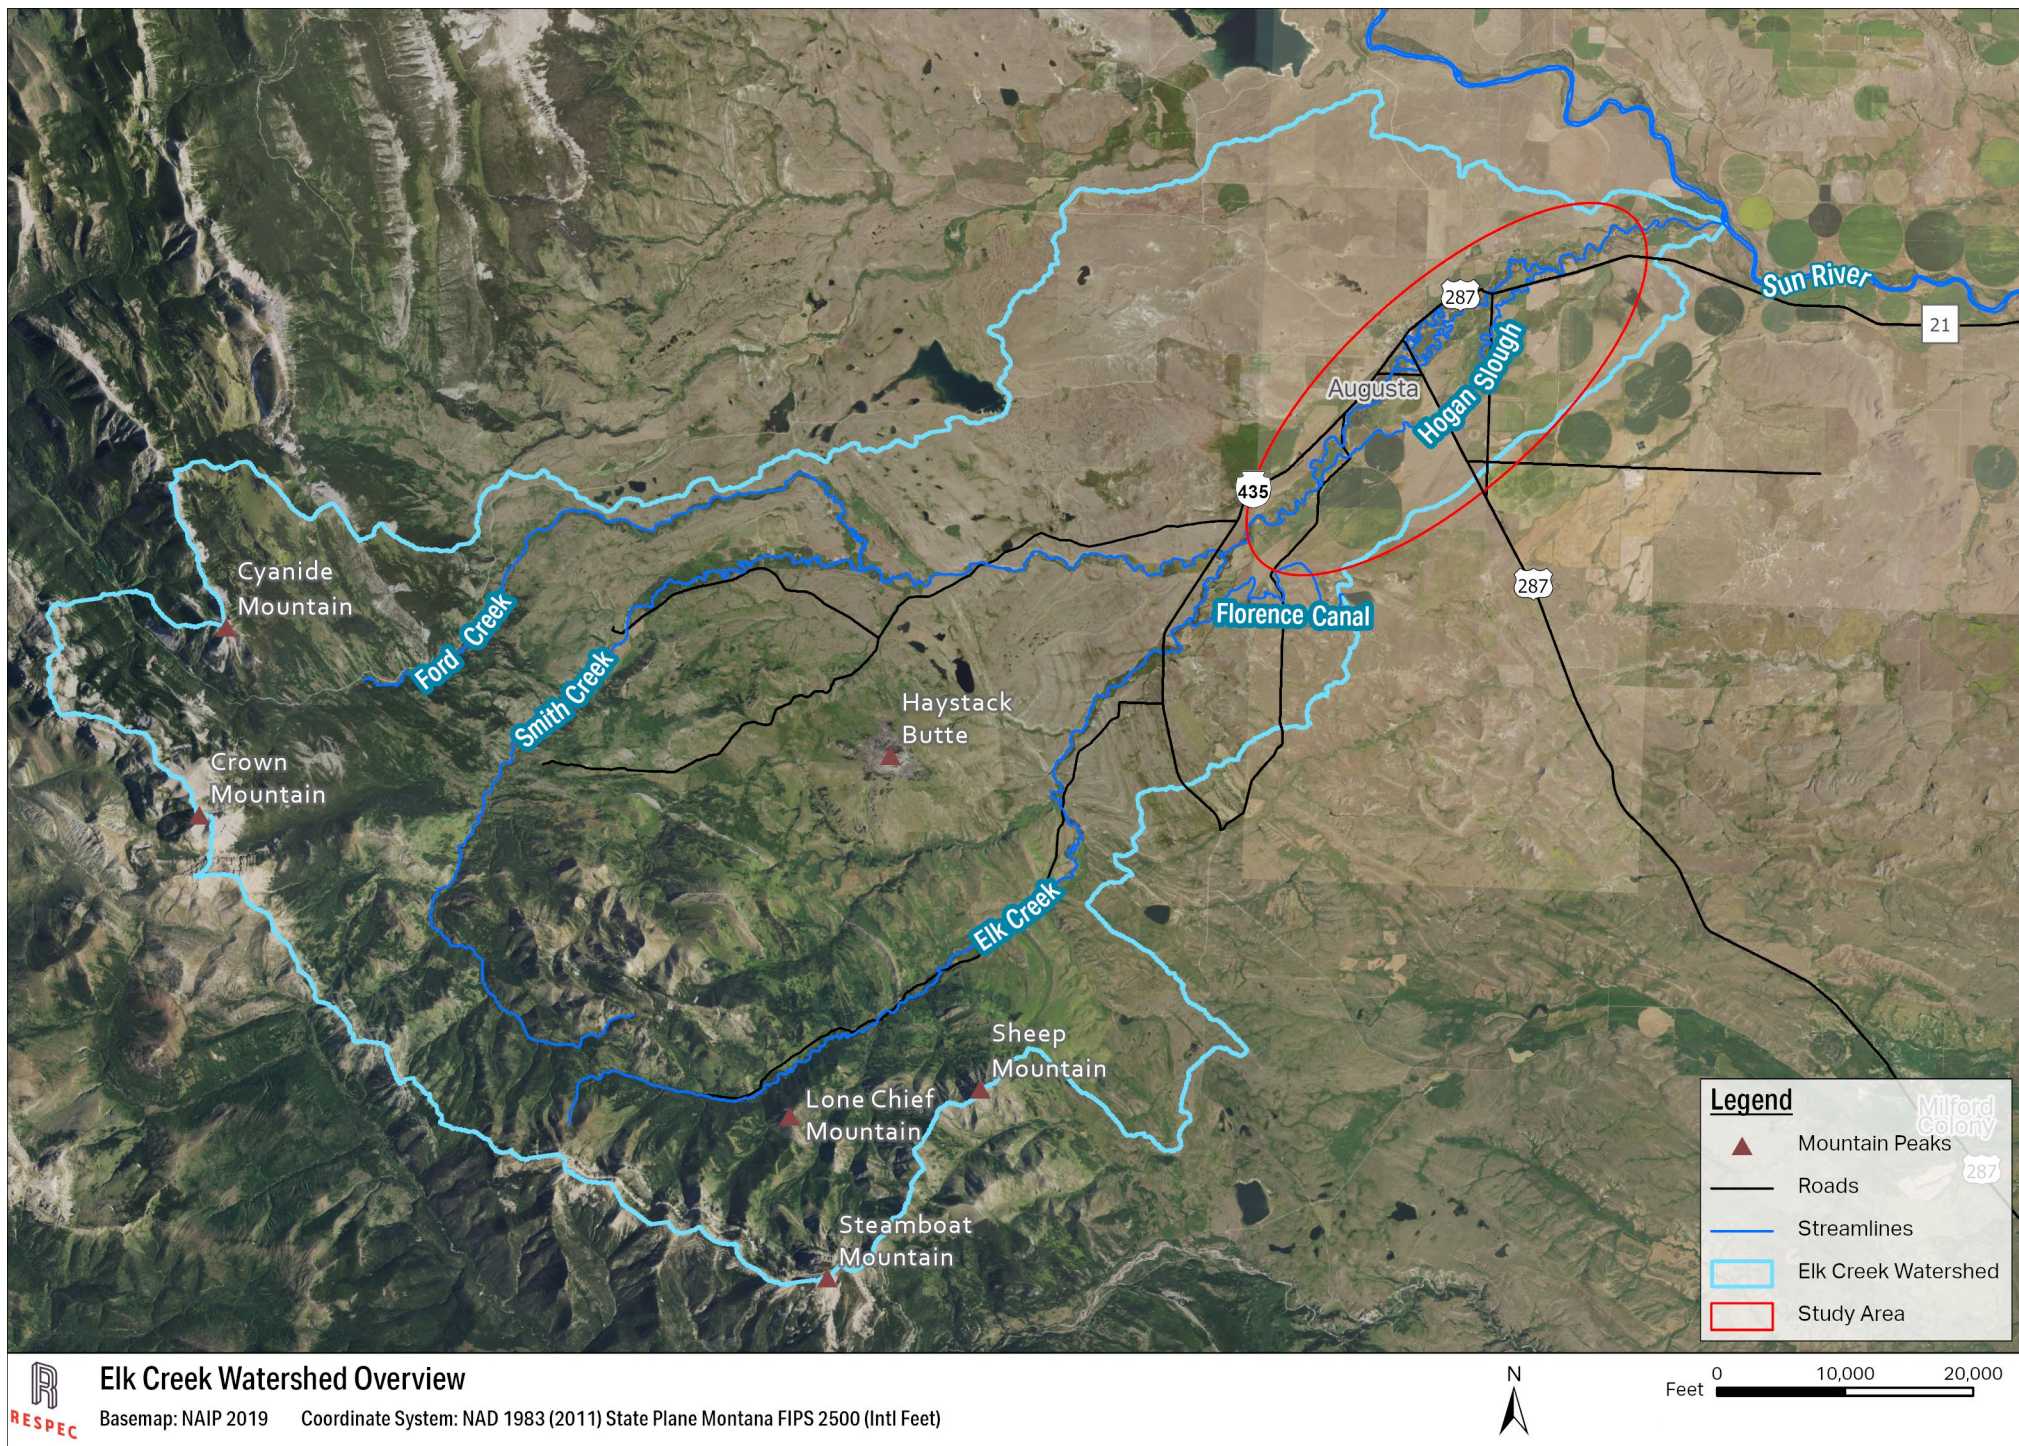
Figure 1. Overview of the Elk Creek Watershed with the location of the study area.

Elk Creek is also a major irrigation source and contains many headgates and irrigation canal diversions. The two major irrigation canals are Florence Canal, which begins 1 mile southwest of the Elk Creek and Smith Creek confluence, and Hogan Slough, which begins 0.7 miles southwest of Elk Creek's crossing with Augusta Clemons Road. Hogan Slough is a major source of irrigation for the northeastern part of the floodplain and begins as a diversion from Elk Creek through headgates just upstream of Augusta Clemons Road. Hogan Slough eventually ties back in with Elk Creek downstream of MT 21. Figure 1 shows the Elk Creek watershed from its confluence with the Sun River and the studied area in relation to the Elk Creek along with major infrastructure features.

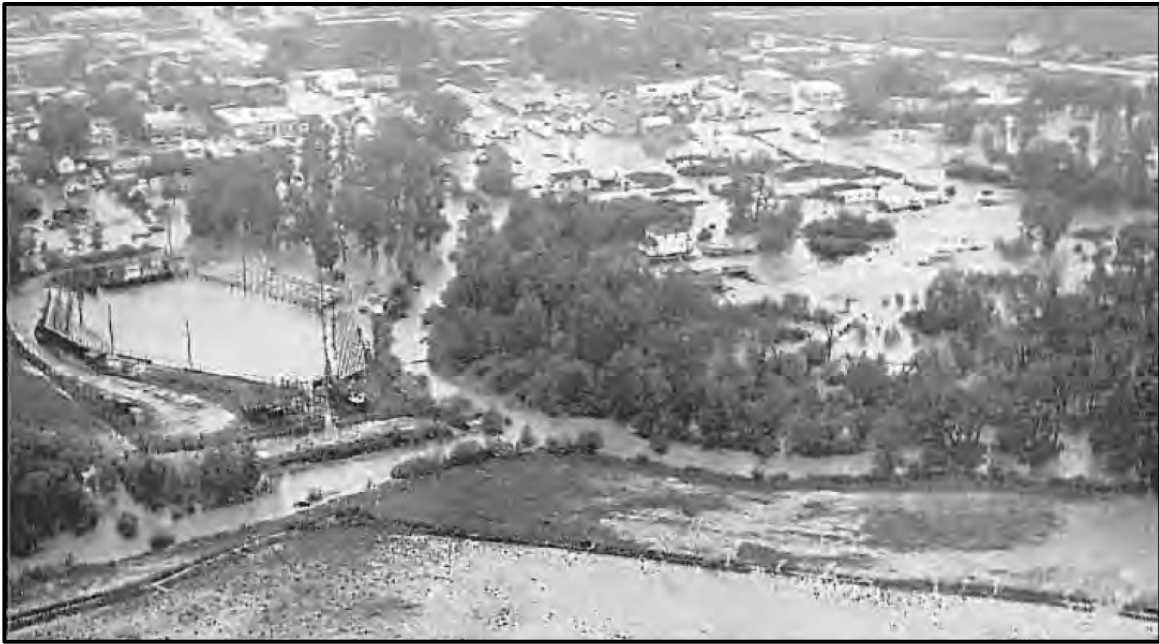
Figure 2. Aerial imagery of the 1964 flood around the rodeo arena in Augusta (left), courtesy of MDT.

Since Augusta was founded in the late 1800s, the community has suffered from numerous floods. Historical floods occurred in 1953, 1964, 1975, 2011, 2018, and 2019. Most flooding along the Rocky Mountain Front results from cool spring temperatures and higher-than-normal spring snowfall followed by rapid warming and abundant rainfall in late May and early June. Historically, Elk Creek has been characterized by long stretches of dry periods with short flood events that cause dramatic alignment and morphological changes to the creek. The largest recorded flood was on June 8, 1964 and was estimated to be an approximately 50- to 100-year event for the Elk Creek watershed. The flooding on Elk Creek was closely related to that of the Sun River and was the same year the Gibson Dam overtopped. Figure 2 shows the 1964 flooding around the rodeo arena in Augusta and Figure 3 shows the Gibson Dam overtopping.

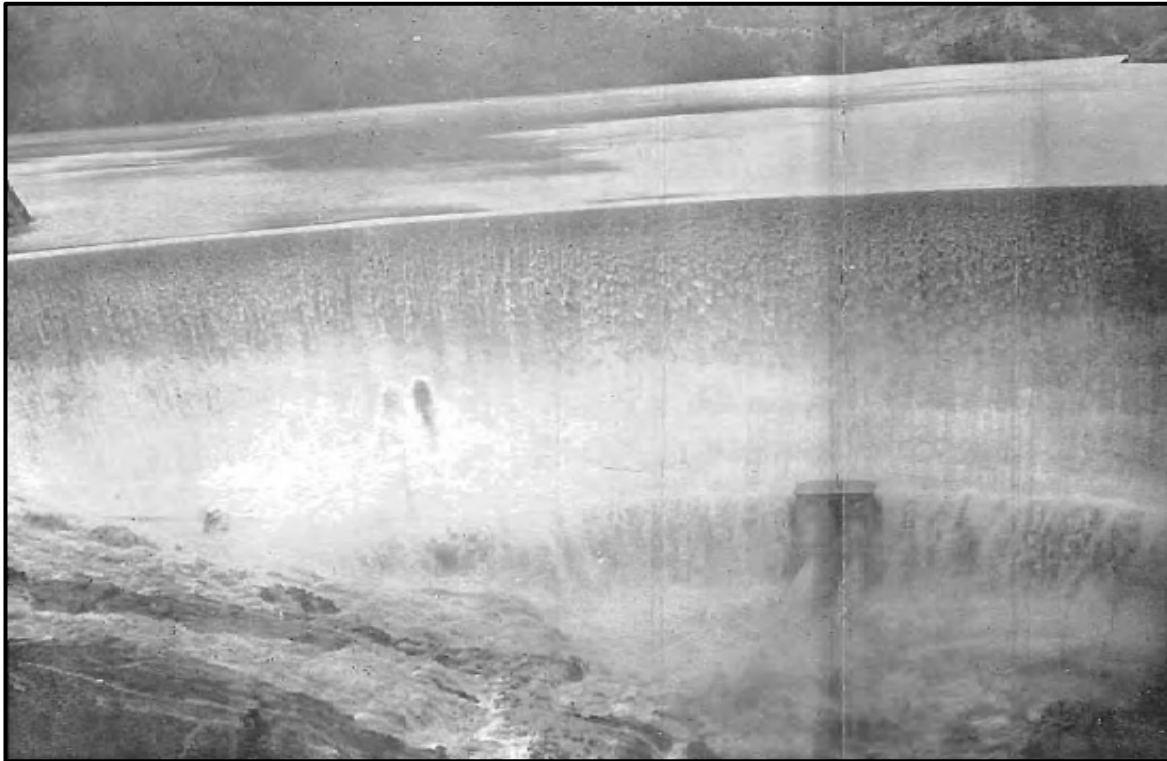
Figure 3. Imagery of the Gibson Dam overtopping during the 1964 flood event.

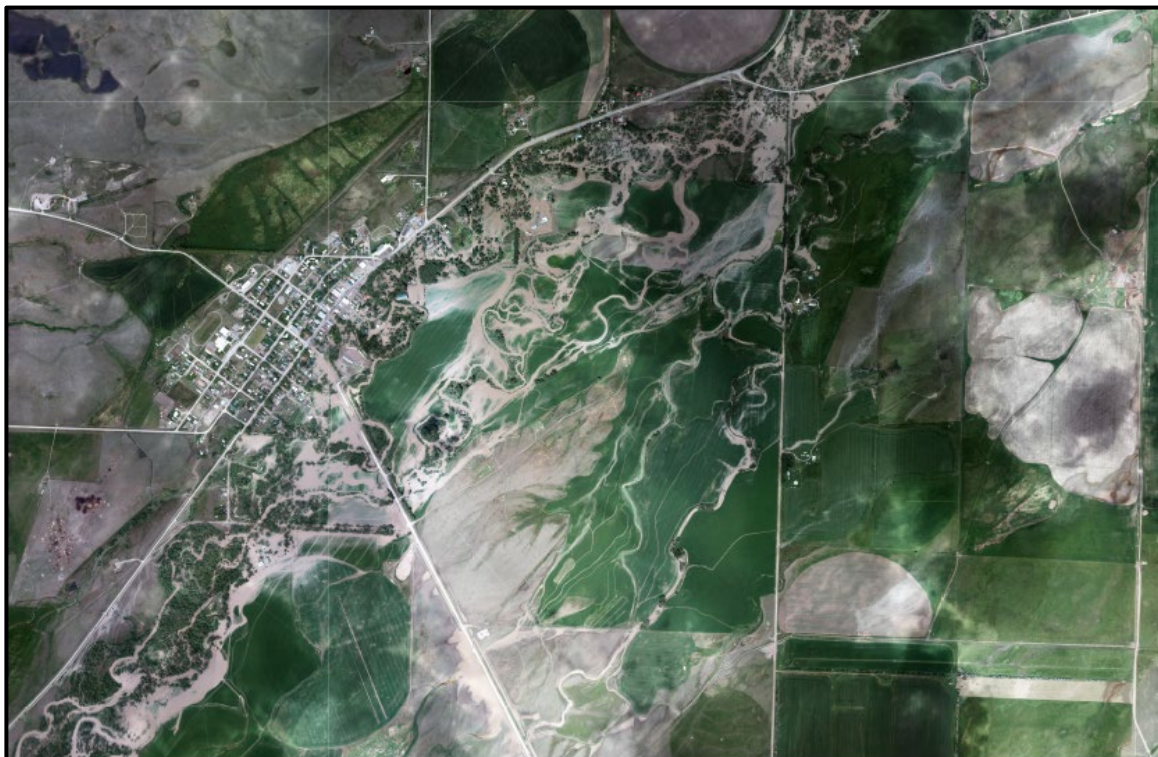
Figure 4. Aerial flood imagery from the 2018 flood event of Augusta from just upstream of US 287 to MT 21, courtesy of MDT.

The most recent flood events were the back-to-back floods in 2018 and 2019. The sequence of the back-to-back events left the community in an extended period of disrepair. The magnitude of the 2018 event—the larger of the two recent floods—is estimated to have only been between a 10- and 25-year event. Figure 4 shows an aerial view of the 2018 flooding of Augusta from just upstream of US 287 to MT 21.

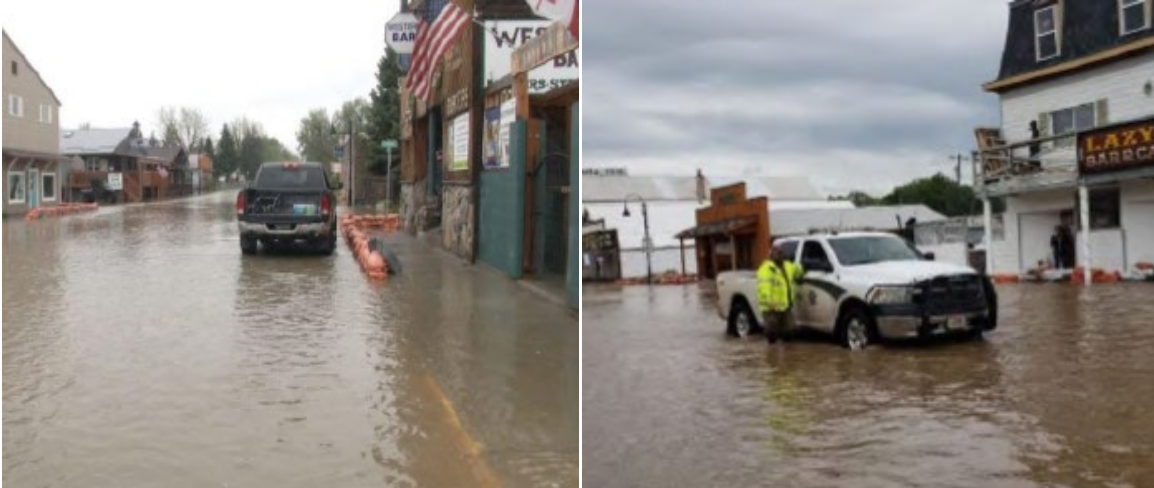
Figure 5. Floodwaters on Main Street in Augusta during the 2018 flood, courtesy of Great Falls Tribune.

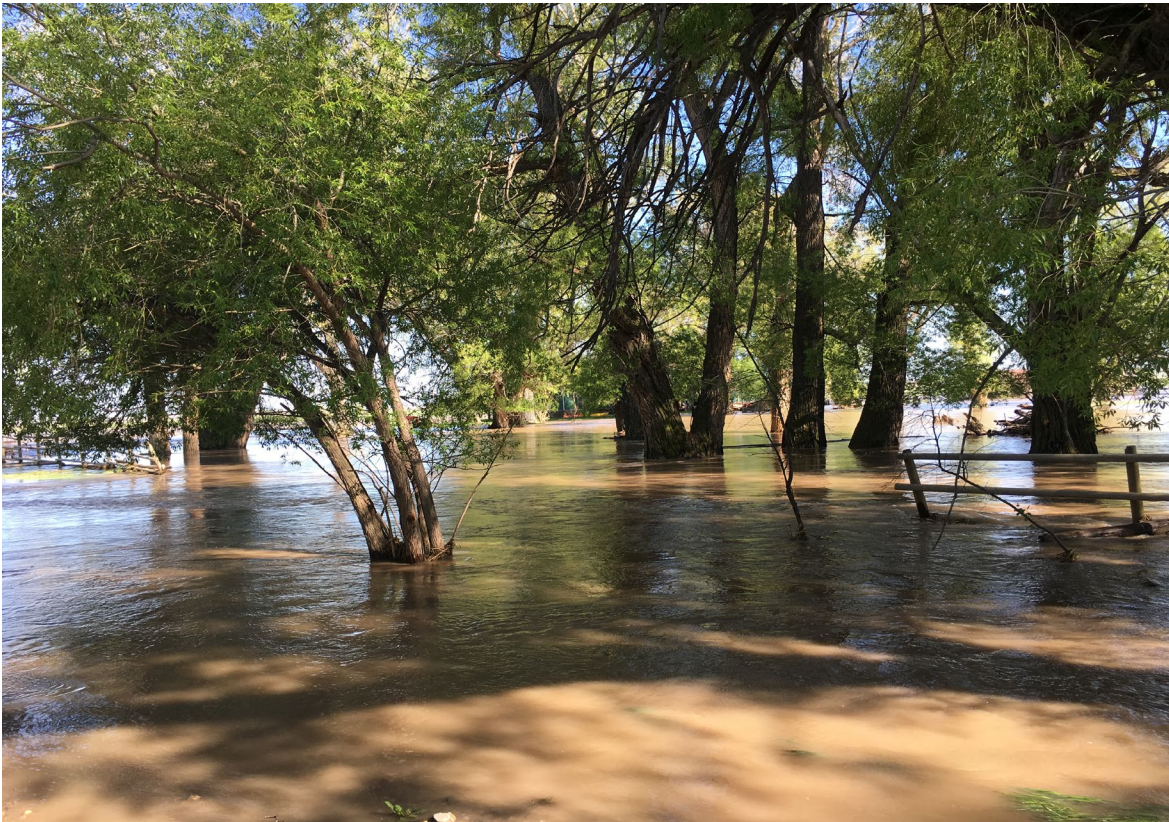
Figure 6. Flooding adjacent to Lovers Lane in Augusta during the 2018 flood event, courtesy of Carol Fechter.

These flooding events caused widespread infrastructure damage; large-scale stream morphology changes; and significant emotional and physical distress to farmers, ranchers, and townspeople. During the 2018 and 2019 floods, substantial amounts of sediment were carried downstream, causing bank erosion, damage to fences, diversion structures, town infrastructure, destruction of beaver dams, and deposition of gravel bars. Because the floodplain of Elk Creek has low gradient slopes, substantial amounts of debris were deposited as water spread and decreased in velocity, causing damage to rancher's fields that are still noticeable today. The town of Augusta experienced high floodwaters flowing down Main Street and the surrounding residential area, as well as extensive damage to structures. Figure 5 shows the floodwaters on Main Street and Figure 6 illustrates the water level in the floodplain adjacent to Lovers Lane during the 2018 flood event.

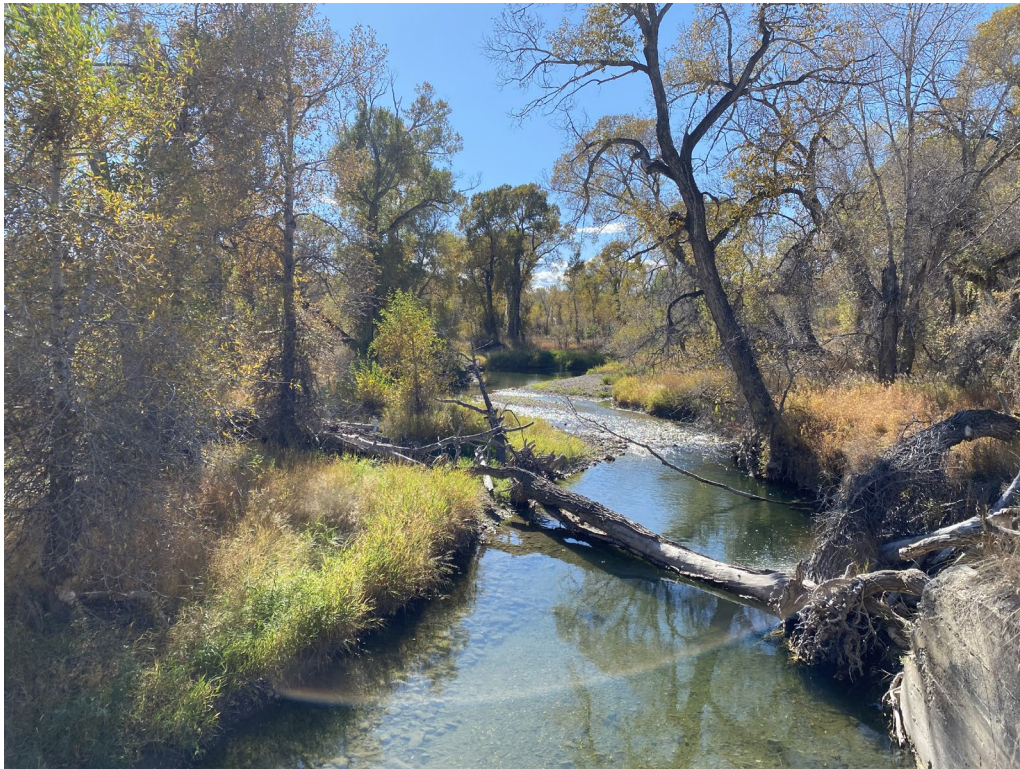
Figure 9. Large woody debris observed on Elk Creek upstream of the Lovers Lane bridge.

On September 30 of 2021 RESPEC performed a site visit to examine channel and structure conditions on Elk Creek within the study area. In many of the channels within the limits formed by Lovers Lane, Highway 435, and US 287, as well as in the Elk Creek Overflow downstream of US 287, substantial amounts of woody debris fill the channels, enough to create large obstructions to flow in some locations. An example of the large woody debris on Elk Creek near the Lovers Lane bridge is shown in Figure 9.

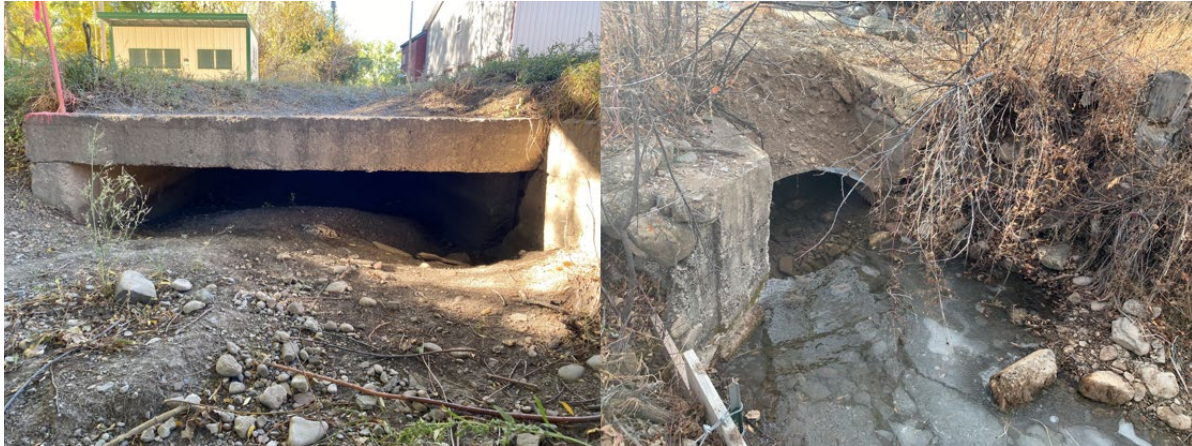
Figure 10. Sediment clogging within a box culvert on Elk Creek Overflow (left) and a circular culvert upstream of Augusta (right).

Many of the culverts within the study area were observed to contain sediment accumulation from flood events and spring runoff, which was often blocking sizeable amounts of the culvert openings. An example of this sediment clogging upstream of Augusta and in Elk Creek Overflow is shown in Figure 10.

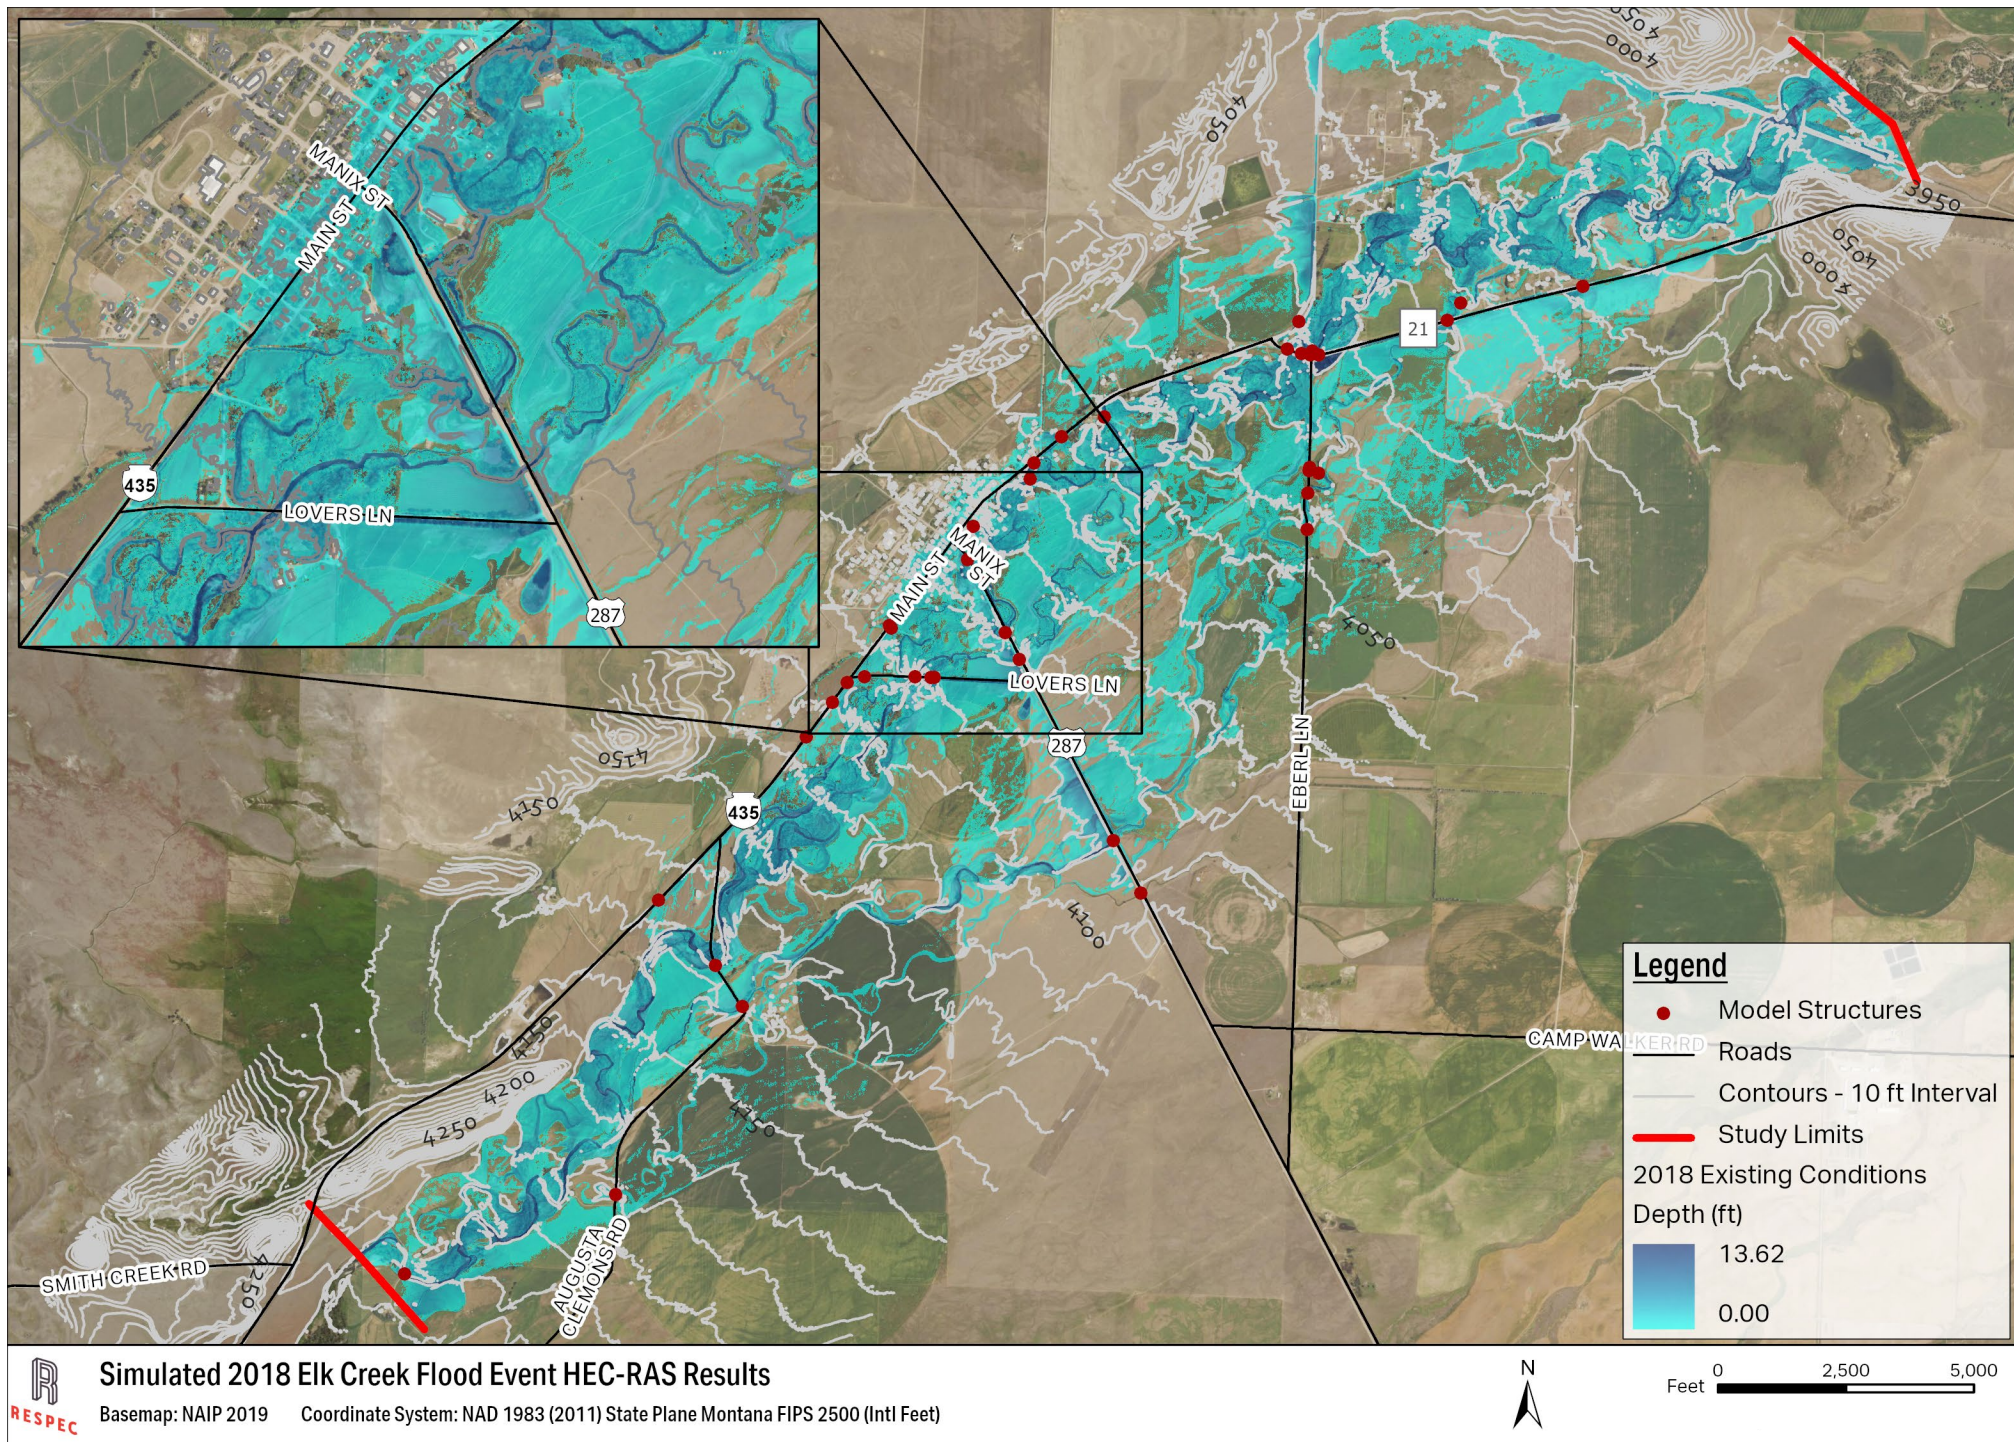
Figure 13. Existing conditions HEC-RAS results from the simulated 2018 flood event.

Existing conditions were assessed for the three USGS recorded events: 2018, 1975, and 1964. The 2018 existing conditions model showed three major flooding regions within the Augusta area: Elk Creek, Elk Creek Overflow, and Hogan Slough. Results split between those three regions showed that just downstream of US 287, the Elk Creek Overflow and its overbanks containing the greatest amounts of floodwaters, approximately 44% of the total flood volume. Elk Creek contained approximately 37% of the flood volume, and Hogan Slough approximately 19%. Significant amounts of backwater were observed behind the US 287 and MT 21 road embankments. The skewed alignment of US 287, combined with its elevation profile being lowest at the intersection with Highway 435, causes backwater to route towards town. The modeled flood also demonstrated which structures influence the amount of flow into the Elk Creek Overflow channel, as well as where floodwaters are overtopping US 287. Also observed in the model and as described in the hydrologic assessment, floodwaters are accessing the Highway 435 borrow ditches and routing floodwaters into town.

The model extents were compared to aerial imagery taken during the 2018 flood event. Flood extents were similar in the model as to those shown in the aerial imagery. It is important to note that because the modeled hydrographs were run under steady-state conditions for the duration of the run time and not fluctuating like they do in nature, flow volumes are not representative of an actual flood event. The models may portray slightly worse flood extents than was experienced during the 2018 flood event. The 2018 existing conditions flood model is shown in Figure 13.

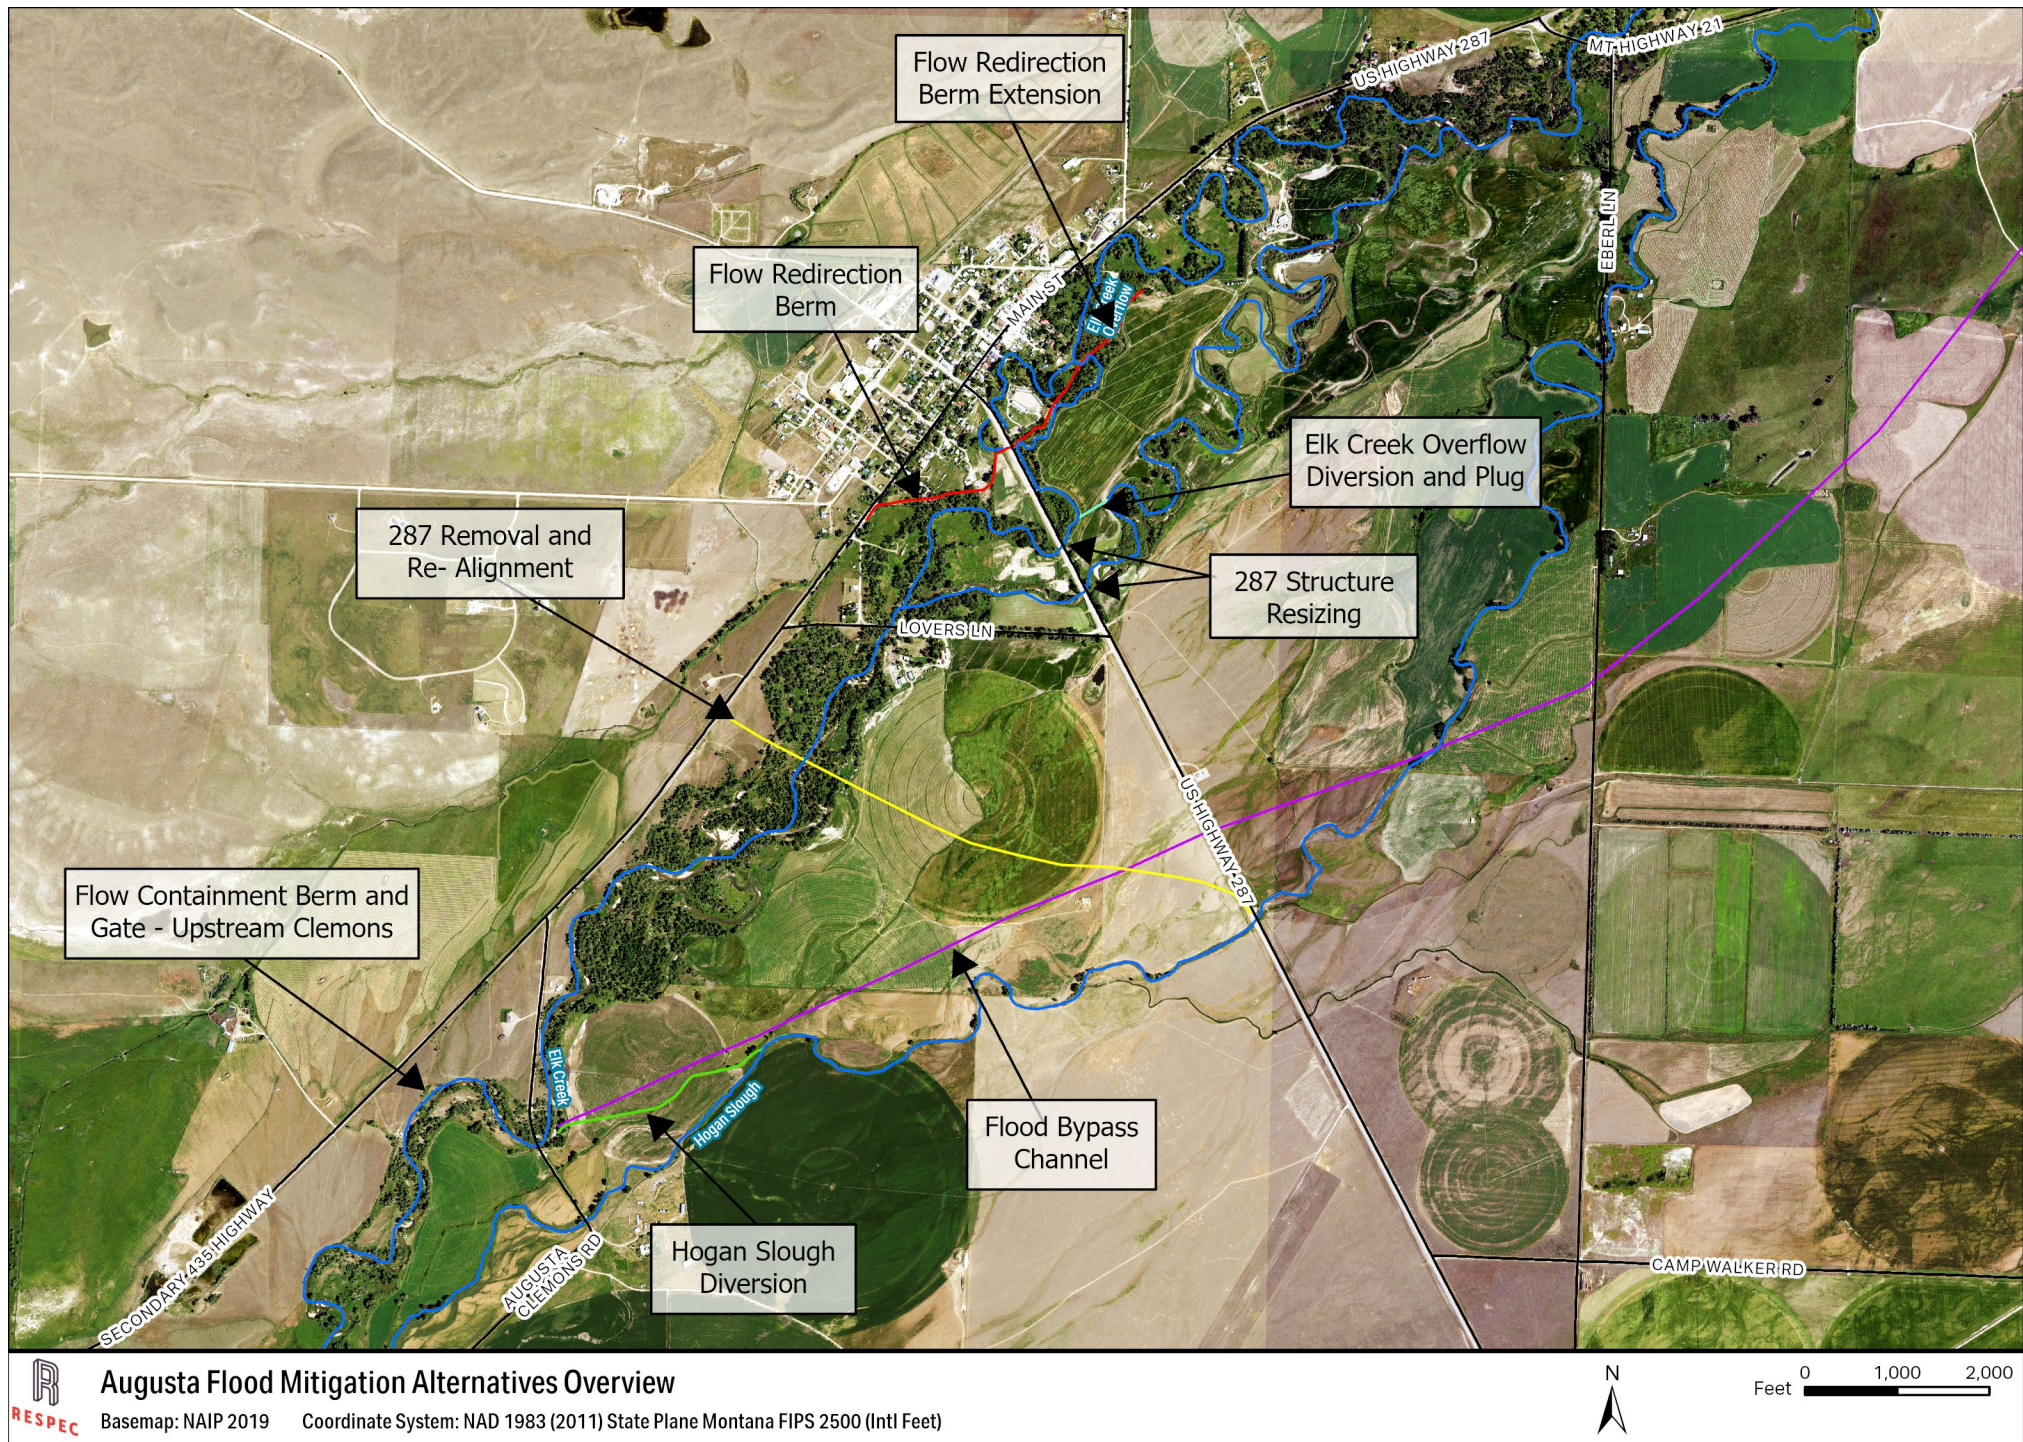
Figure 14. Overview of the Augusta flood mitigation alternatives.

All alternatives were analyzed using hydraulic models and compared to the existing model results. Alternatives were evaluated based on feasibility and constructability, effectiveness at mitigating flooding damages, and overall public benefit. Results of the alternatives analyses were presented at the town meeting on May 6, 2022. Figure 14 outlines the alternatives presented at the second town meeting. The following sections provide an overview and results of the evaluated flood mitigation alternatives. Larger results images are provided in Appendix B.

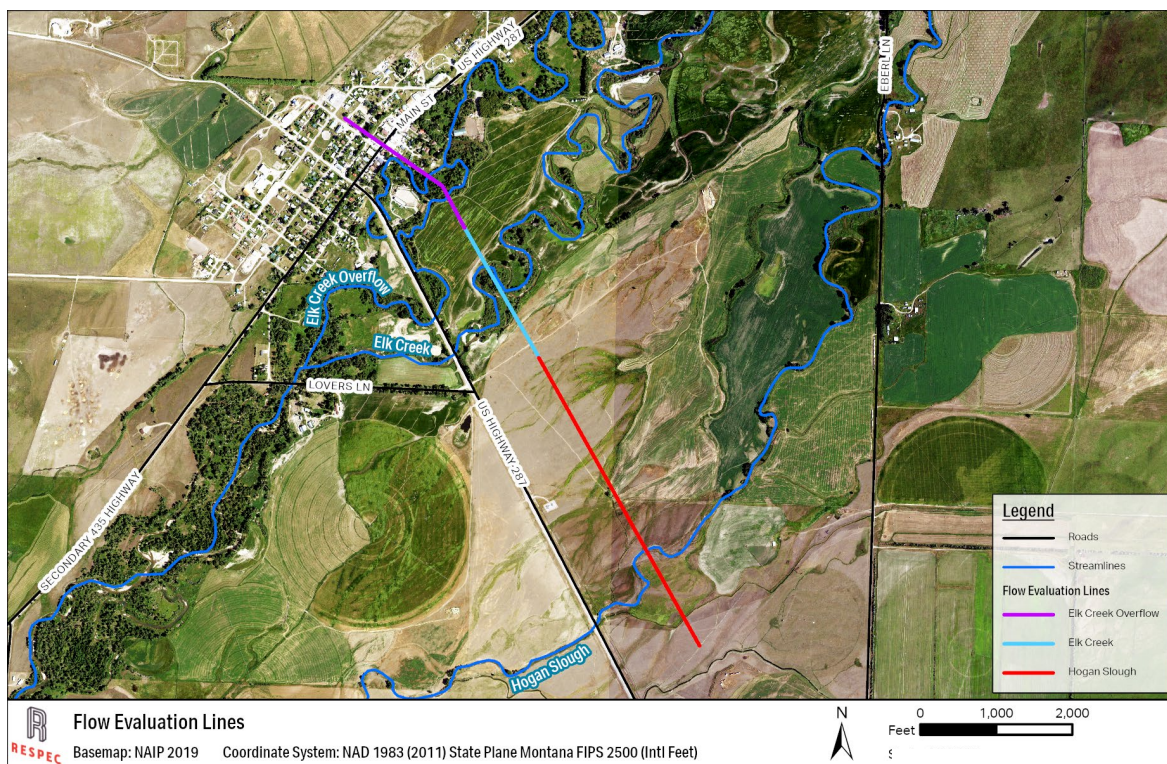
Figure 15. The evaluation lines drawn in HEC-RAS to evaluate flow change between 2018 existing conditions and the alternatives.

The eleven alternatives are organized into an overview section to describe the alternative and a results section to present the results of the two-dimensional models. The results of the alternatives presented in this section were evaluated on WSEL changes, flow changes, velocity changes, and flooding extent changes. Raster calculators were used to determine WSEL, velocity, and flooding extent changes across the entire model domain and compared to the simulated 2018 existing conditions. The results figures placed in the text area are available as full size figures in Appendix B. Flow changes were evaluated at specific locations within the model domain because evaluating flow changes within a two-dimensional model can be difficult. Specifically, evaluation lines were created to assess flow changes just downstream of US 287. This location was chosen because it is in an ideal location to compare both the town of Augusta flooding down Main Street, the surrounding residential area, and in the Elk Creek Overflow to the flooding occurring in the channels and floodplains of Elk Creek and Hogan Slough. Figure 15 shows the flow evaluation lines chosen for this analysis.

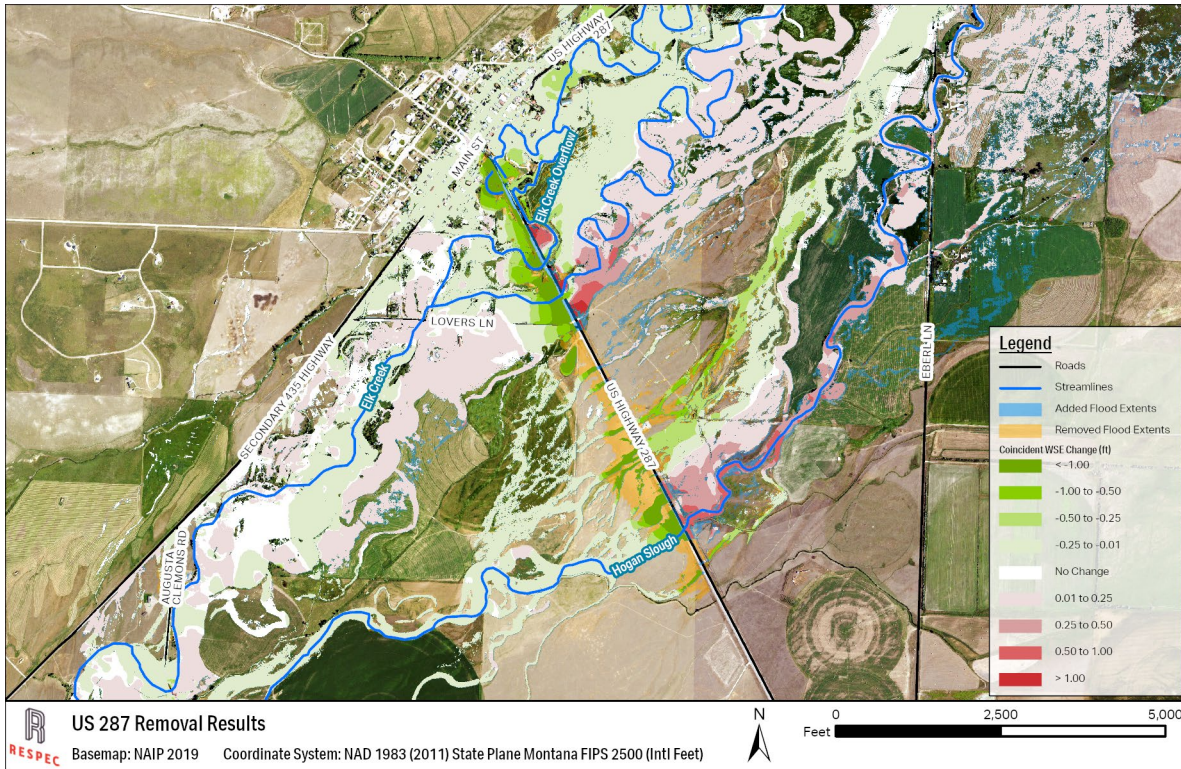
Figure 17. HEC-RAS output WSEL comparison between the US 287 removal alternative and the 2018 existing conditions.

Results of removing US 287 showed a smaller flood footprint behind the highway because of removed backwater. Large water surface elevation reductions were observed where backwater was in the 2018 existing conditions models, as well as along the Elk Creek Overflow evaluation line. Figure 17 illustrates the flood areas removed and added as result of removing US 287. Also shown are the changes in water surface elevations where coincident flooding occurs between the 2018 existing conditions results and the US 287 Removal results. Decreases in water surface elevations are shown in green, and increases are shown in red. White or slightly tinted colors represent very small changes in WSEL.

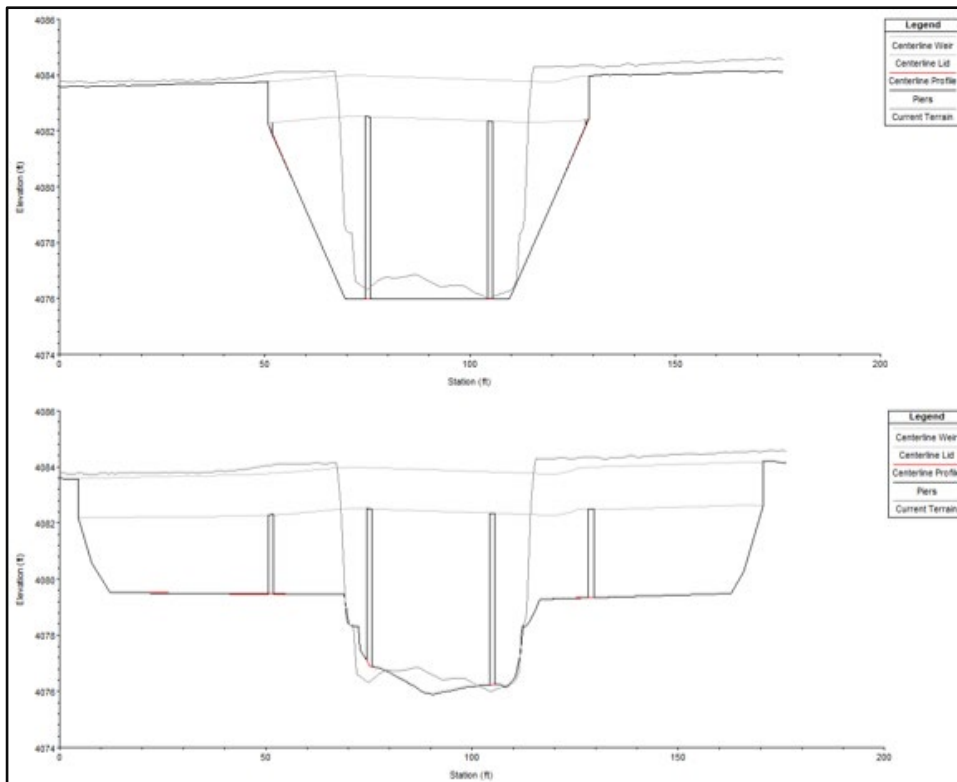
Figure 18. The modeled cross section alignments of the two US 287 Elk Creek bridge opening increases: excavation and widening of channel (top), and replacement with addition of floodplain benches (bottom).

The bridges along US 287 spanning Elk Creek and Elk Creek Overflow are often a problem during large flood events as described in the 2020 *Post-Flooding Hydrologic Assessment of Elk, Ford, and Smith Creeks*, observed in existing conditions model results, and expressed in comments from residents of Augusta. The bridges are a contributor to backwater during flood events because of the topography and relatively small opening size of the structures themselves. Photographs of flooding during the 2018 event showed floodwaters on US 287 up to the bridge deck elevations and overtopping in some locations. Two scenarios were assessed in this alternative to increase efficiency of the two bridges: widening the channel under the existing bridges and replacing the existing bridges with larger span bridges. The first scenario includes excavating the channel to remove aggradation and widening it to increase the existing bridge opening size. The second scenario includes the replacement of the existing bridges and creation of benches matching the elevation of the surrounding floodplain on either side of the active channel. The two scenarios for the US 287 bridge spanning Elk Creek are shown in Figure 18.

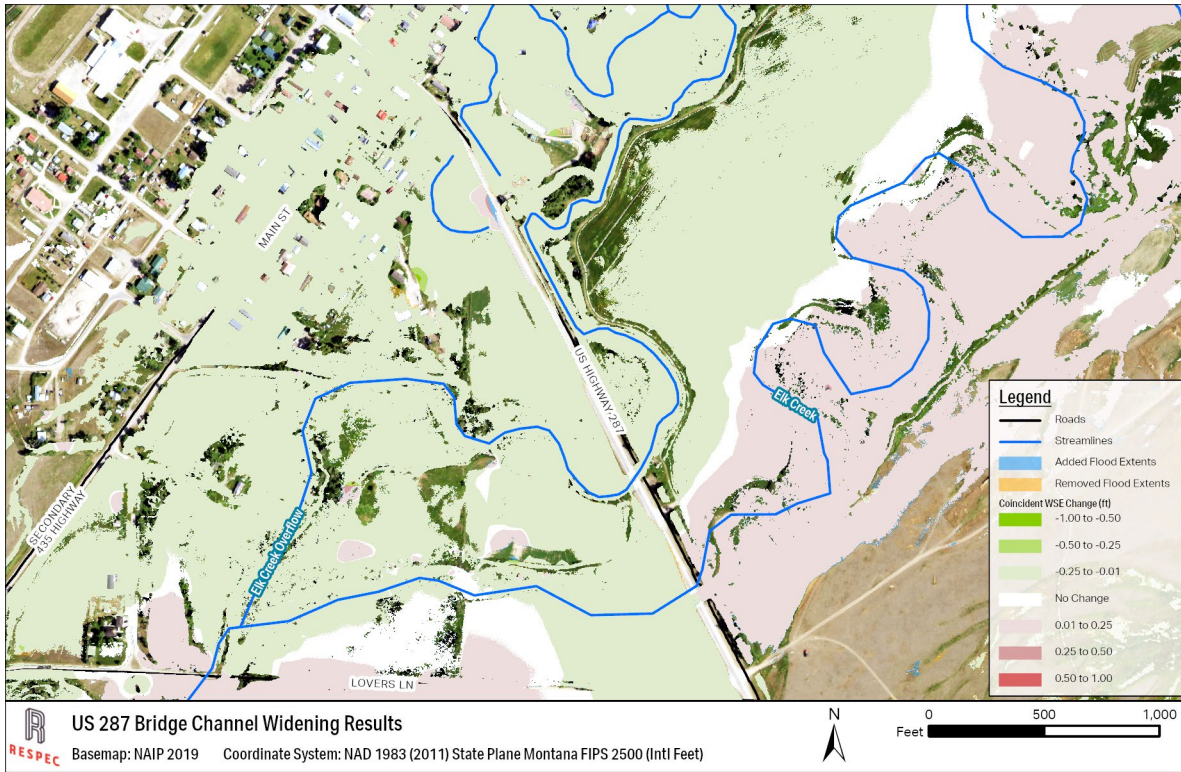
Figure 19. HEC-RAS output WSEL comparison between the US 287 bridge channel excavation alternative and the 2018 existing conditions. Small flow reductions occurred along the Elk Creek Overflow, small flow increases at Elk Creek, and no flow change at Hogan Slough because of increasing bridge capacities. Table 6 summarizes the depth and flow changes along the evaluation lines.

The flooding extents did not change in comparison to the 2018 existing conditions model. Small depth decreases were observed just upstream and downstream of the bridges as a result of some reduction in backwater. Figure 19 illustrates the flood areas removed and added to the floodplain because of widening the existing channel around the US 287 bridges. Also shown are the changes in water surface elevations where coincident flooding occurs between the 2018 existing conditions results and the US 287 Existing Bridge Channel Widening results. Decreases in water surface elevations are shown in green, and increases are shown in red. White or slightly tinted colors represent very small changes in WSEL.

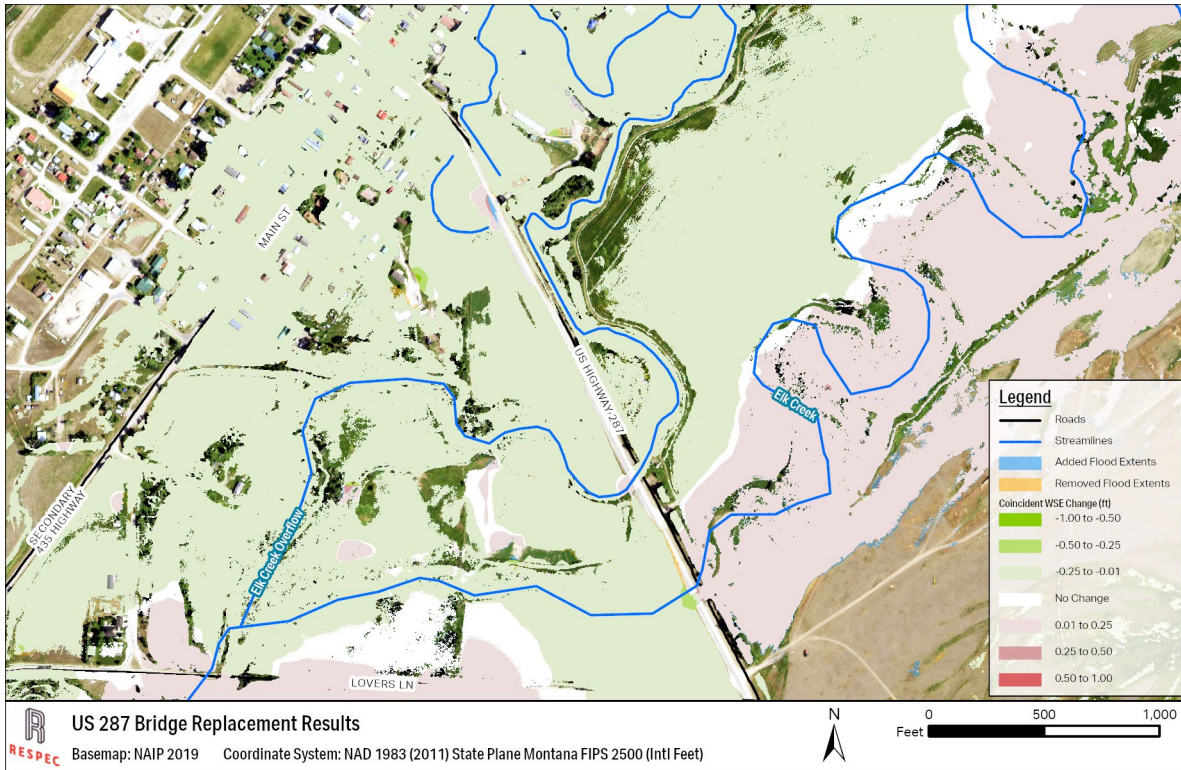
Figure 20. HEC-RAS output WSEL comparison between the US 287 bridge replacement alternative and the 2018 existing conditions.

The flooding extents did not change in comparison to the 2018 existing conditions model. Small depth decreases were observed just upstream and downstream of the bridges. Figure 20 shows the same but for the US 287 Bridge Replacement scenario. Decreases in water surface elevations are shown in green, and increases are shown in red. White or slightly tinted colors represent very small changes in WSEL.
