AUGUSTA FLOOD MITIGATION ENGINEERING RECOMMENDATIONS REPORT LEWIS AND CLARK COUNTY, MONTANA

JUNE 2022

RESPEC Company LLC
3810 Valley Commons Drive, Suite 4
Bozeman, MT 5971

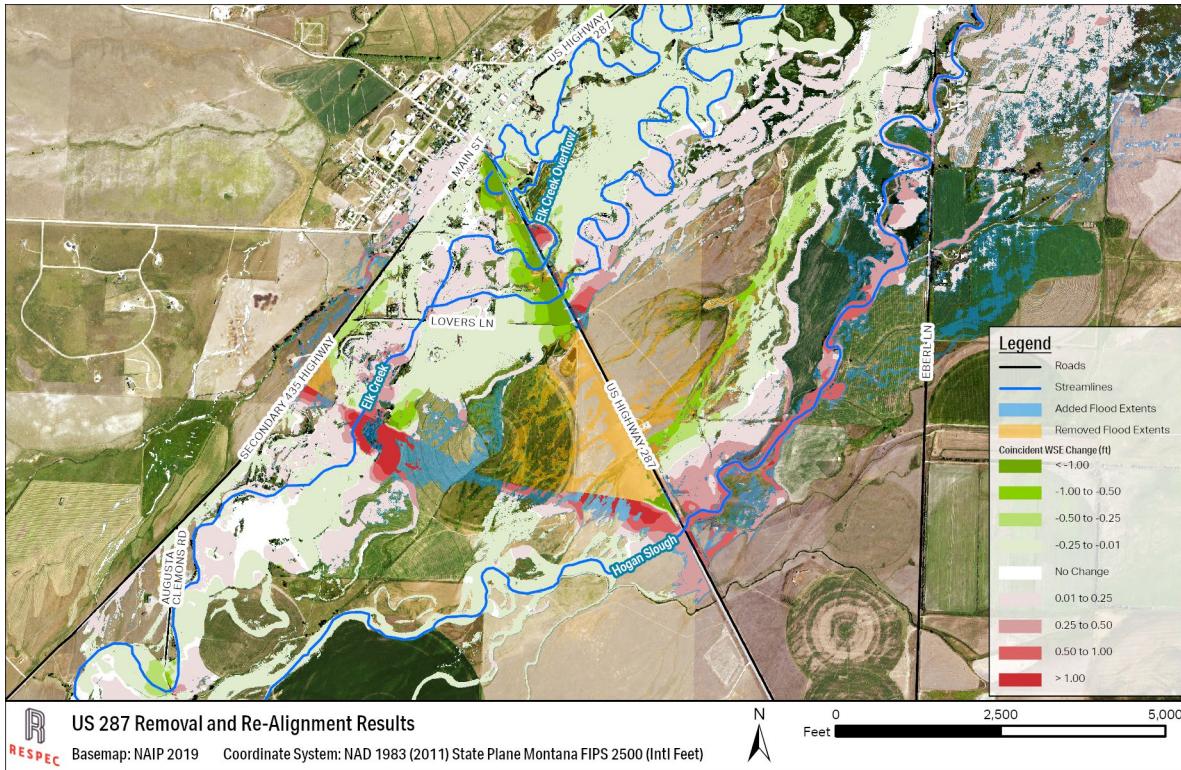
Figure 22. HEC-RAS output WSEL comparison between the US 287 re-alignment alternative and the 2018 existing conditions.

Similar to the results of the US 287 removal, large depth decreases were observed just upstream of the existing US 287 road embankment. Depth decreases were observed between the new alignment and the existing US 287, through the Elk Creek Overflow, and through the town center. Increases in depth were created upstream of the new alignment due to backwater caused by the road embankment. Hogan Slough also saw an increase in depths due to the increase flow towards that area. Figure 22 illustrates the flood areas removed and added to the floodplain because of re-aligning US 287. Also shown are the changes in water surface elevations where coincident flooding occurs between the 2018 existing conditions results and the US 287 Re-Alignment results. Decreases in water surface elevations are shown in green, and increases are shown in red. White or slightly tinted colors represent very small changes in WSEL.

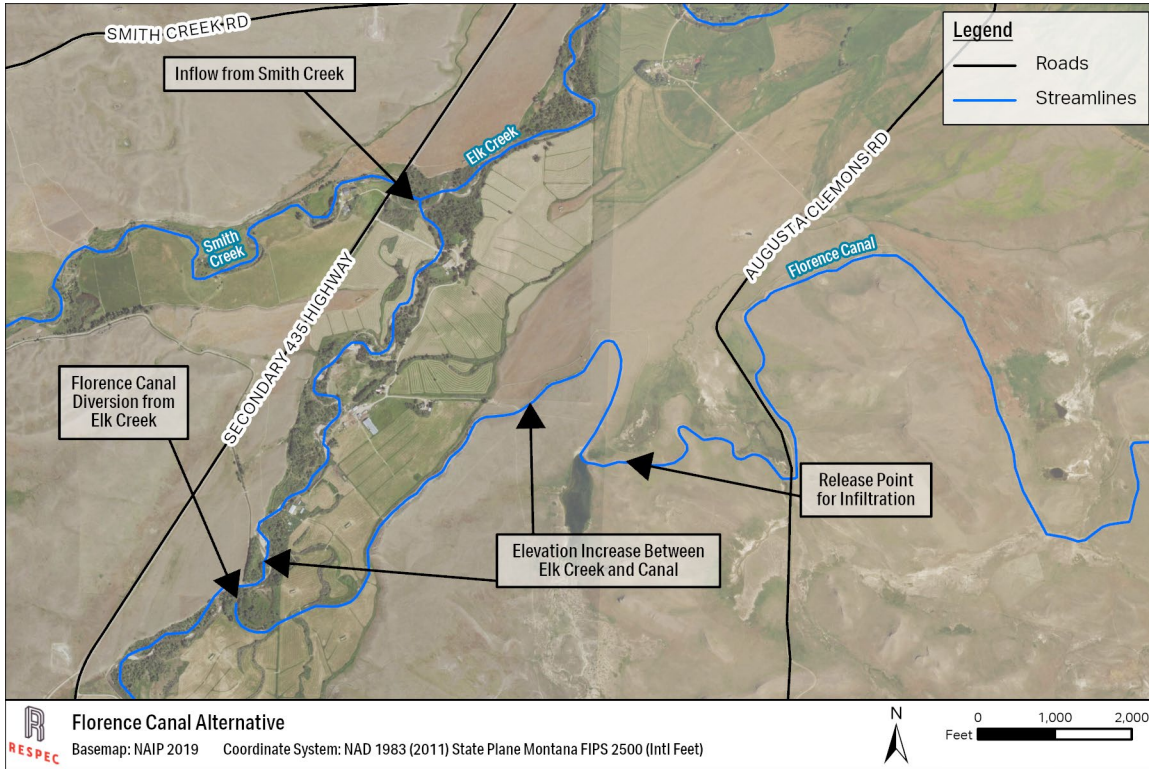
Figure 23. Overview of the evaluated Florence Canal alternative.

infiltration. Figure 23 outlines the evaluated Florence Canal alternative and recommendations made in the hydrological report.

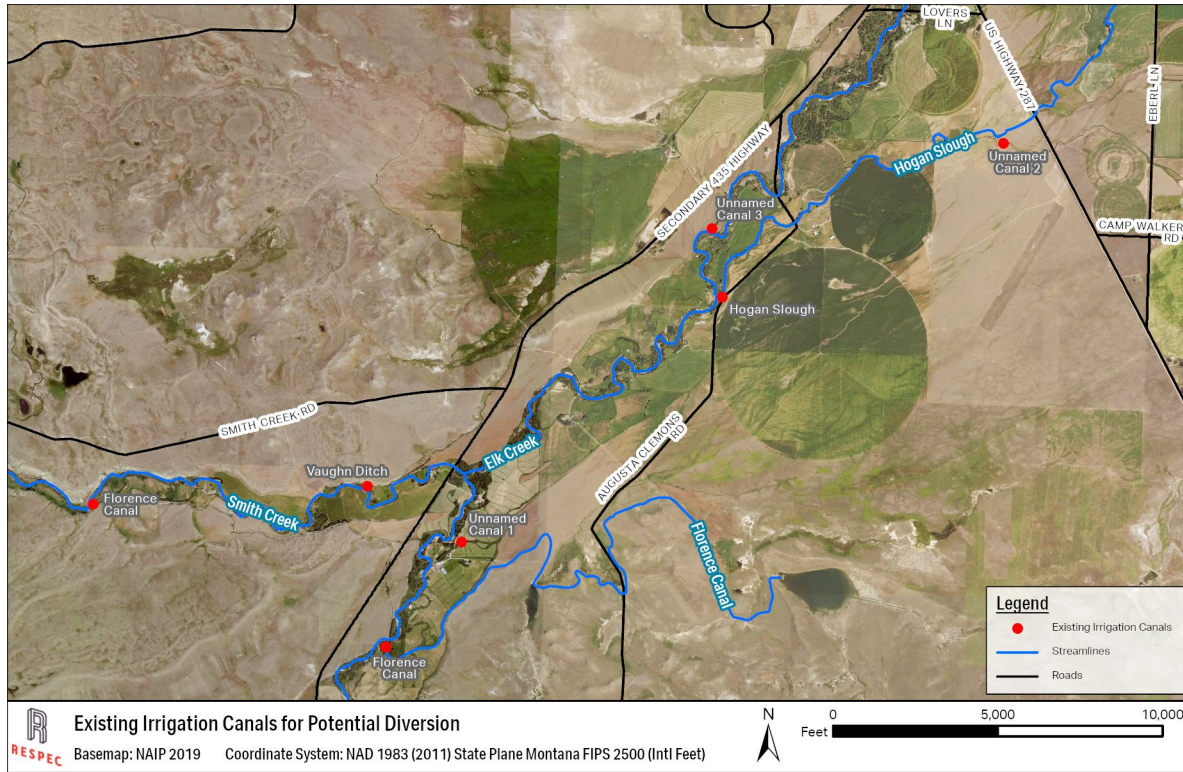
Figure 24, Existing irrigation canals for potential flow diversion from Elk Creek.

Comments from both the public meetings reflected positively and in favor of using existing irrigation canals to divert floodwaters away from the floodplain to decrease the volume of water flowing through Augusta during flood events. Anecdotally, it was also mentioned by long-term residents that diverting floodwaters into these channels was a flood mitigation technique used during past historic floods. Following the second public meeting, five additional irrigation canals were identified as potential flow diversion and infiltration options. These canals lack detailed data to accurately determine their flow capacity. Consequently, capacities were reasonably estimated, and a scenario ran with a reduced flow in Elk Creek. Figure 24 shows the potential flow diversion locations, where additional data is needed for further study and consideration.

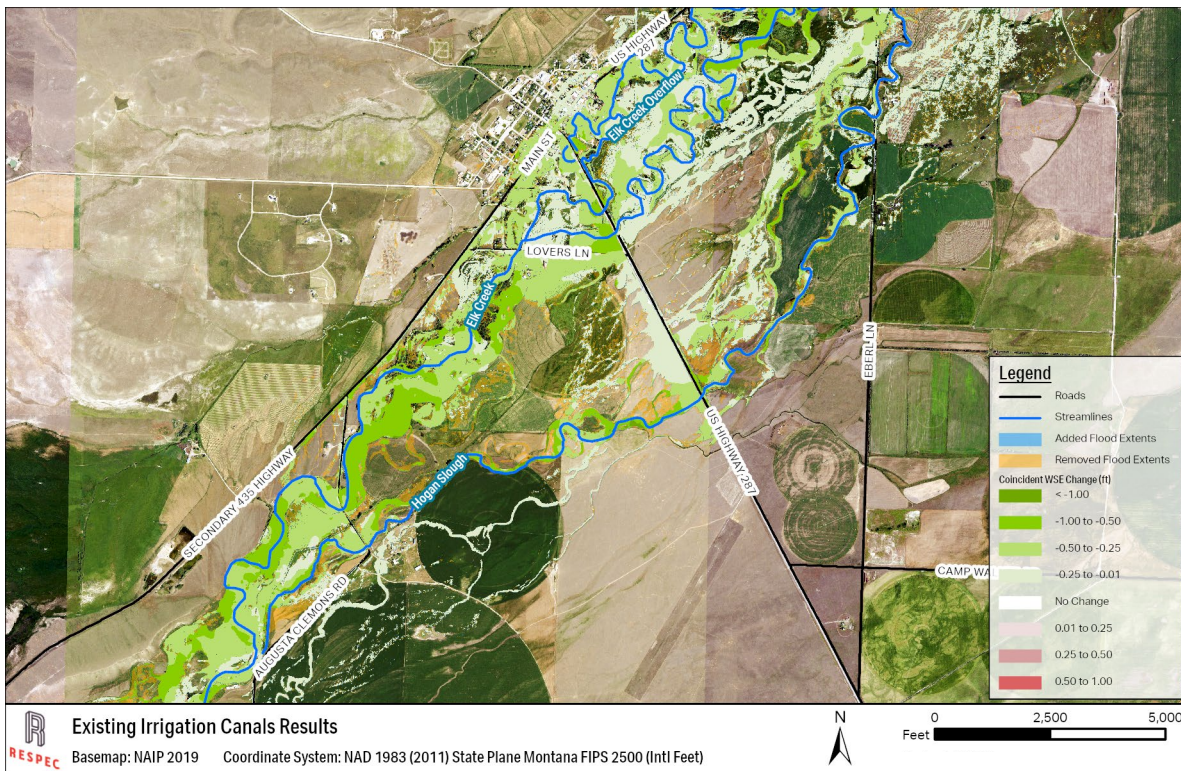
Figure 25. HEC-RAS output WSEL comparison between the existing irrigation canal alternative and the 2018 existing conditions.

Overall, water surface elevations decreased for the entire model domain. Small flood extent changes occurred throughout the entire model domain. Figure 25 illustrates the flood areas removed and added to the floodplain because of the removed irrigation canal flow volumes. Also shown are the changes in water surface elevations where coincident flooding occurs between the 2018 existing conditions results and the Existing Irrigation Canal Diversion results. Decreases in water surface elevations are shown in green, and increases are shown in red. White or slightly tinted colors represent very small changes in WSEL.

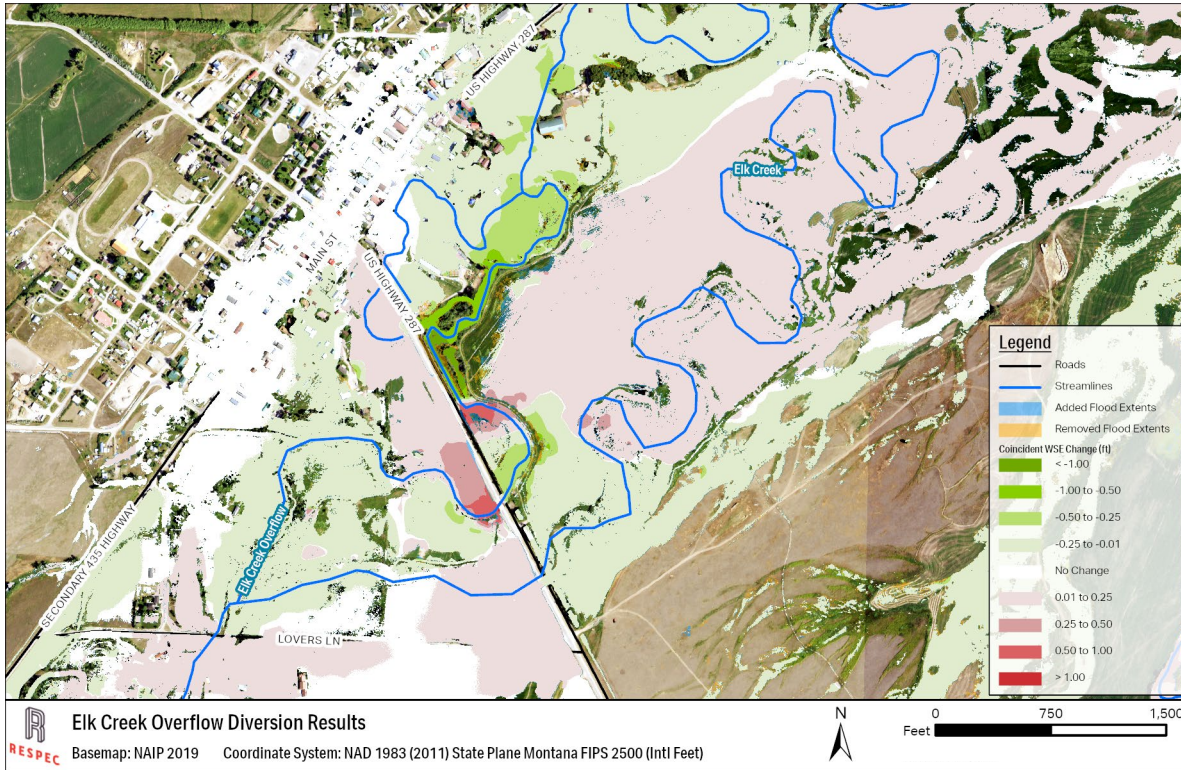
Figure 27. HEC-RAS output WSEL comparison between the Elk Creek Overflow diversion alternative and the 2018 existing conditions.

downstream. Decreases were observed along the Hogan Slough and Elk Creek Overflow channels downstream of US 287. Figure 27 illustrates the flood areas removed and added to the floodplain because of the addition of the Elk Creek Overflow diversion channel and plug. Also shown are the changes in water surface elevations where coincident flooding occurs between the 2018 existing conditions results and the Elk Creek Overflow Diversion results. Decreases in water surface elevations are shown in green, and increases are shown in red. White or slightly tinted colors represent very small changes in WSEL.

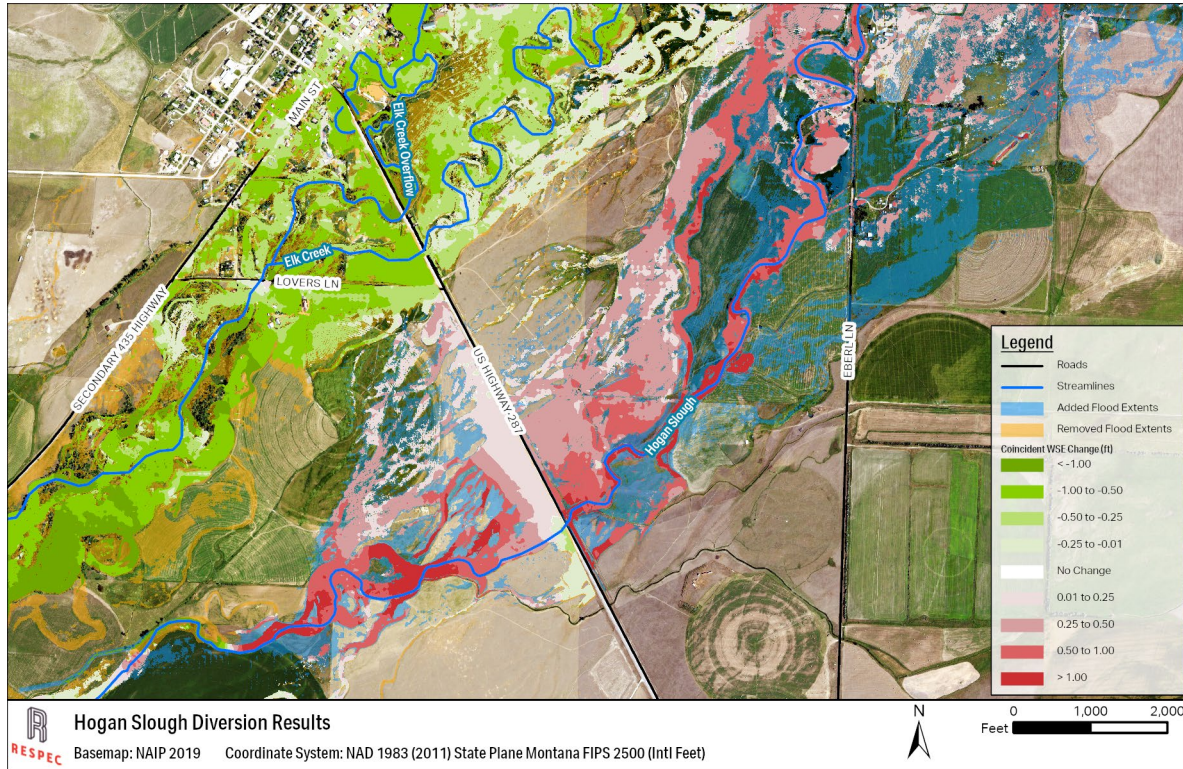
Figure 29. HEC-RAS output WSEL comparison between the Hogan Slough diversion alternative and the 2018 existing conditions.

Decreases in water surface elevations are shown in green, and increases are shown in red. White or slightly tinted colors represent very small changes in WSEL.

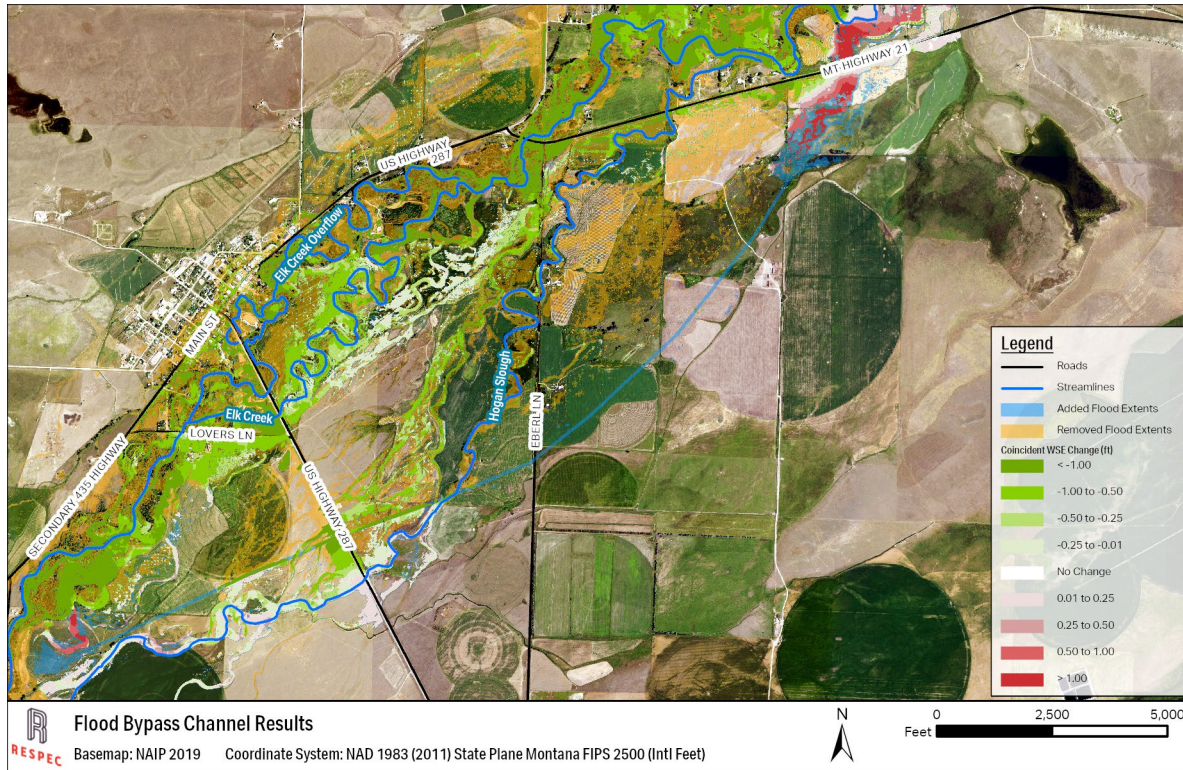
Figure 31. HEC-RAS output WSEL comparison between the flood bypass channel alternative and the 2018 existing conditions.

Flooding extents drastically decreased for the flood bypass channel in comparison with the 2018 existing conditions results. A small flood footprint remains outside the channel on the overbanks of Elk Creek and Hogan Slough. Similar to the flooding extents, water surface elevations also dramatically decreased for the entire model domain, except for in the flood bypass channel itself. Figure 31 illustrates the flood areas removed and added to the floodplain because of the Flood Bypass Channel. Decreases in water surface elevations are shown in green, and increases are shown in red. White or slightly tinted colors represent very small changes in WSEL.

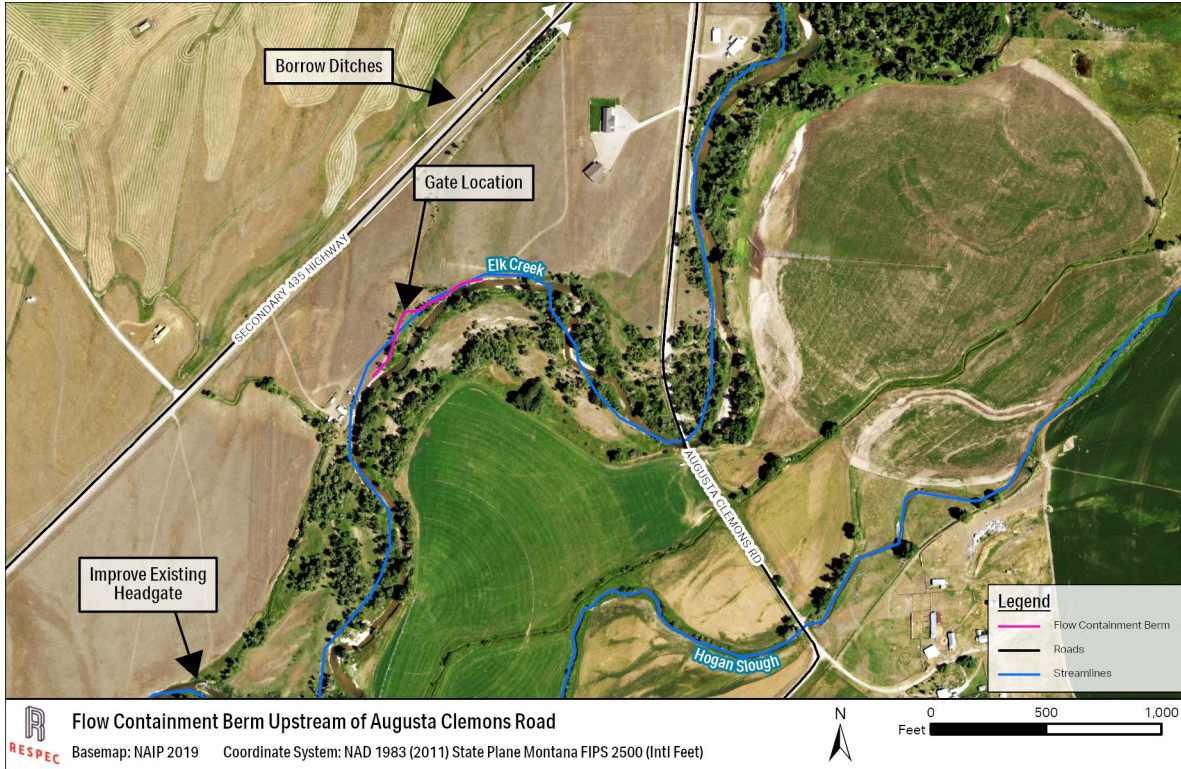
Figure 32. The modeled Elk Creek berm implementation upstream of Augusta Clemons Road.

banks and accessing the borrow ditch. The modeled berm extended 3' on average above the existing ground profile. This alternative also includes the reconstruction of the upstream headgate to increase the overtopping elevation and adding a gate to the berm for irrigation purposes when flood events are not occurring. Figure 32 outlines the modeled alternative and headgate locations.

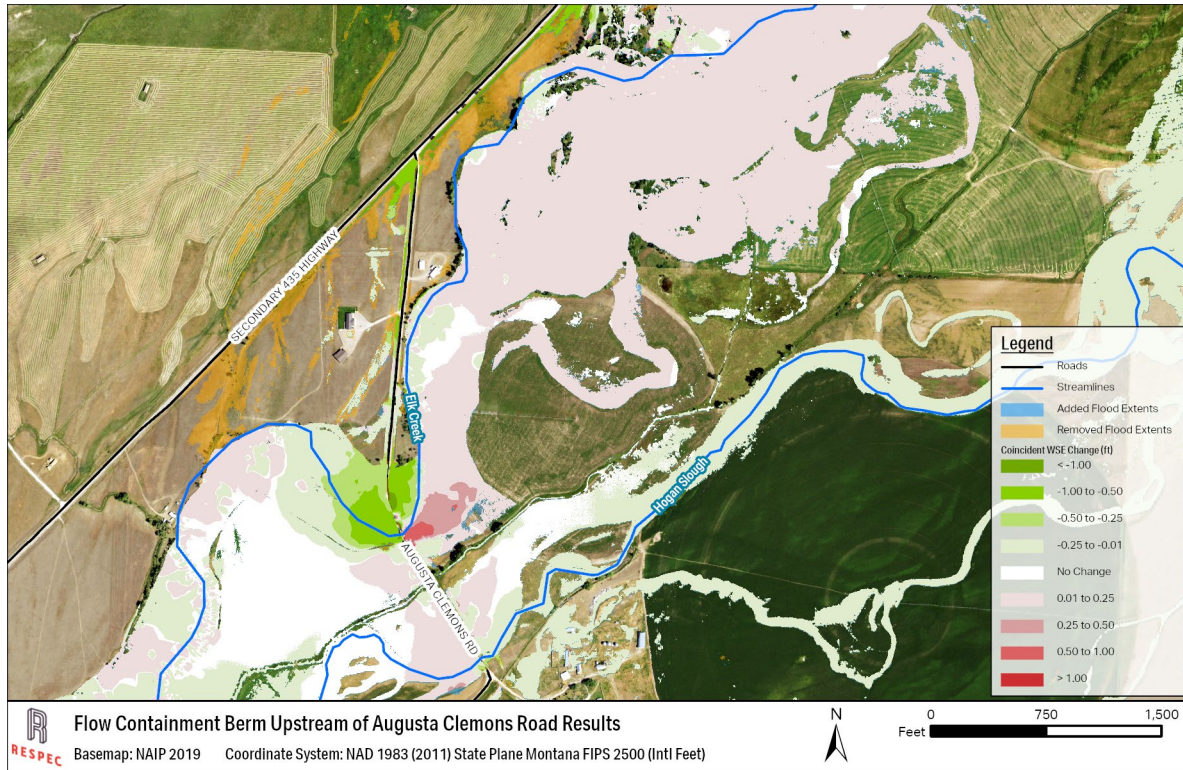
Figure 33. HEC-RAS output WSEL comparison between the flow containment berm alternative and the 2018 existing conditions.

Downstream of the modeled berm, floodwaters surface elevations increased slightly because water was not allowed to spill out of the channel. Flood extents downstream of the berm did not experience any significant changes, however floodwaters were eliminated from the left overbanks where the berm was placed. Figure 33 illustrates the flood areas removed from the floodplain with the berm implementation and the changes in the coincident water surface elevations within the immediate alternative location. Decreases in water surface elevations are shown in green, and increases are shown in red. White or slightly tinted colors represent very small changes in WSEL.

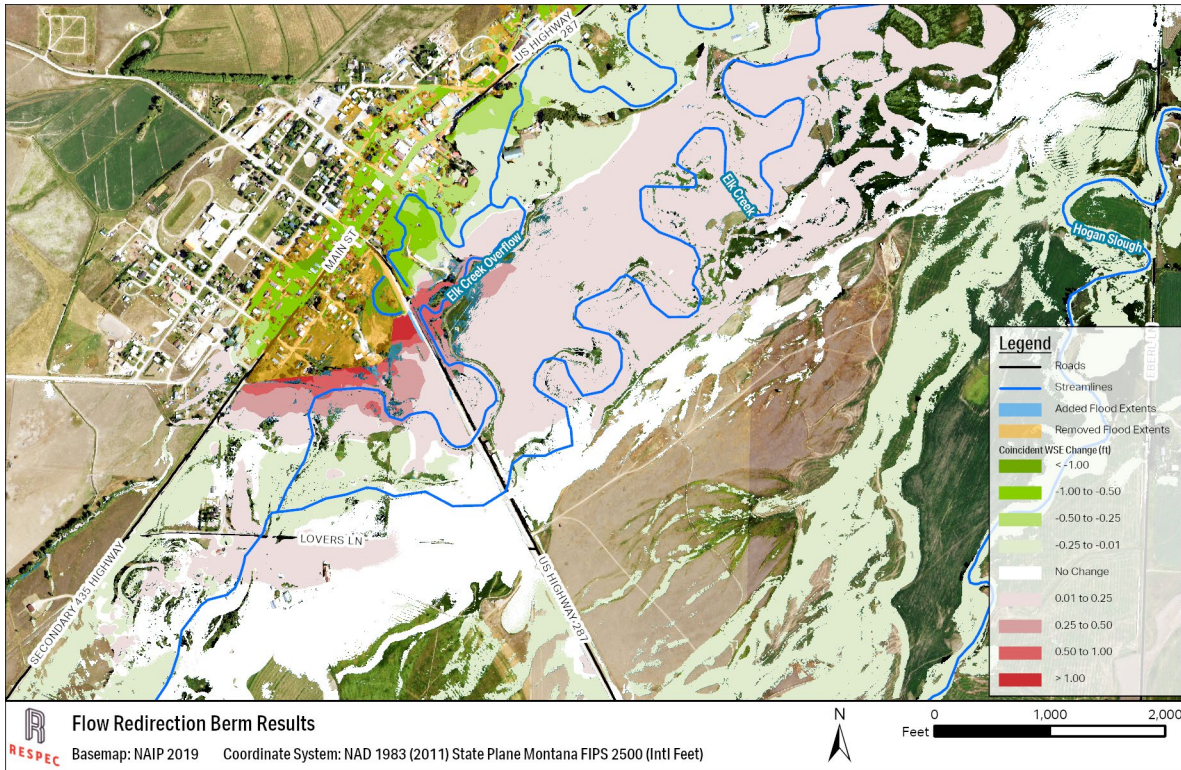
Figure 35. HEC-RAS output WSEL comparison between the flow redirection berm alternative and the 2018 existing conditions.

The floodplain footprint decreased behind the flow redirection berm, and along the left overbanks of the Elk Creek Overflow downstream of US 287. The floodplain extents stayed the same through the rest of the model domain. Water surface elevation decreases occurred behind the modeled berm and remained decreased by approximately 0.25 to 0.5' through the rest of the Elk Creek Overflow channel, larger water surface elevations increases were observed along and upstream of the berm for approximate 450' upstream. Further upstream than the 450' experienced slight increases in locations, but generally did not change. Figure 35 illustrates the flood areas removed and added to the floodplain because of the Flow Redirection Berm. Also shown are the changes in water surface elevations where coincident flooding occurs between the 2018 existing conditions and flow redirection berm results. Decreases in water surface elevations are shown in green, and increases are shown in red. White or slightly tinted colors represent very small changes in WSEL.

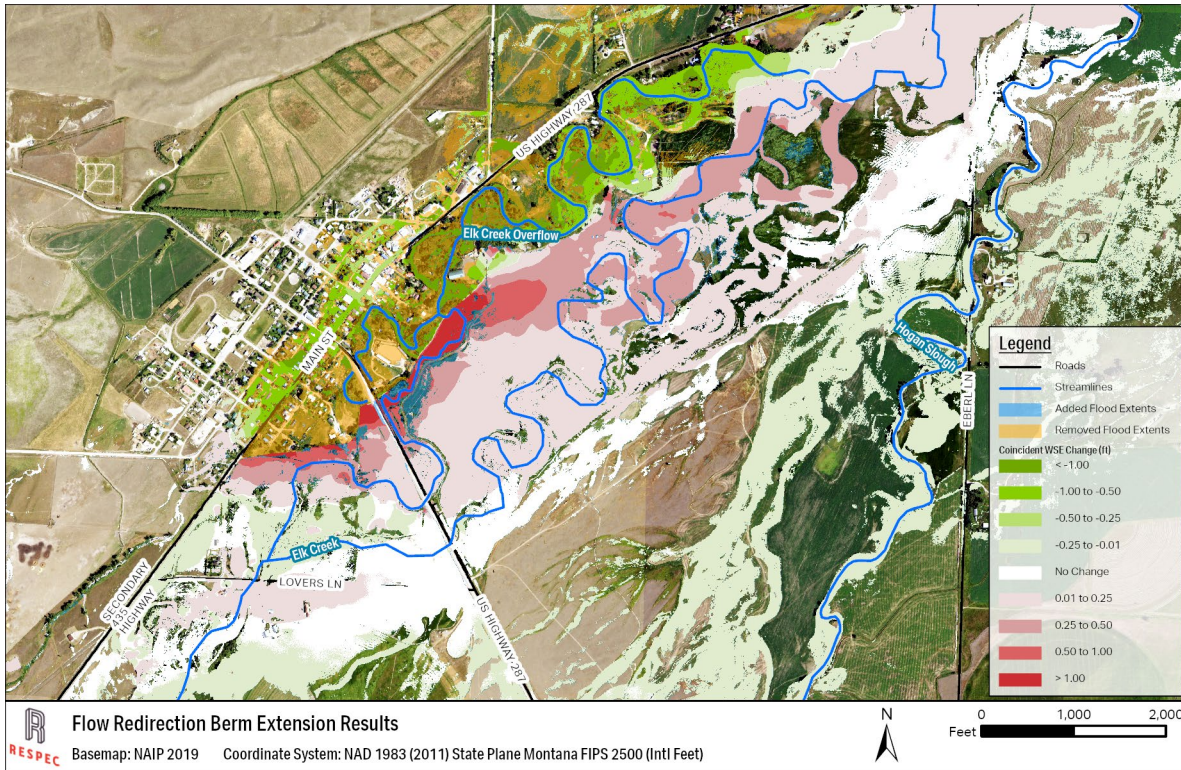
Figure 37. HEC-RAS output WSEL comparison between the flow redirection berm extension alternative and the 2018 existing conditions. Similar to the flow redirection berm alternative, small flow reductions were seen along the Elk Creek Overflow flow evaluation line, mainly within the channel itself and its left overbanks, as well as behind the extended berm. Flow increases were observed along the Elk Creek line, but the Hogan Slough flows remained the same. Flow changes between the 2018 existing conditions and flow redirection berm results are shown in Table 17.

Large floodplain extent removal occurred behind the flow redirection berm with the extension, also within the Elk Creek Overflow channel and its overbanks downstream of US 287 until it joins back up with the Elk Creek just upstream of MT 21. Floodplain extents elsewhere in the model domain remained the same. Water surface elevations largely decreased behind the berm and extension and remained significantly decreased until joining Elk Creek. Significant increases in water surface elevations were observed behind the berm for up to 500'. Figure 37 illustrates the flood areas removed and added to the floodplain because of the Flow Redirection Berm with Extension alternative, as well as the difference in water surface elevations where coincident flooding occurs. Decreases in water surface elevations are shown in green, and increases are shown in red. White or slightly tinted colors represent very small changes in WSEL.

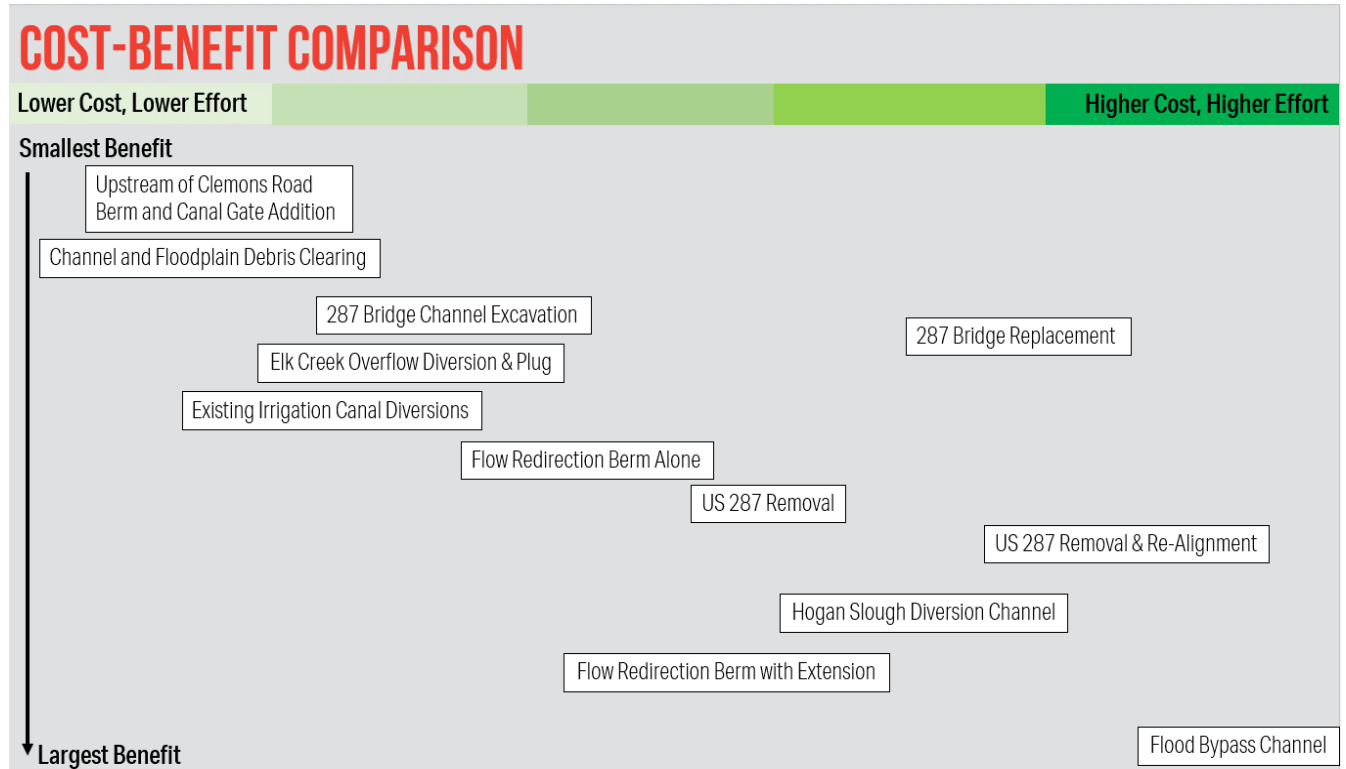
Figure 38. Qualitative cost-benefit analysis for all evaluated alternatives.

Based on the model results, public meeting comments, and preliminary cost estimates, a qualitative cost-benefit analysis graph was created to help visualize the cost and benefit relationship between each of the alternatives. Positive feedback from public meetings was received from displaying the information in this way. Figure 38 shows the qualitative cost-benefit analysis for each of the alternatives.

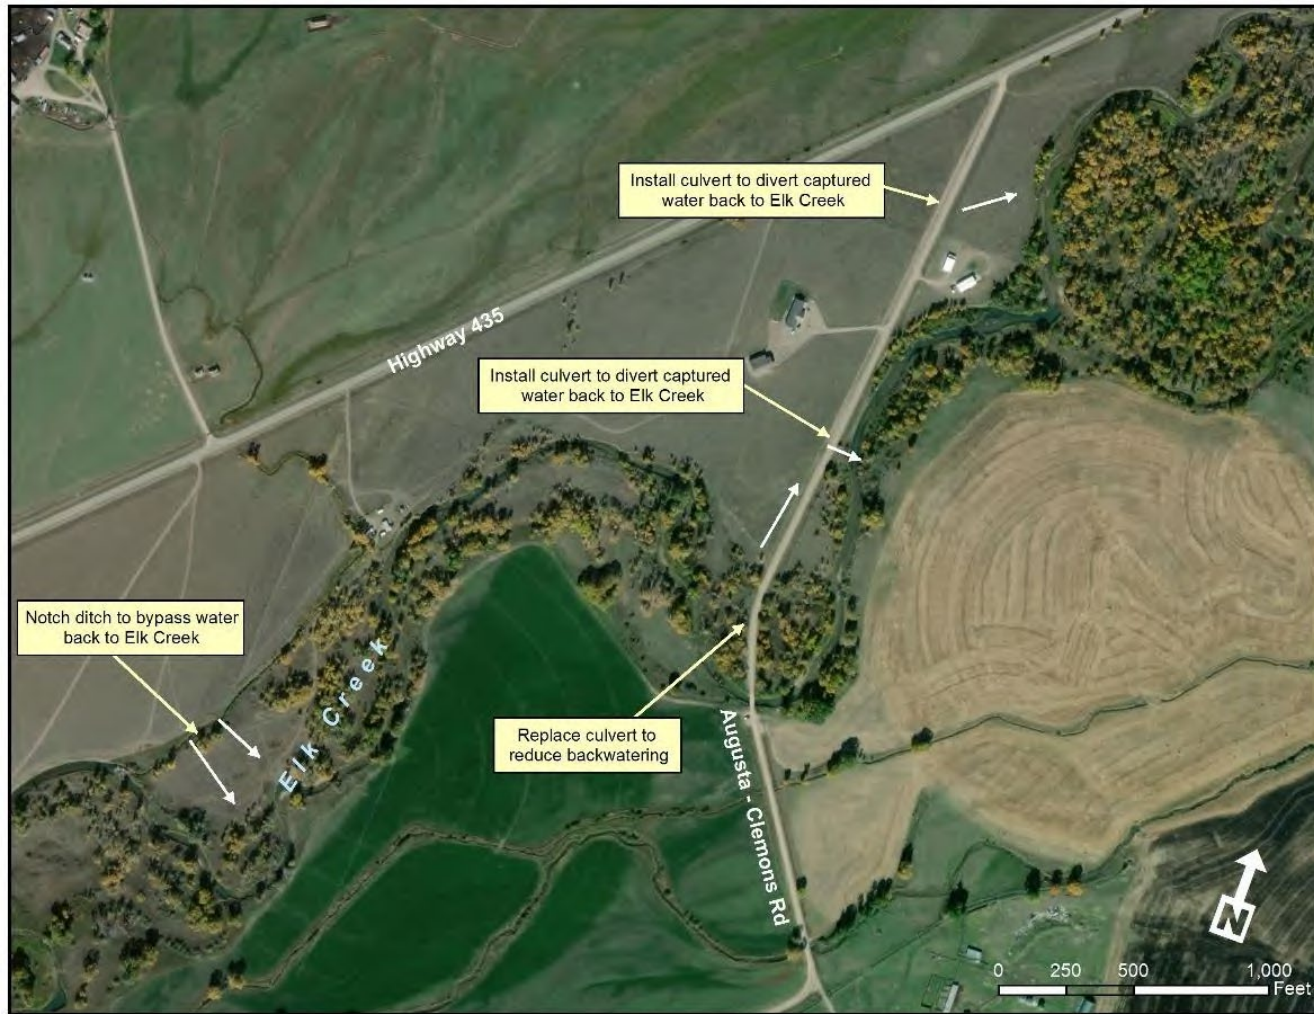
LIMITING BORROW DITCH ABILITY TO FUNNEL FLOOD WATERS

Figure from the Post-Flooding Hydrological Assessment by Confluence and Applied Geomorphology (2020).

- › EX. : HIGHWAY 435 BORROW DITCHES
- › LOWER COST OPTION
- › SHORTER TIMEFRAME

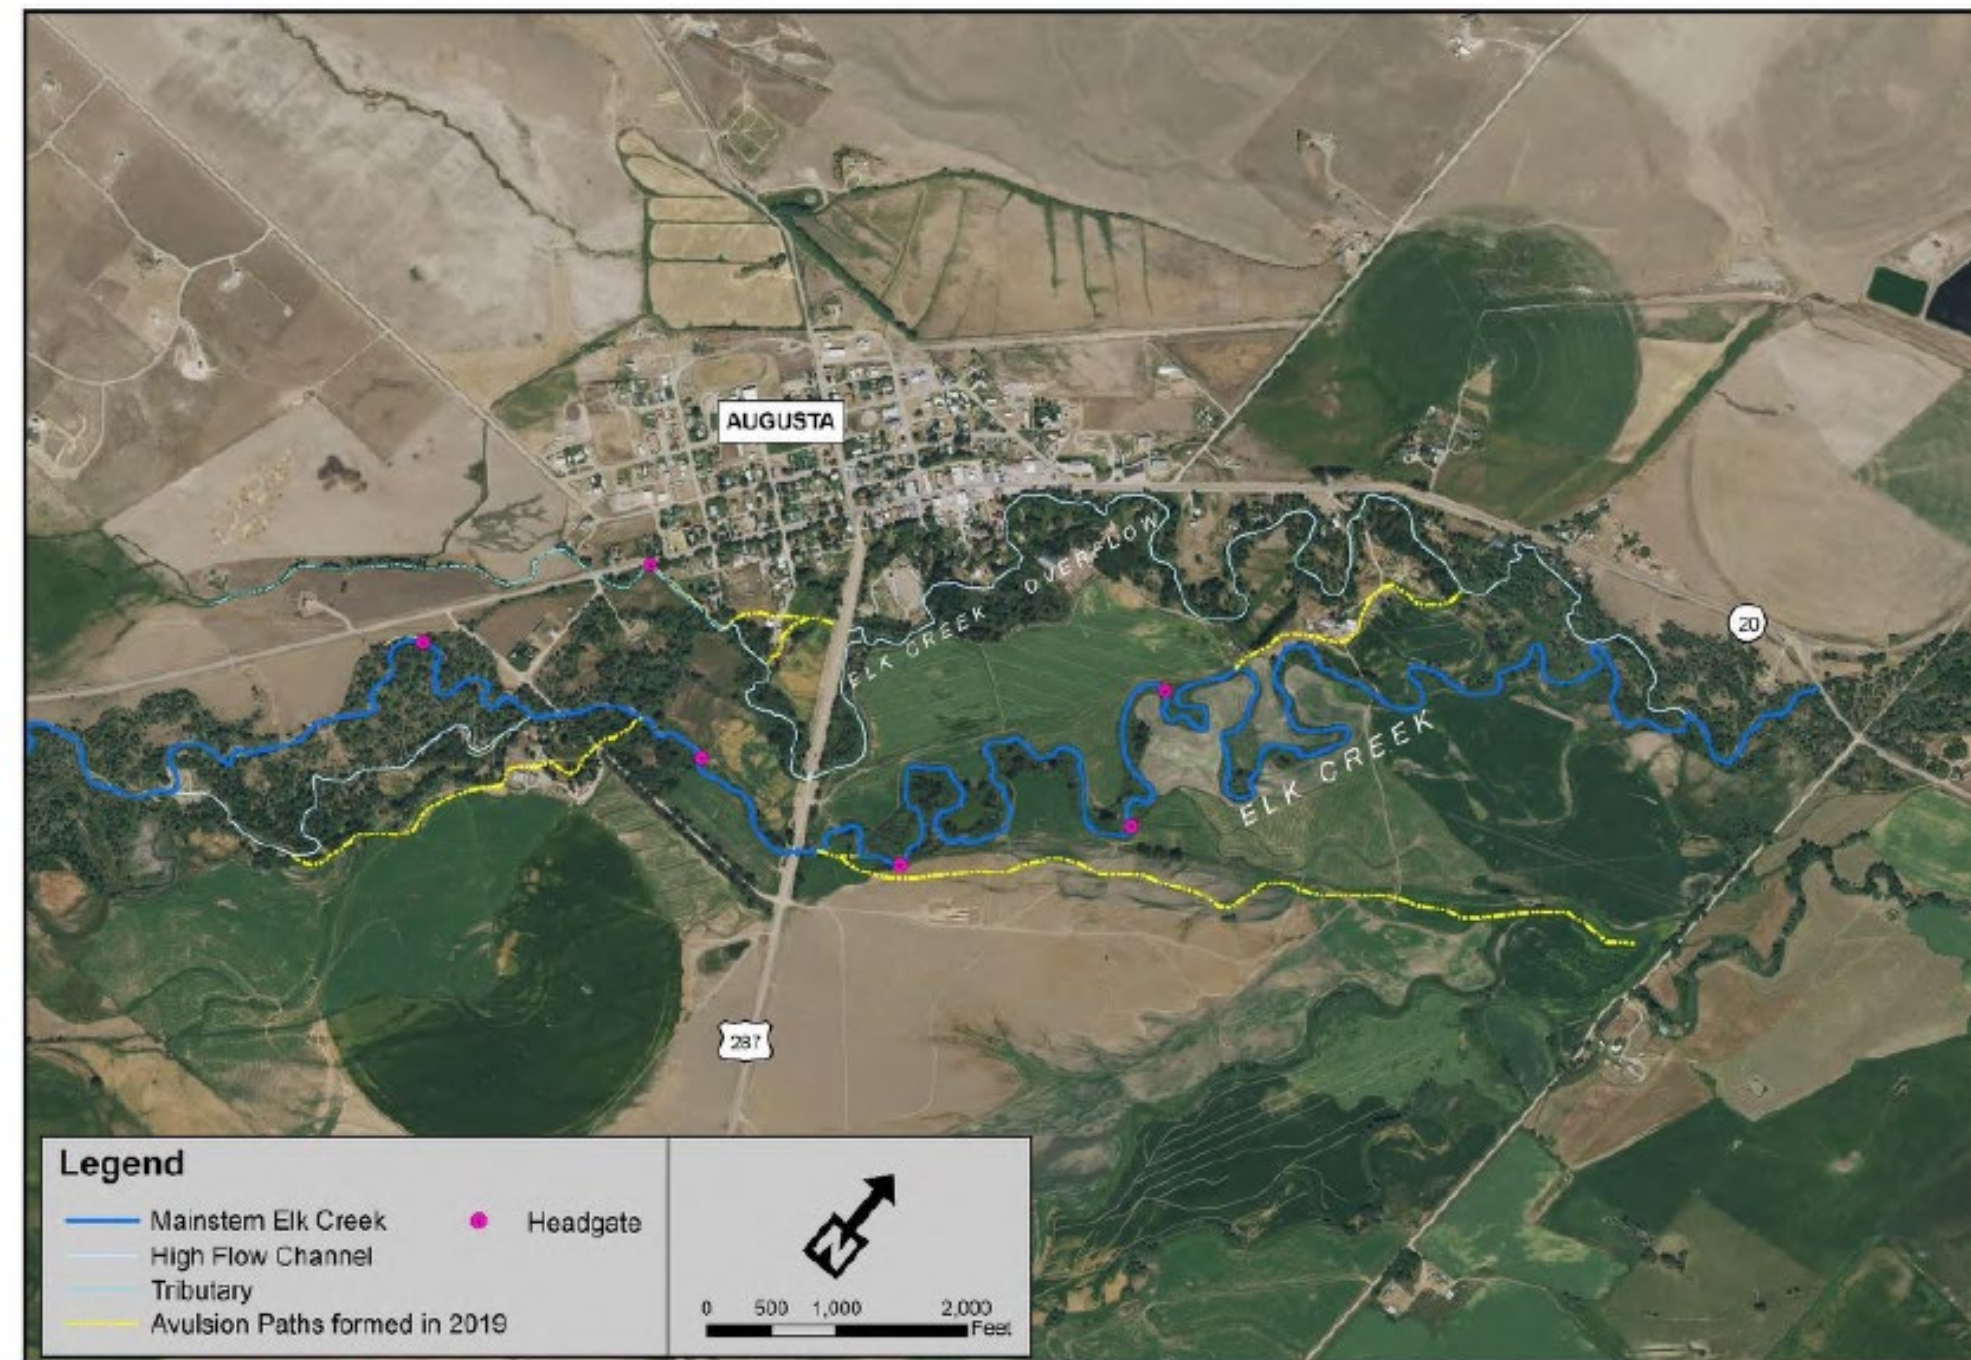
Figure 102. Avulsion paths formed during 2019 flood in the vicinity of Augusta.

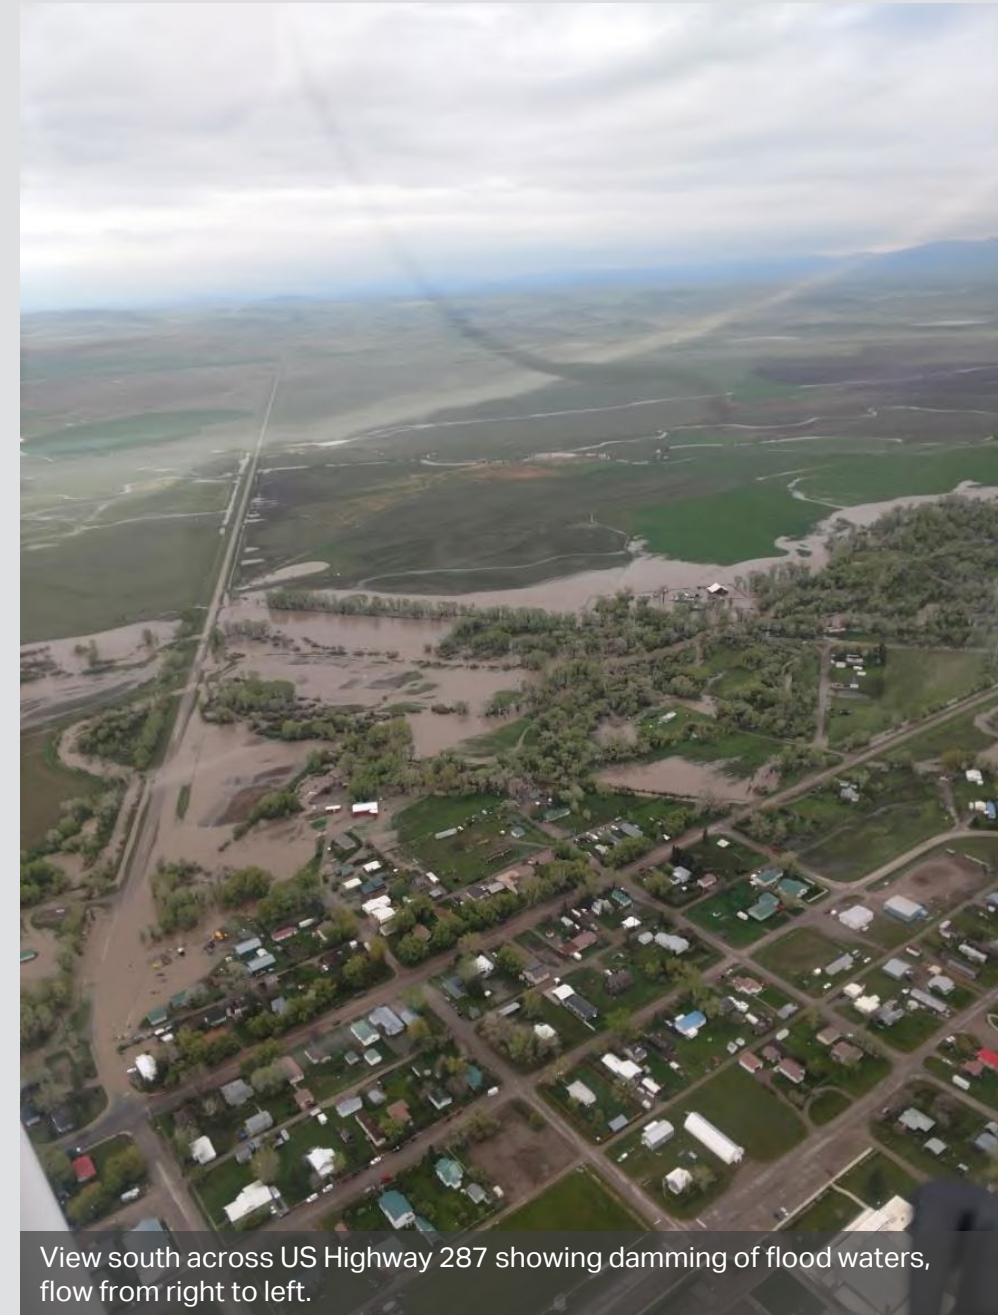
View south across US Highway 287 showing damming of flood waters, flow from right to left.

- › US HIGHWAY 287 IS A LARGE BOTTLENECK
- › HIGH COST, LONG TERM
- › EVALUATE EFFECTIVENESS IN MODEL
- › COLLABORATE WITH MDT

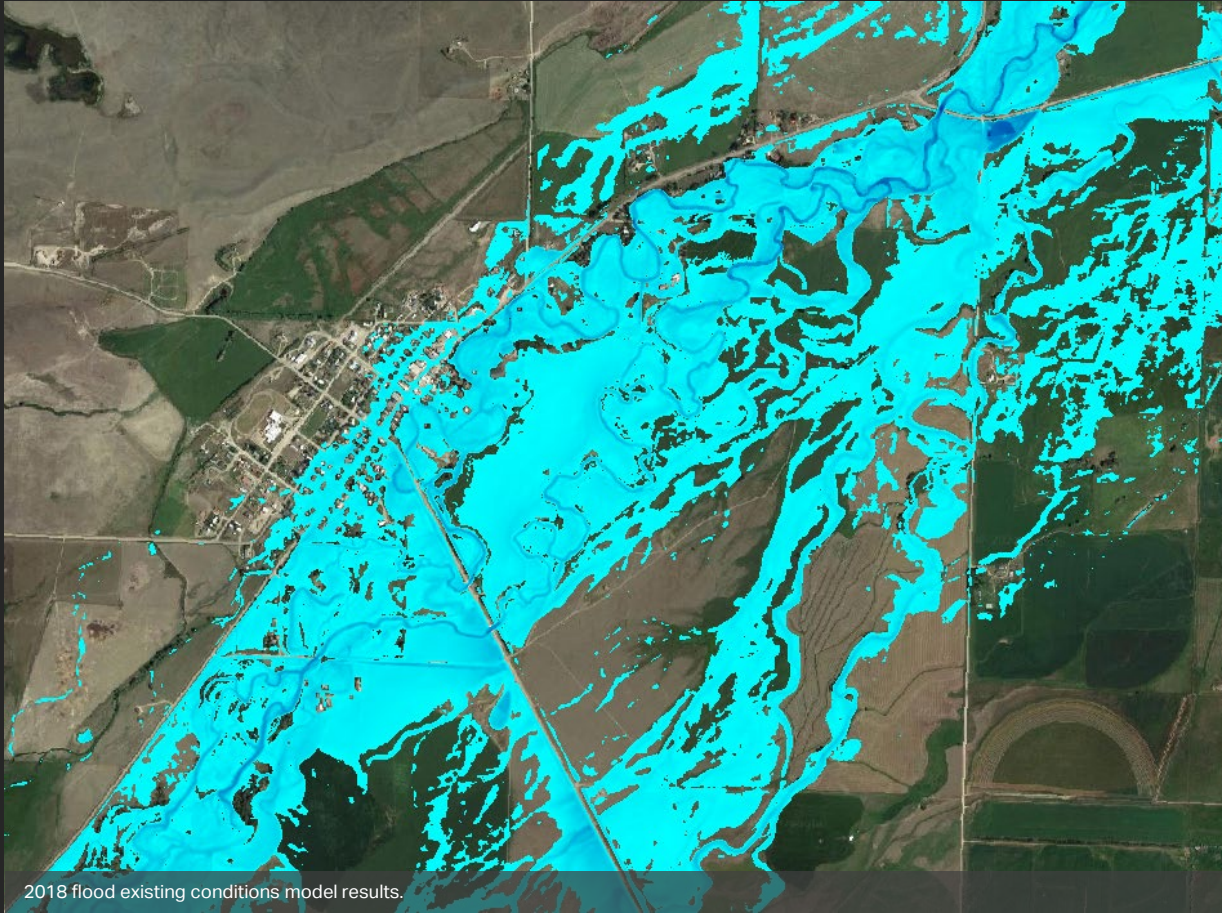
2018 flood existing conditions model results.

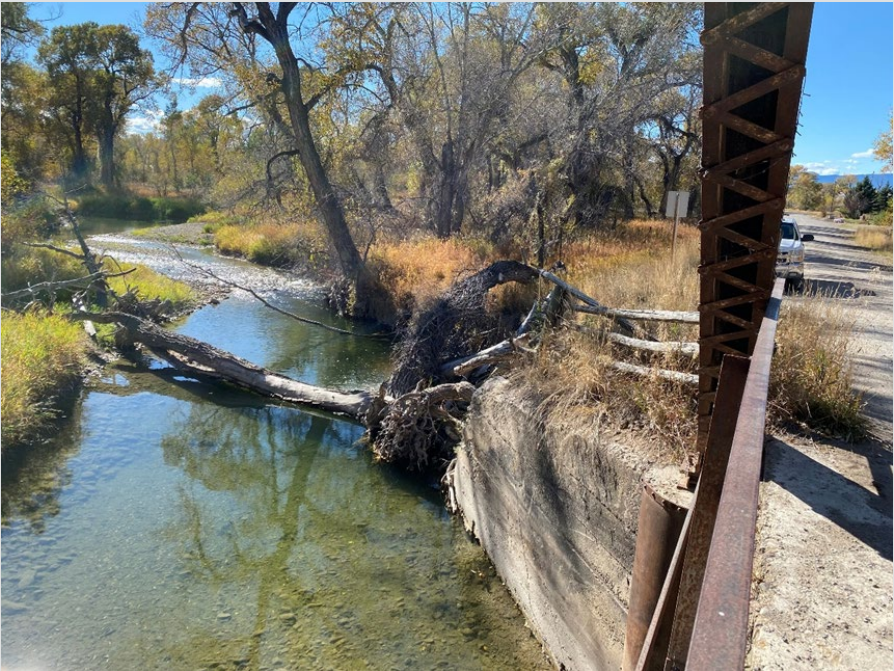
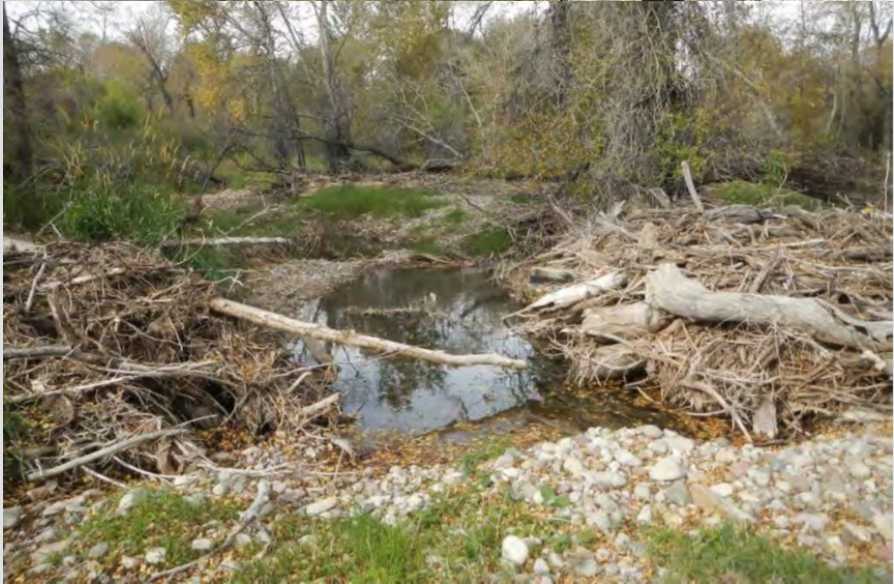
Model Results Percentage of Total Flow In Each Region Just Downstream of US 287

Scenario	Elk Creek Overflow + Floodplain	Elk Creek Main + Floodplain	Hogan Slough + Floodplain
2018 Flood	37%	43%	20%
Channel and Floodplain Debris Clearing	38%	43%	19%

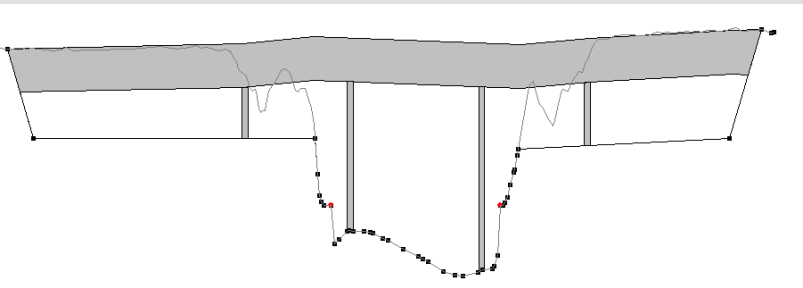
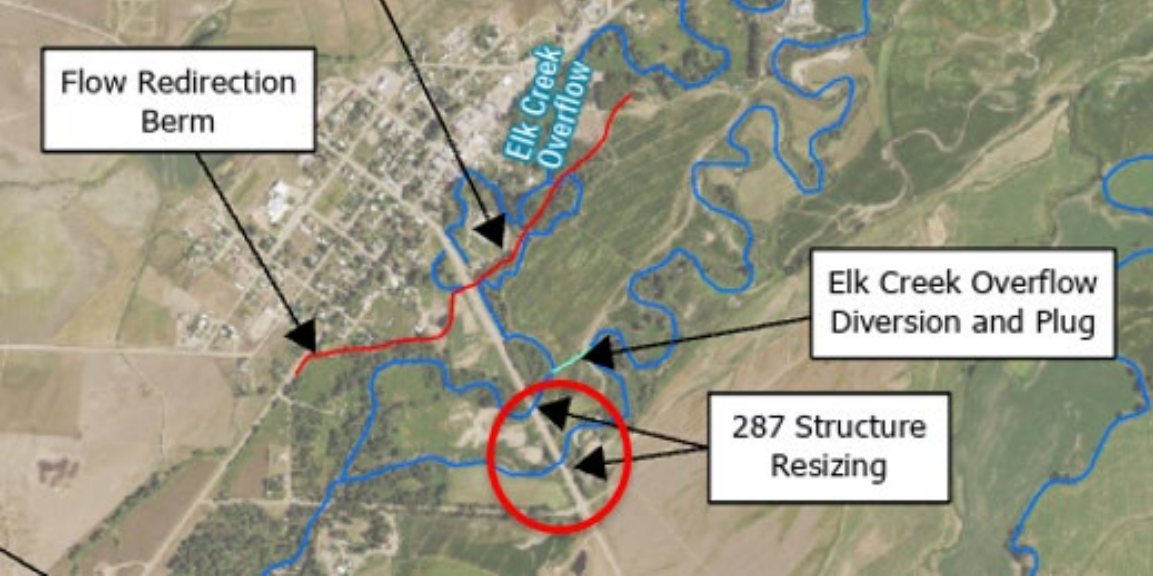
b. Addition of floodplain elevation level benches
