AUGUSTA FLOOD MITIGATION ENGINEERING RECOMMENDATIONS REPORT LEWIS AND CLARK COUNTY, MONTANA

JUNE 2022

RESPEC Company LLC
3810 Valley Commons Drive, Suite 4
Bozeman, MT 5971

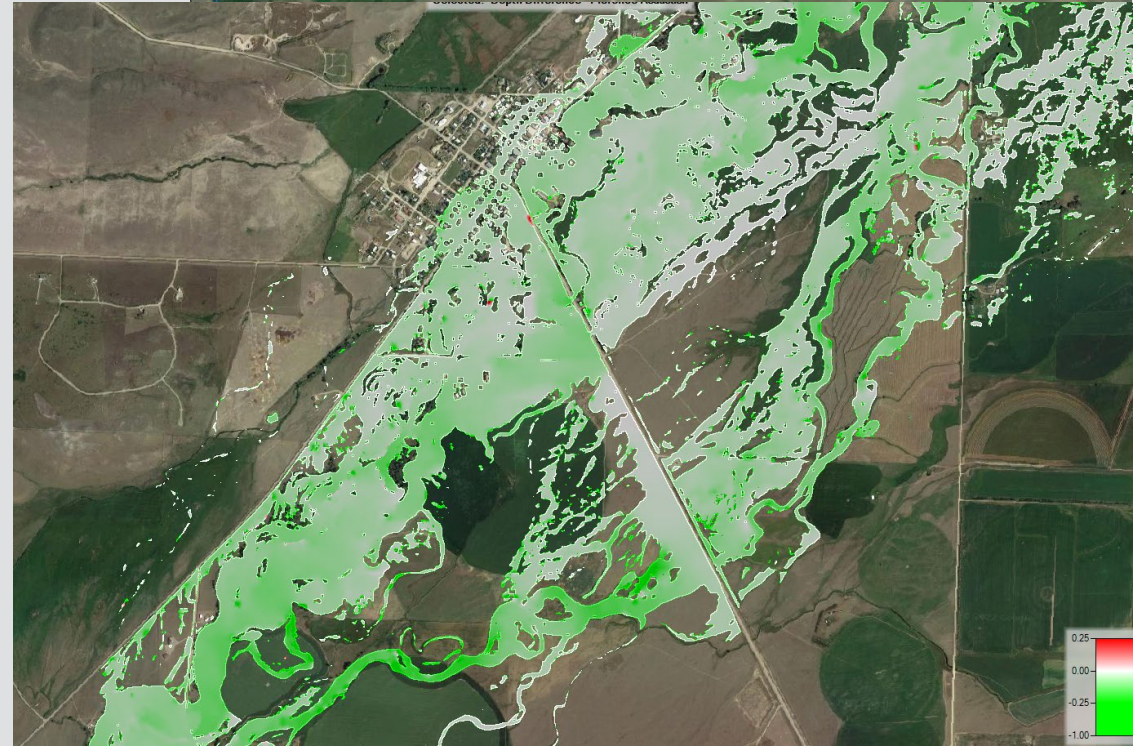
- › LOW-CAPACITY CANAL (~500 CFS)
- › PERCHED CANAL ABOVE FLOODPLAIN
- › APPROXIMATELY A 0.05' DECREASE OF DEPTH IN ELK CREEK OVERFLOW JUST DOWNSTREAM OF US 287
- › SMALL DEPTH DECREASES

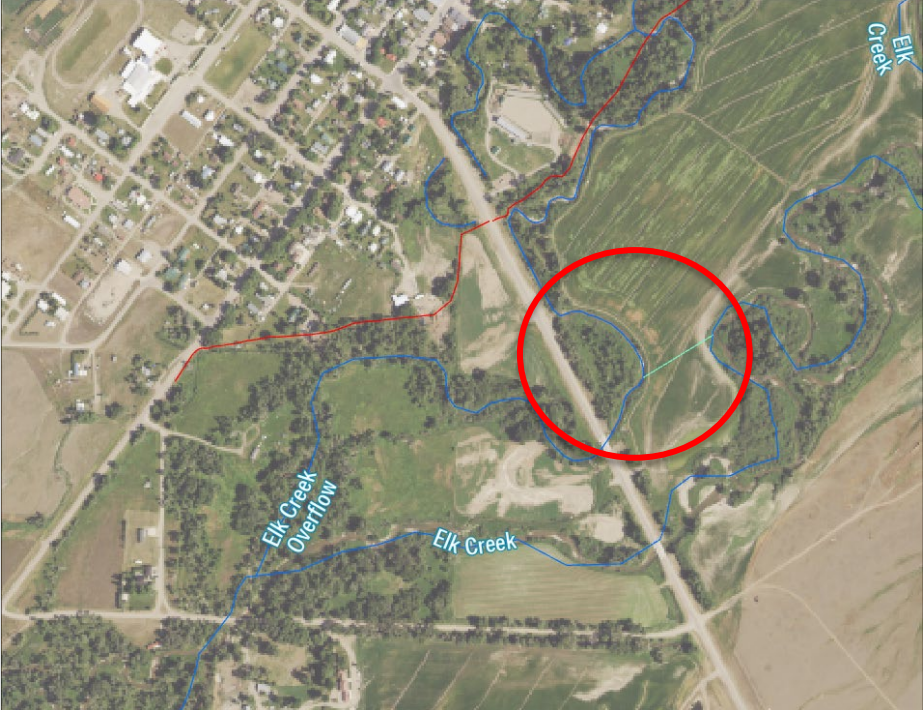
- ▶ **DIVERT FLOW BACK INTO ELK CREEK MAIN AT FLOOD STAGES**
 - / Small channel creation connecting Elk Creek Overflow and Elk Creek Main
 - / Plug Elk Creek Overflow
 - / Downstream bank stabilization efforts
 - / Consider prevention of backwater into culverts to support

Model Results Percentage of Total Flow In Each Region Just Downstream of US 287

Scenario	Elk Creek Overflow + Floodplain	Elk Creek Main + Floodplain	Hogan Slough + Floodplain
2018 Flood	37.1%	42.9%	20%
Elk Creek Overflow Diversion	31.4%	48.7%	19.9%
