# Preliminary Engineering Report

## BIRDSEYE ROAD—BARRETT ROAD TO LINCOLN ROAD

LEWIS AND CLARK COUNTY

*RPA Project No. 10502.001*

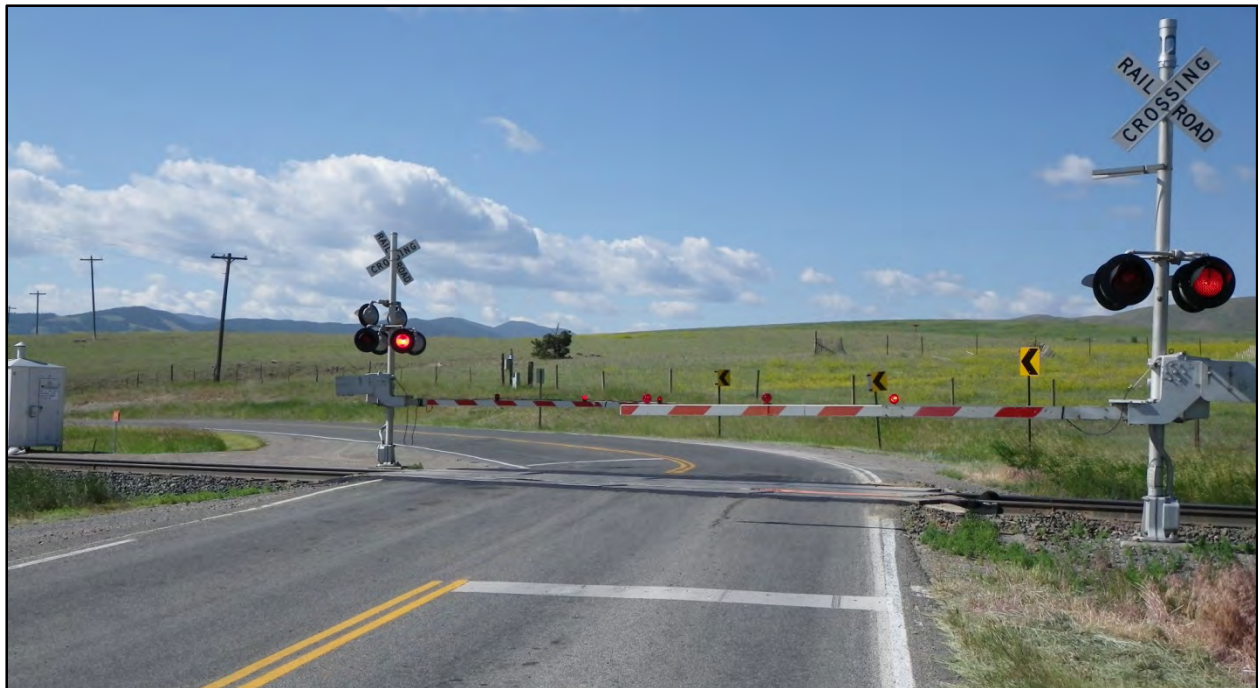
**Photo 3.1: Curve and railroad crossing at MP 1.80 – Looking Southwest.**

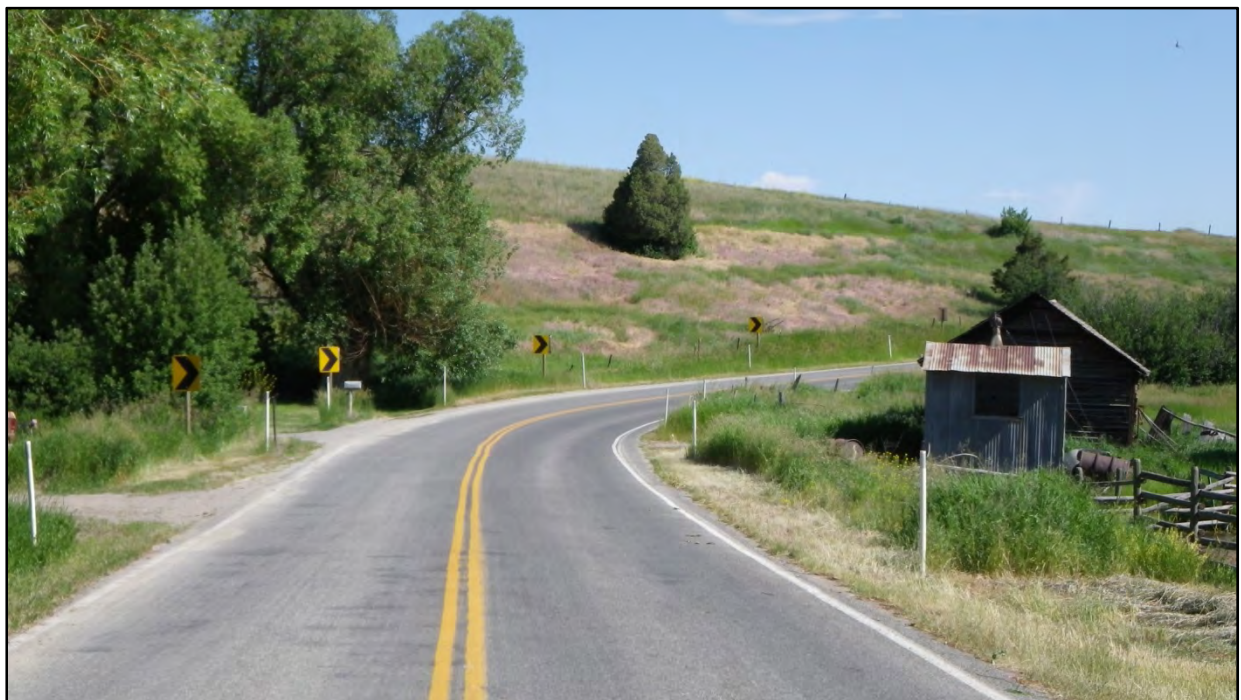
**Photo 3.2: Curve and poor sight distance at MP 6.45 – Looking North.**

**Figure 4.7: Horizontal Curve Improvement at MP 6.45.**

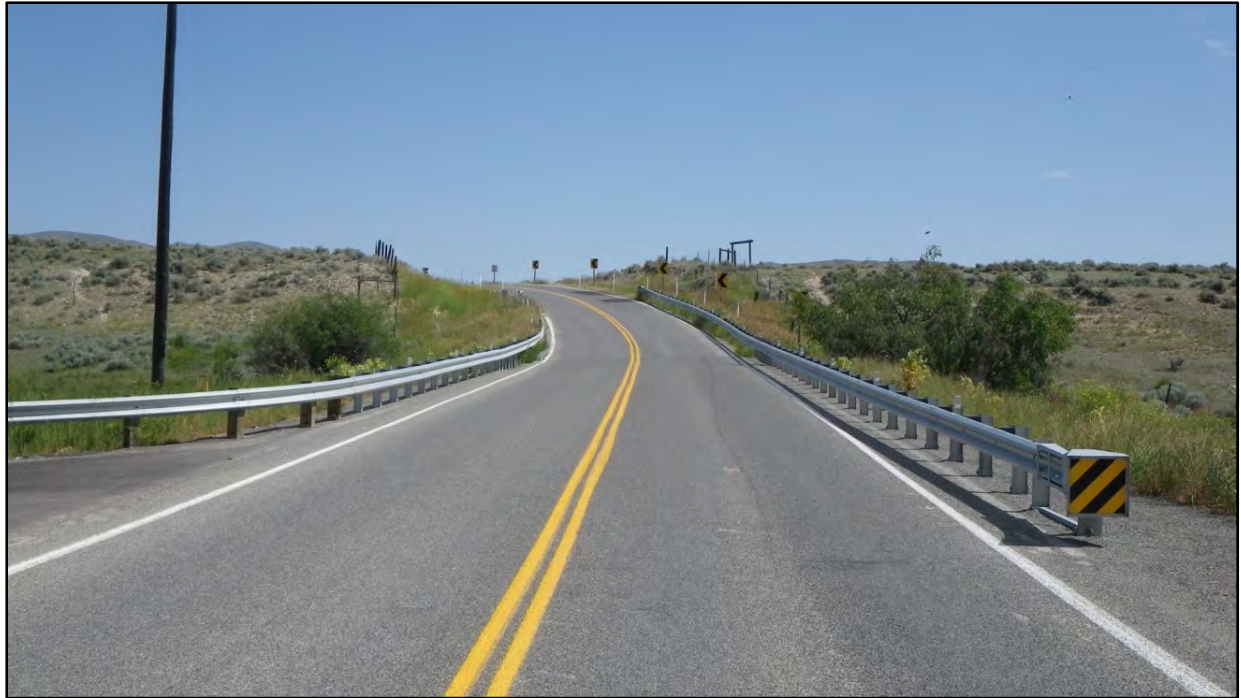
**Photo 3.3: End of MDT Safety Improvement Project STPHS-HSIP 25(52) – Looking North.**

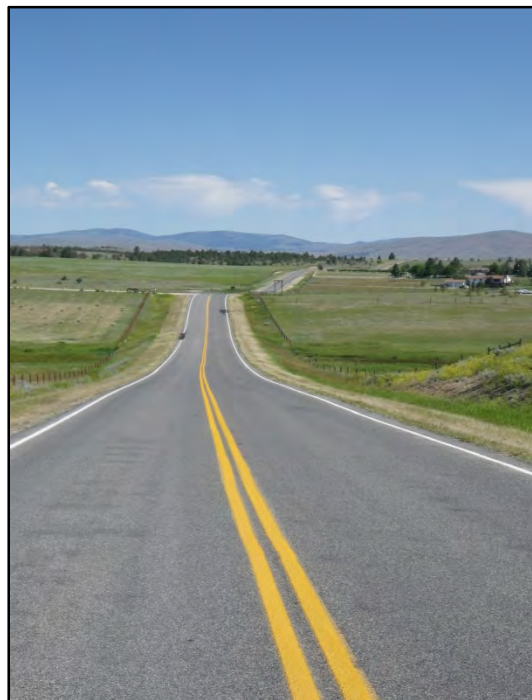
Three of the grades in **Table 3.3** are currently signed with an advisory speed. All three would appear to meet AASHTO design standards for the advised speed. However, substandard curvature should be addressed when roadway reconstruction is undertaken. **Photo 3.4** shows the steep grade at MP 7.10.

**Photo 3.4: Steep grade near MP 7.10 – Looking North.**

The steep grade at MP 7.10 should also be improved in order to meet County road standards based on this report's terrain classifications. What appears to be poor sight distance at MP 7.10 may be addressed by raising the grade, but lengthening the vertical curve may also be needed to mitigate apparent sight distance issues.

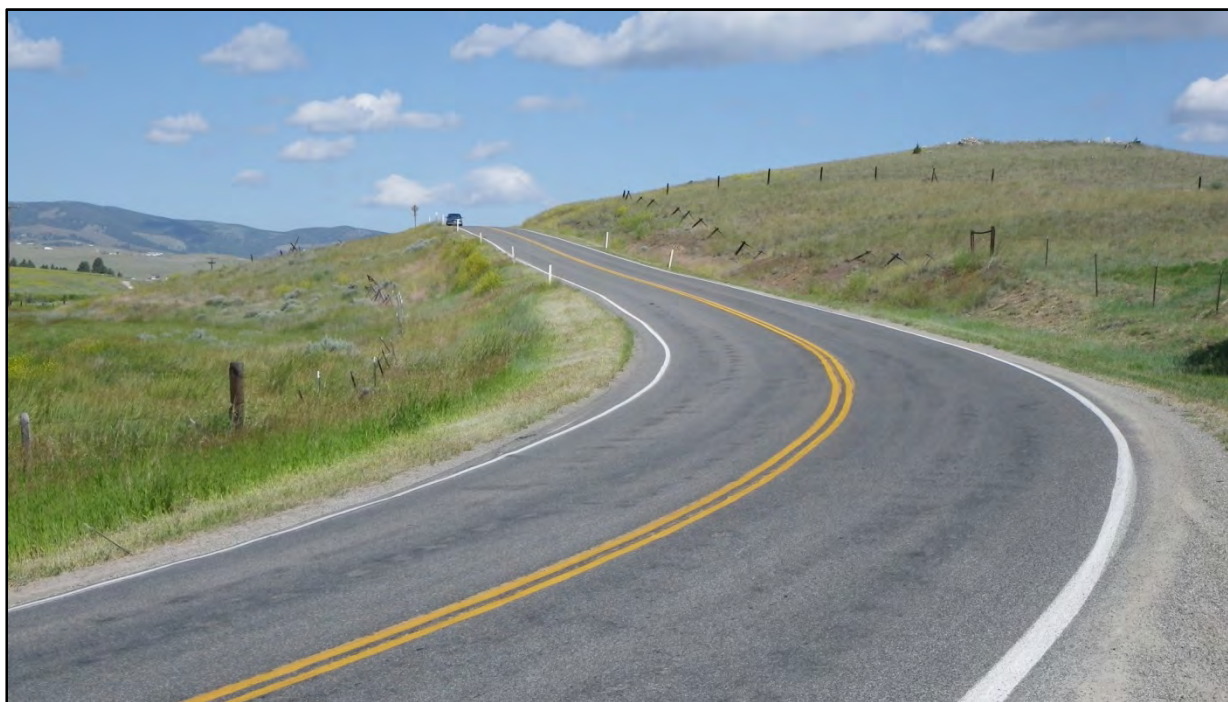
**Photo 3.5: Poor hill crest sight distance near MP 2.10 – Looking North.**

It is projected that most of the locations need to add a few hundred feet to the length of the curve to meet minimum standards. However, the two curves near MP 2.10 and MP 7.28 will have a longer impact due to the greater difference in grades at these locations. In particular, the curve at MP 2.10 is along an existing cut slope and will require a substantial amount of earthwork to lengthen the curve (see **Photo 3.5**).

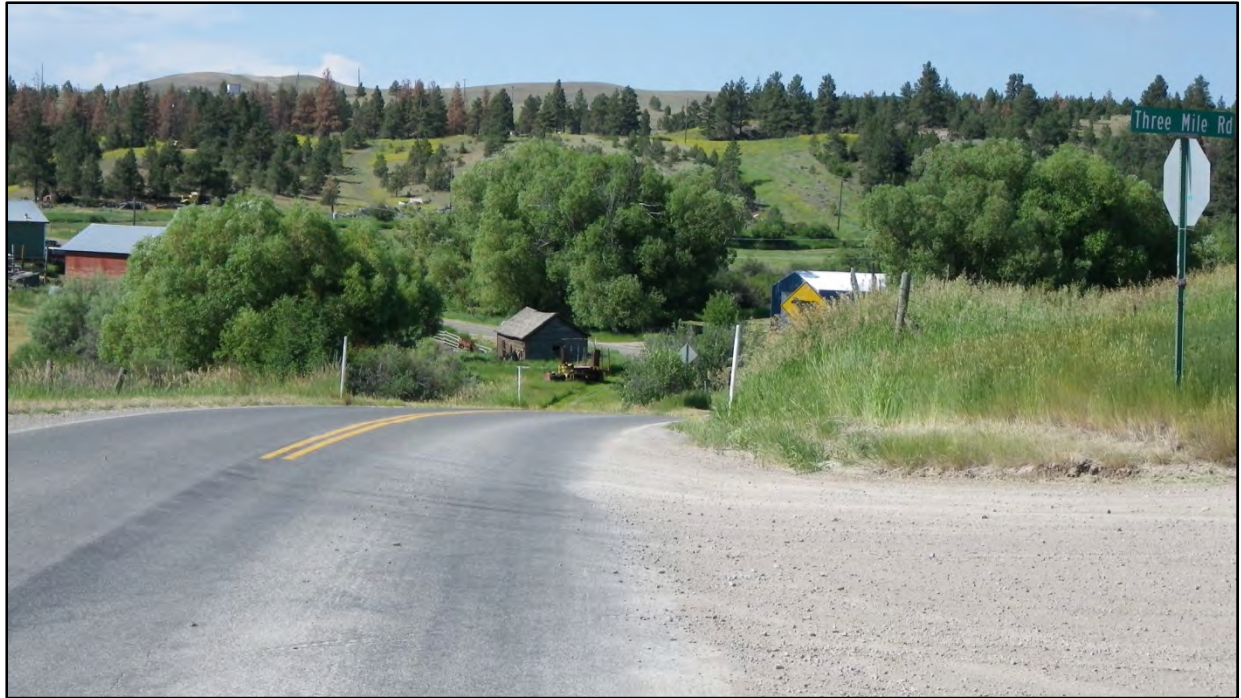
**Photo 3.6: Poor sight distance at Three Mile Road intersection near MP 6.55 – Looking Southwest.**

Some locations in **Table 3.4** have intersecting road approaches. The intersecting sight distance was observed to be questionable for both Birdseye Road and vehicles turning onto Birdseye Road from the intersecting road at these locations. If no vertical curve improvements are undertaken at these locations, signs warning of intersections may be warranted.

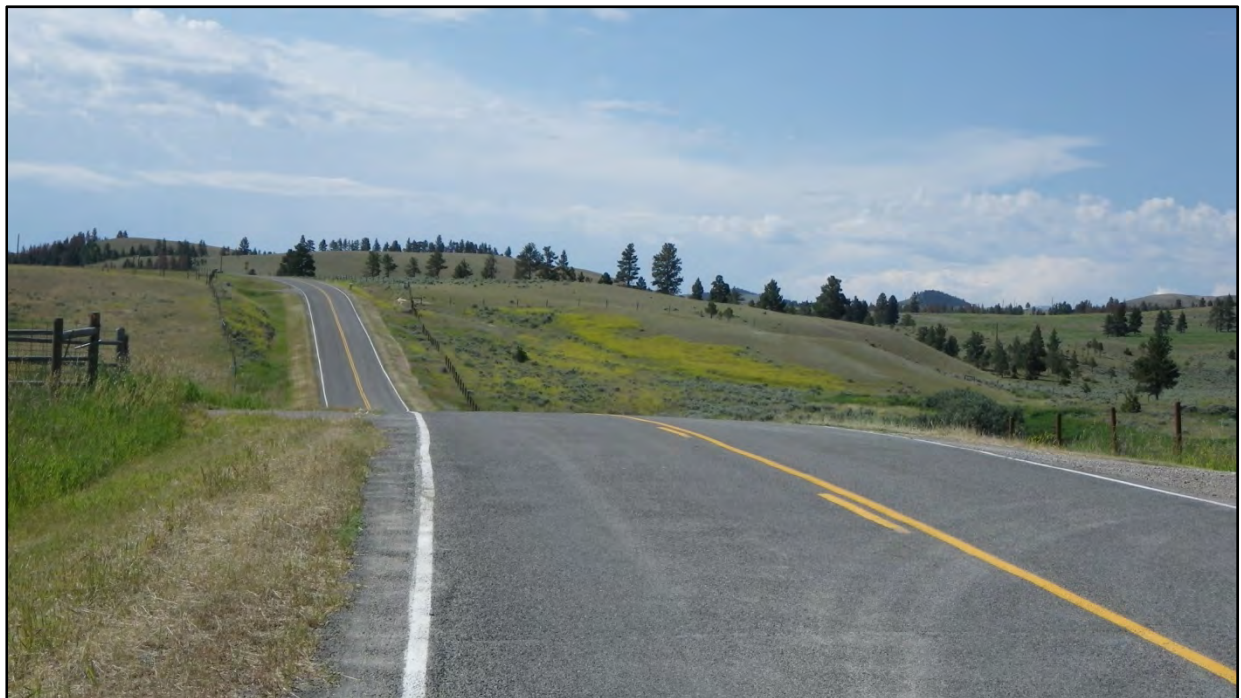
**Photo 3.7: Poor sight distance at Hickory Road intersection near MP 7.30 – Looking South.**

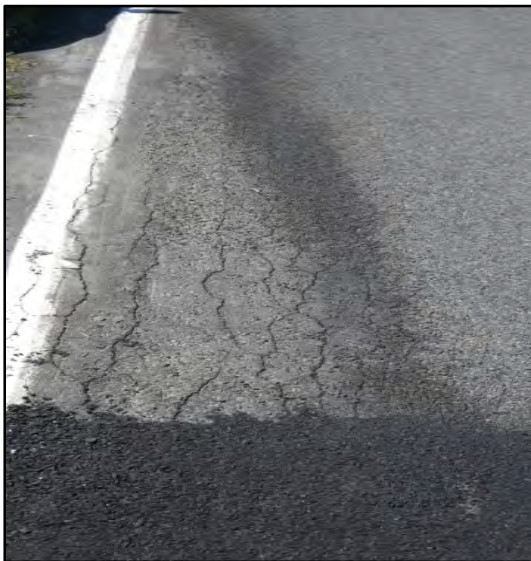
Signs of pavement degradation were observed during the field review. Intermittent areas of alligator cracking and rutting in the driving lanes were noted for the entire length of Birdseye Road and may indicate the progression of subgrade failures along the roadway (**Photo 3.8**).

**Photo 3.8: Rutting and cracking of asphalt surface.**

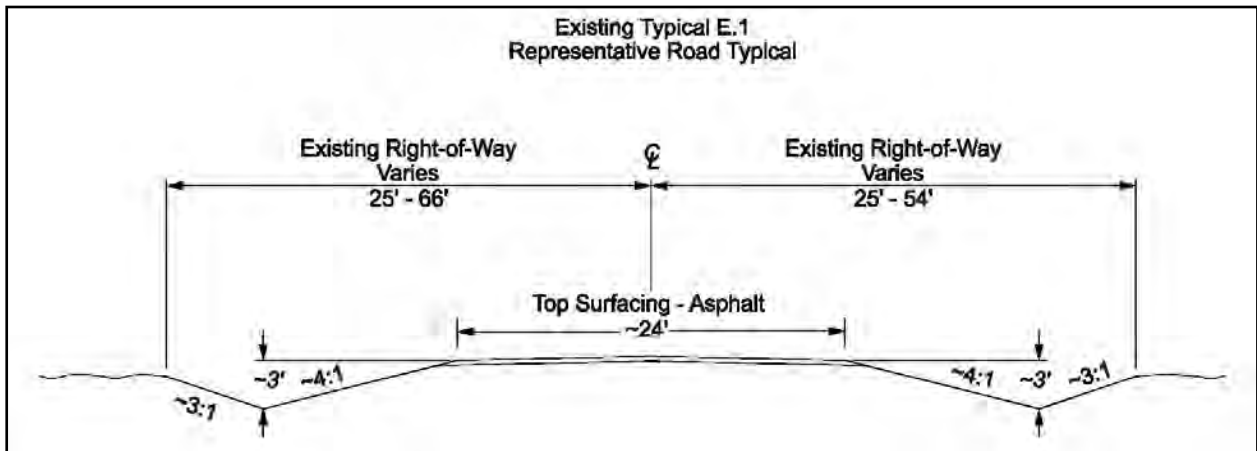
average ditch depth was calculated to be 3 feet on both sides.

Figure 3.1: Existing Typical Section E.1 – Looking North.

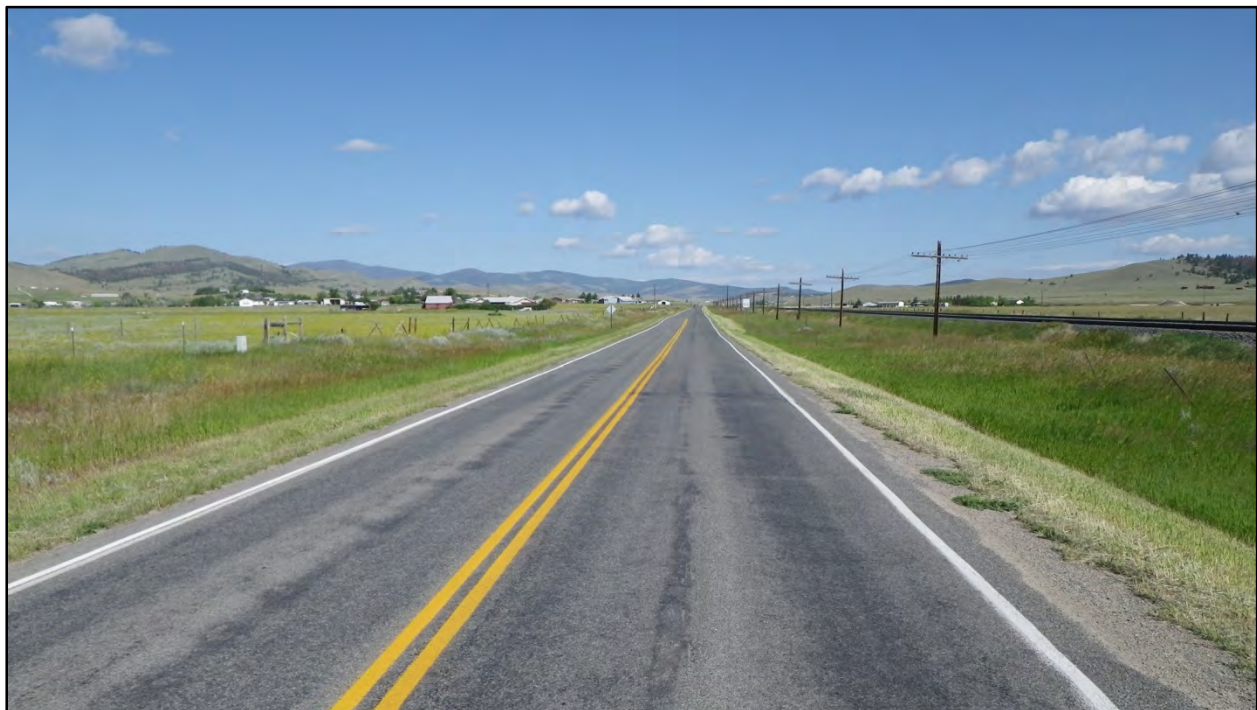
Photo 3.9: Existing Typical Section E.1 – Looking North.

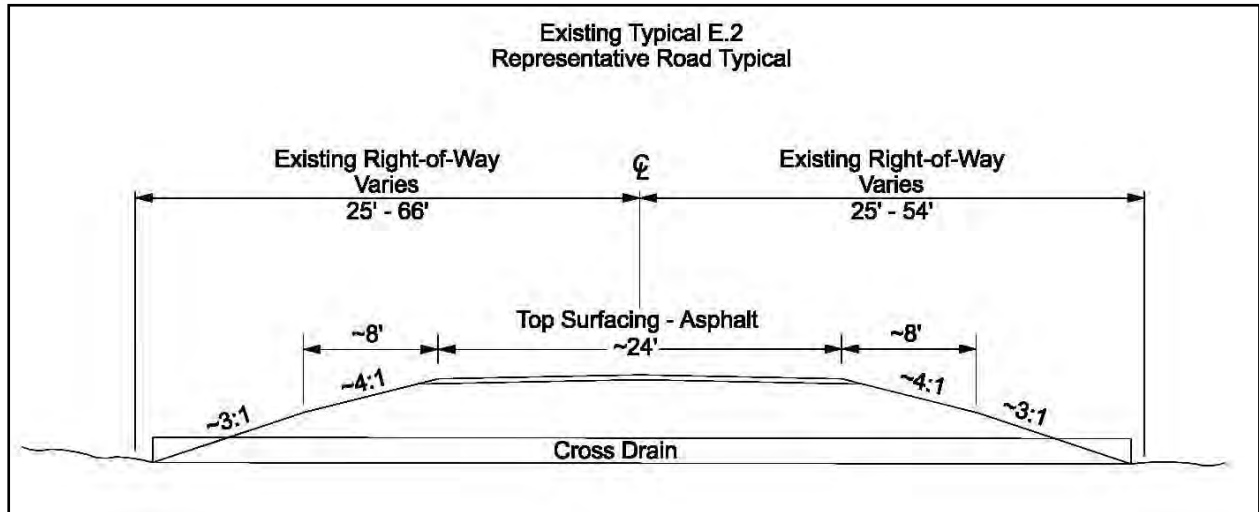
1.5:1 near MP 2.20), but can be approximated at 3:1 on average. Many of the cross drains in these locations spanned the entire width of right-of-way. Many of the fill slopes would appear to meet current County road standards.

**Figure 3.2: Existing Typical Section E.2 – Looking North.**

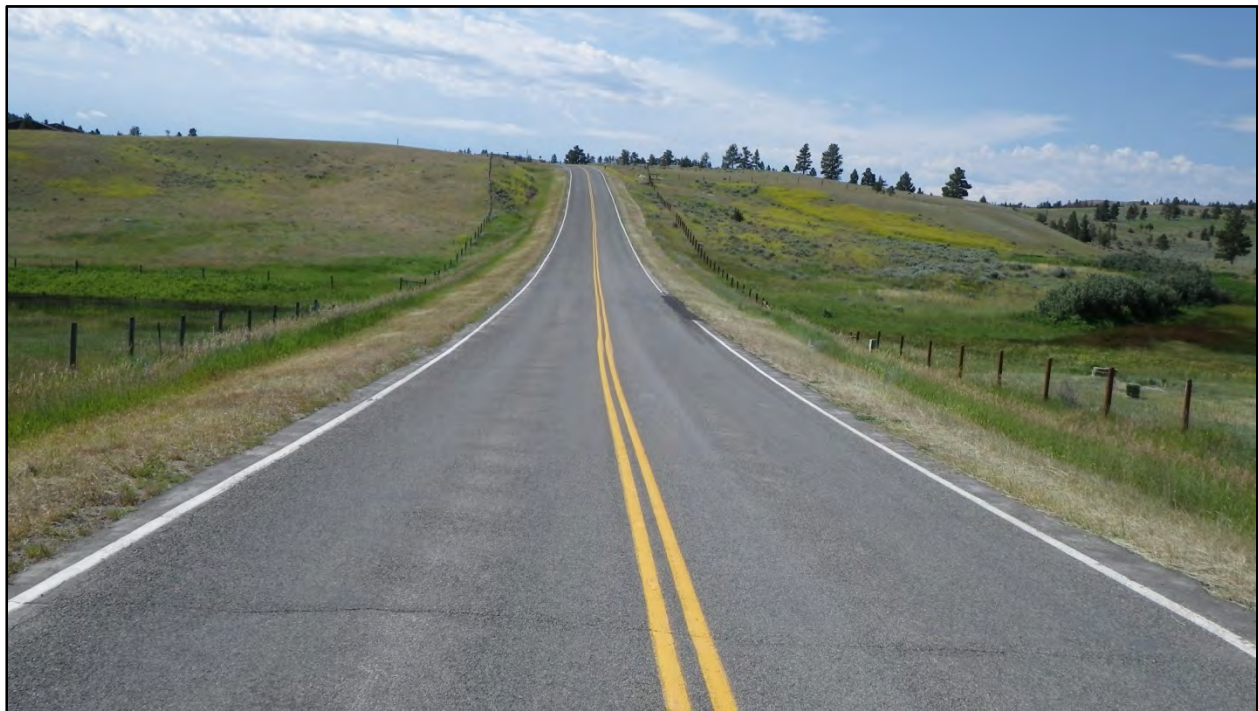
**Photo 3.10: Existing Typical Section E.2 – Looking South.**

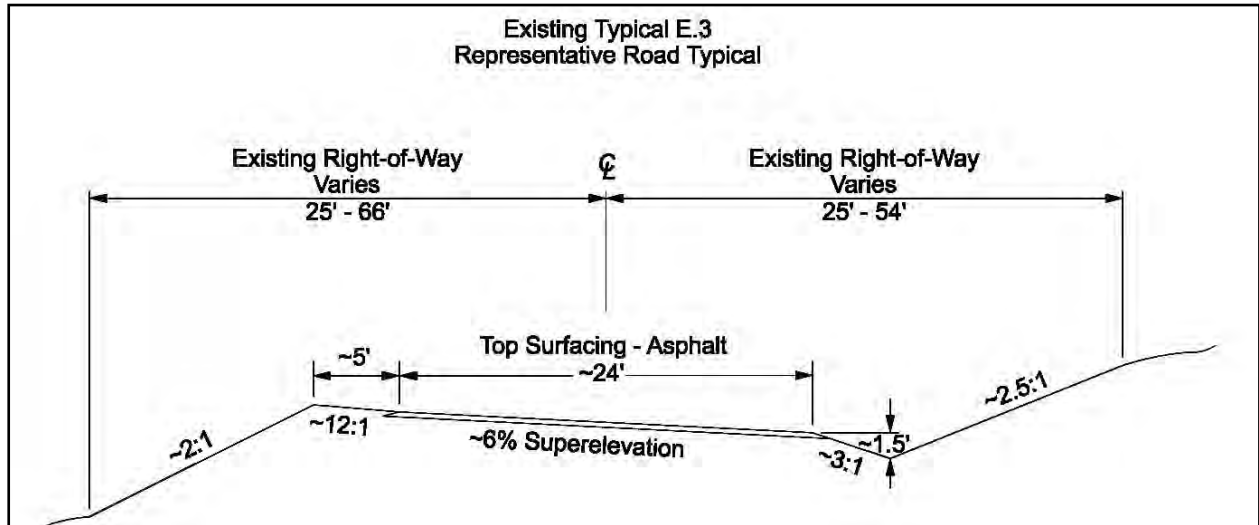
On the uphill side, the roadside ditch foreslopes were measured to be approximately 3:1 with a ditch depth of 1.5 feet or shallower. The ditch backslopes that create the cut slope were averaged to be approximately 2.5:1. On the downhill side, there is an average of about 5 feet of flat ground (approximately 12:1) for curve widening, and then an average slope of 2:1 down from there. The superelevation along curves varied from 2% to 9%, and is shown as an average of 6% in the figure below.

Figure 3.3: Existing Typical Section E.3 – Looking North.

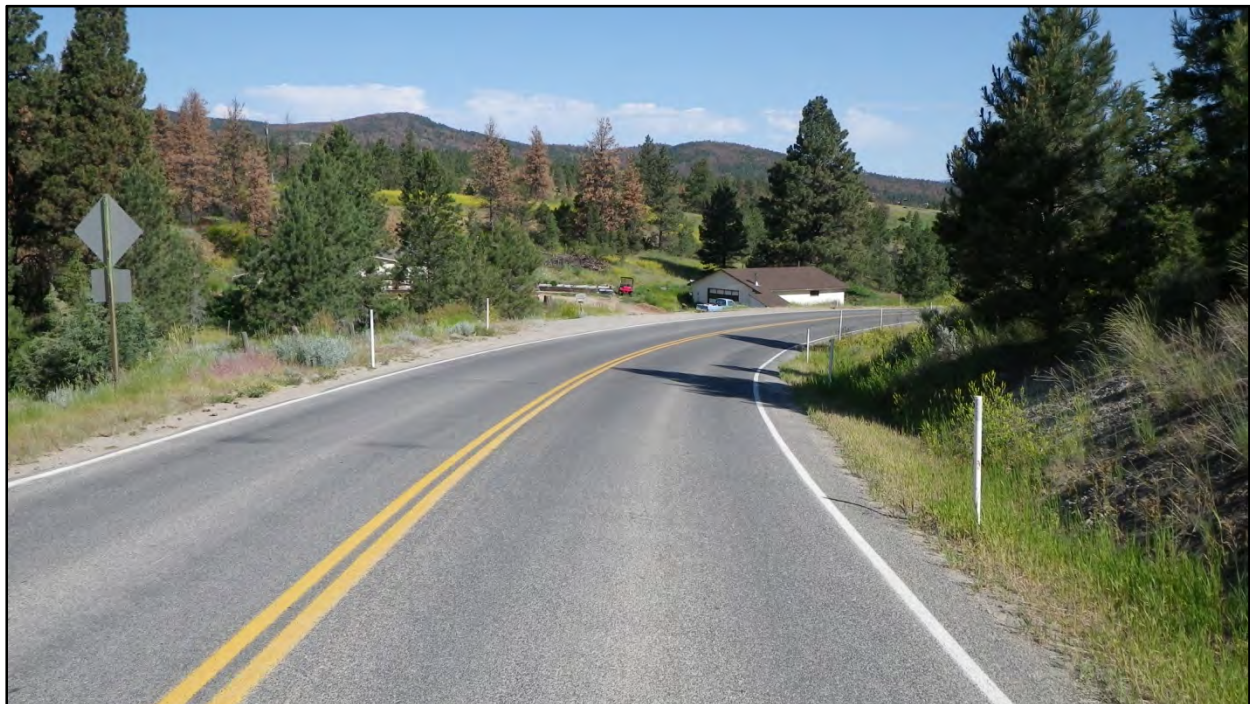
Photo 3.11: Existing Typical Section E.3 – Looking North.

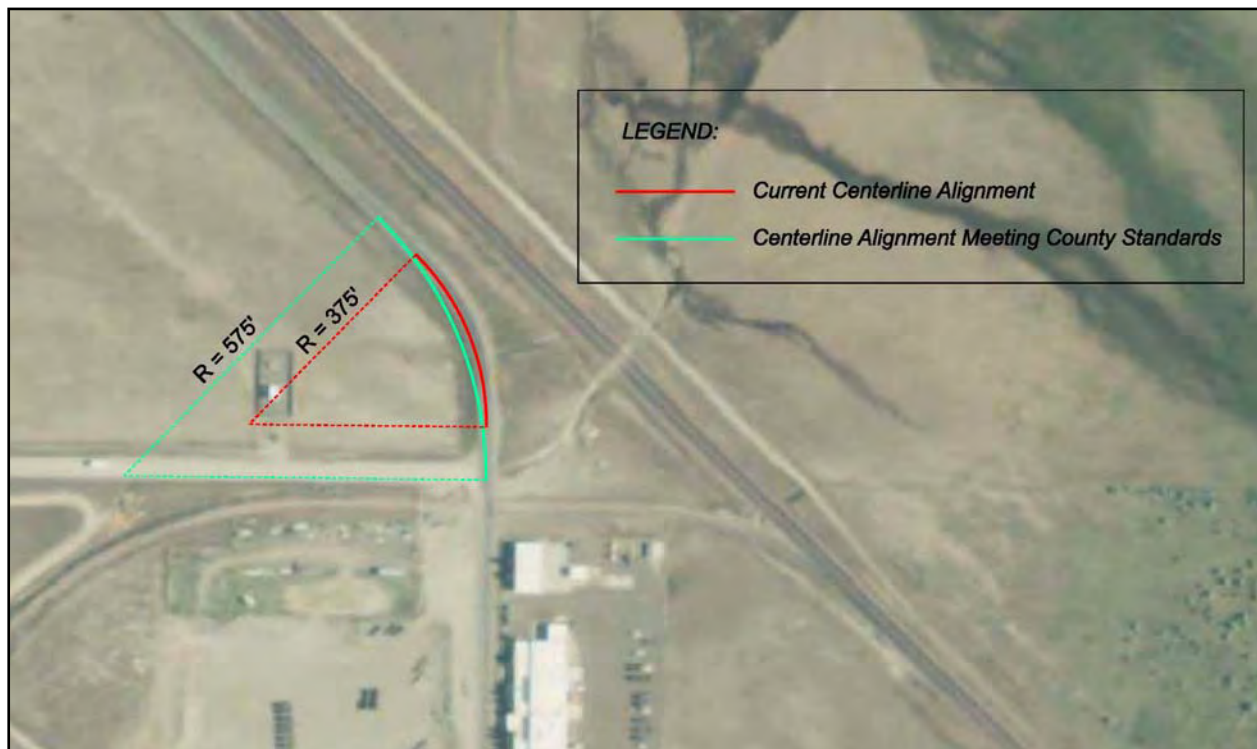
Figure 4.4: Horizontal Curve Improvement at MP 0.05.

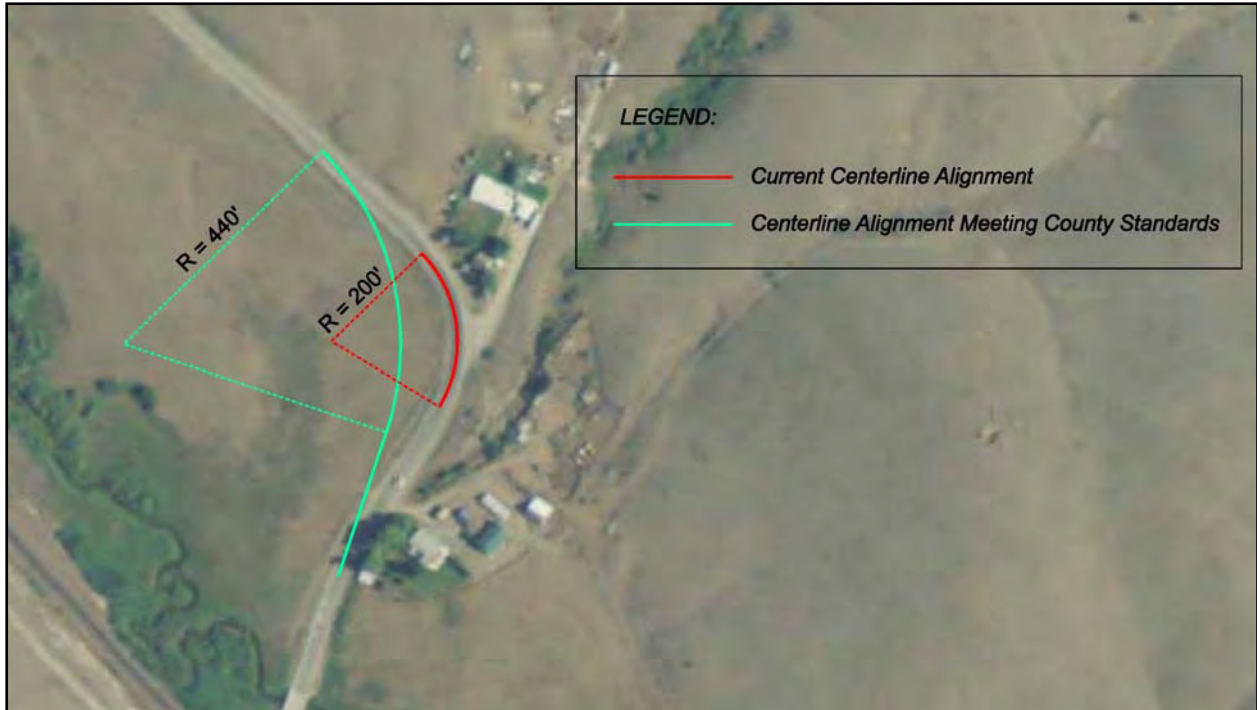
Figure 4.5: Horizontal Curve Improvement at MP 1.95.

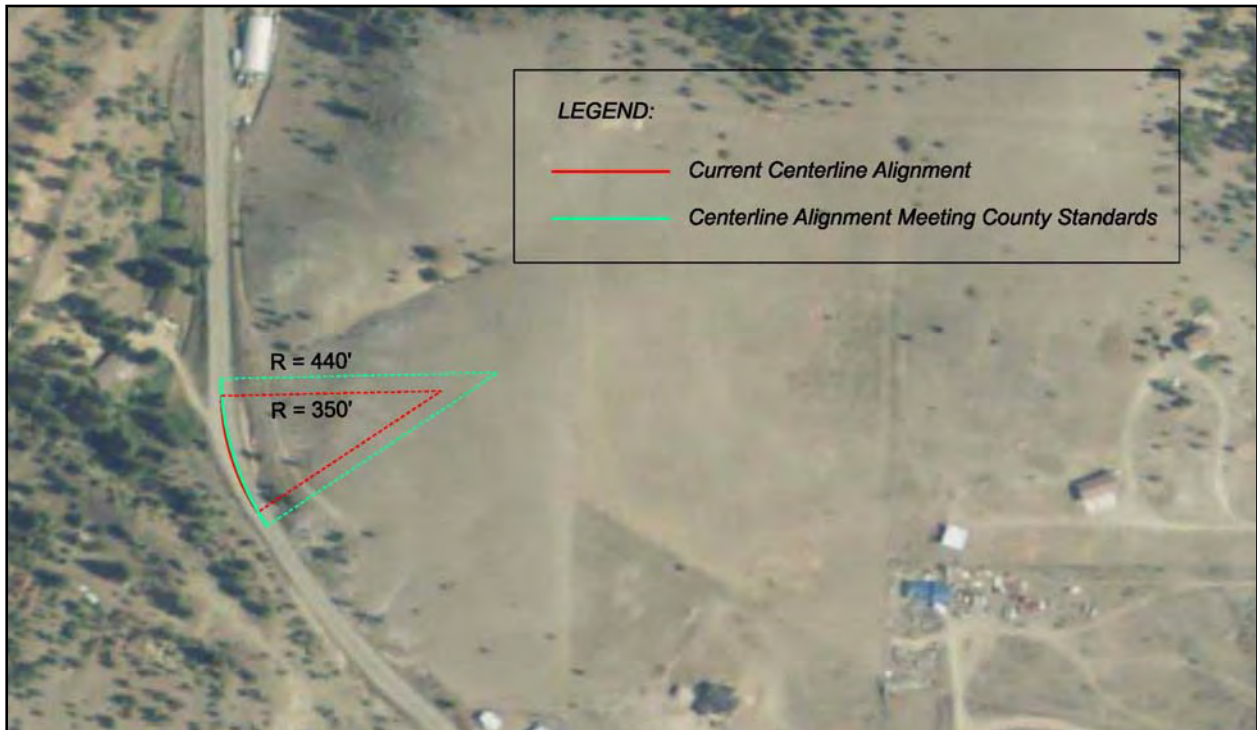
Figure 4.6: Horizontal Curve Improvement at MP 6.15.

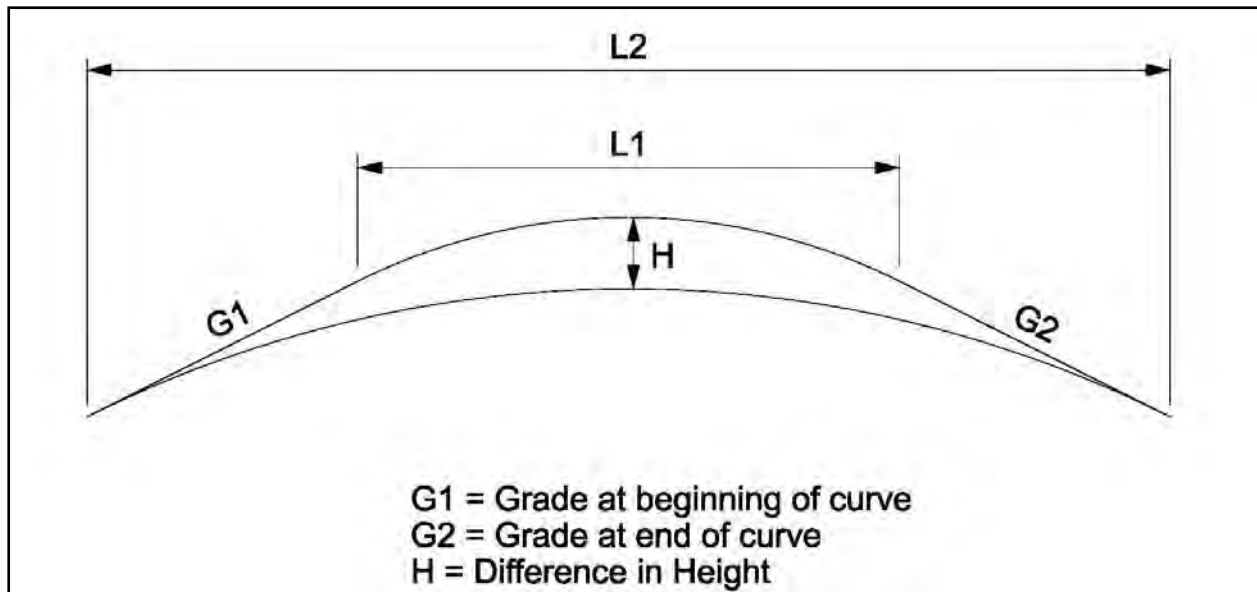
Figure 4.8: Vertical Curve Improvement.

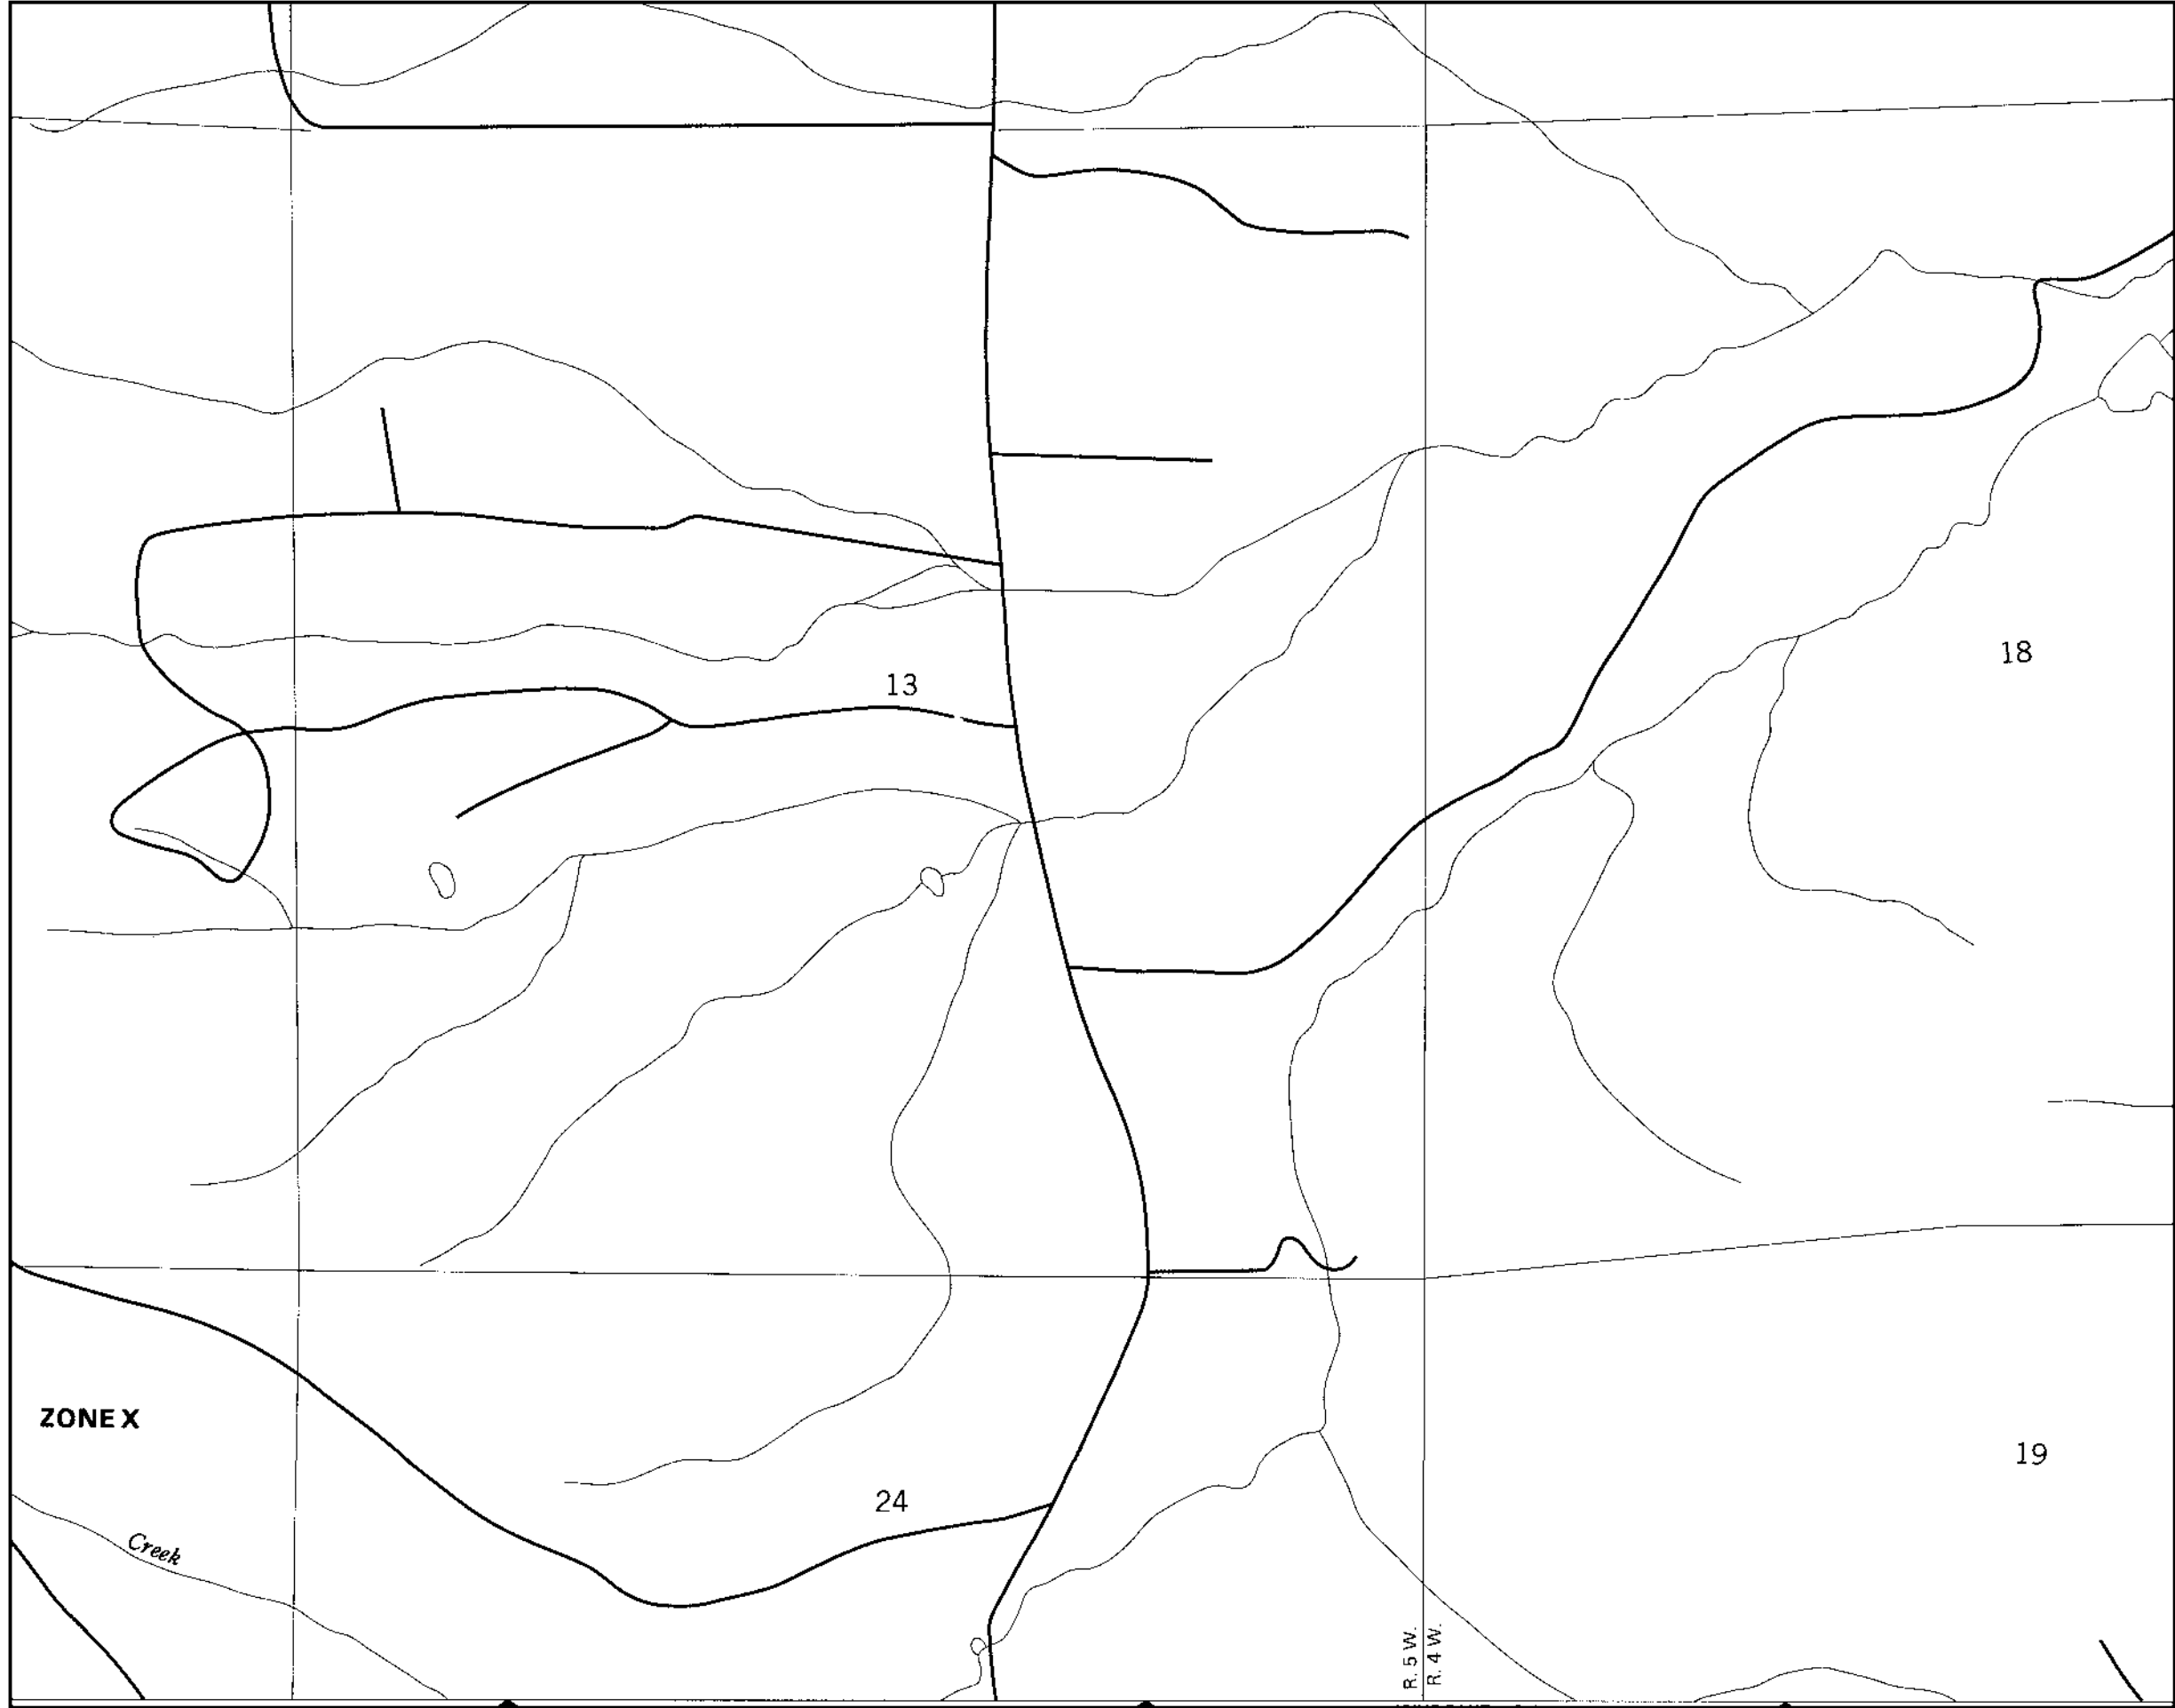
**FIRM**  
FLOOD INSURANCE RATE MAP

NATIONAL FLOOD INSURANCE PROGRAM

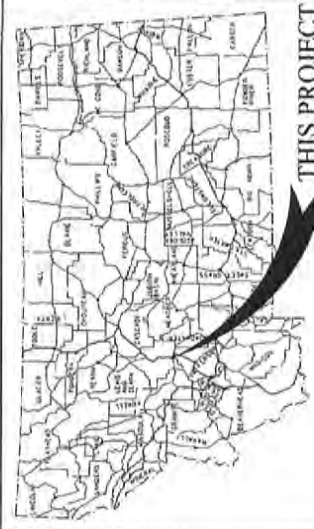
# MONTANA DEPARTMENT OF TRANSPORTATION FEDERAL AID PROJECT NO. STPHS - HSIP 25(52) 2002-SAFETY IMPROVEMENTS - LEWIS AND CLARK COUNTY BIRDSEYE ROAD LEWIS AND CLARK COUNTY LENGTH 0.3 MILES SCALES

THIS PROJECT

A Montana Department of Transportation (MDT) Safety Improvement Project let for construction in the fall of 2009, STPHS-HSIP 25(52) Birdseye Road, realigned a 0.40-mile section of Birdseye Road to mitigate a deficient horizontal curve and improve other roadside geometrics. The low bid was approximately \$682,000 for the 0.40-mile reconstruction. The project provides a good example of the construction costs associated with realigning the roadway template. The County could similarly improve other segments of Birdseye Road by spot improvement projects. This new section of Birdseye Road meets most applicable County design standards, with only the shoulder width being less than the minimum Major Collector standard. Adding two extra feet to the shoulders would bring the section up to minimum County standards for a Major Collector.
