Preliminary Engineering Report

VALLEY DRIVE

LEWIS AND CLARK COUNTY

RPA Project No. 10502.003

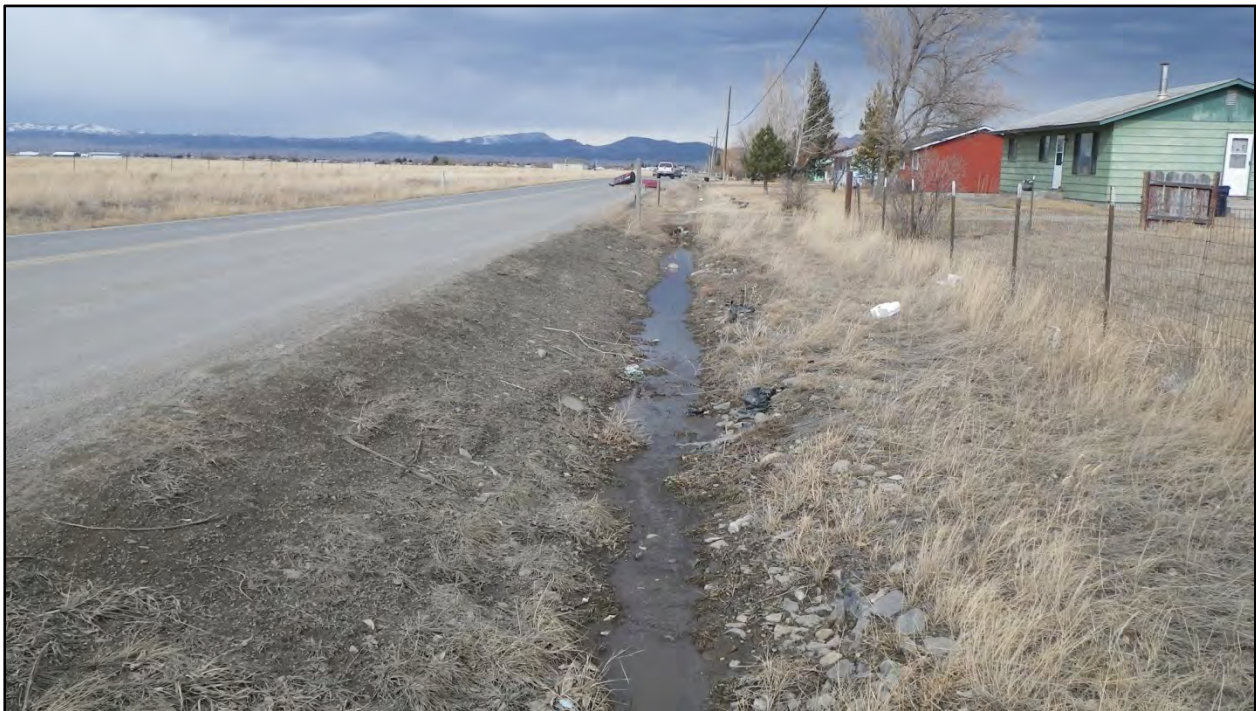
Photo 3.1: Existing Typical Section E.1 looking north.

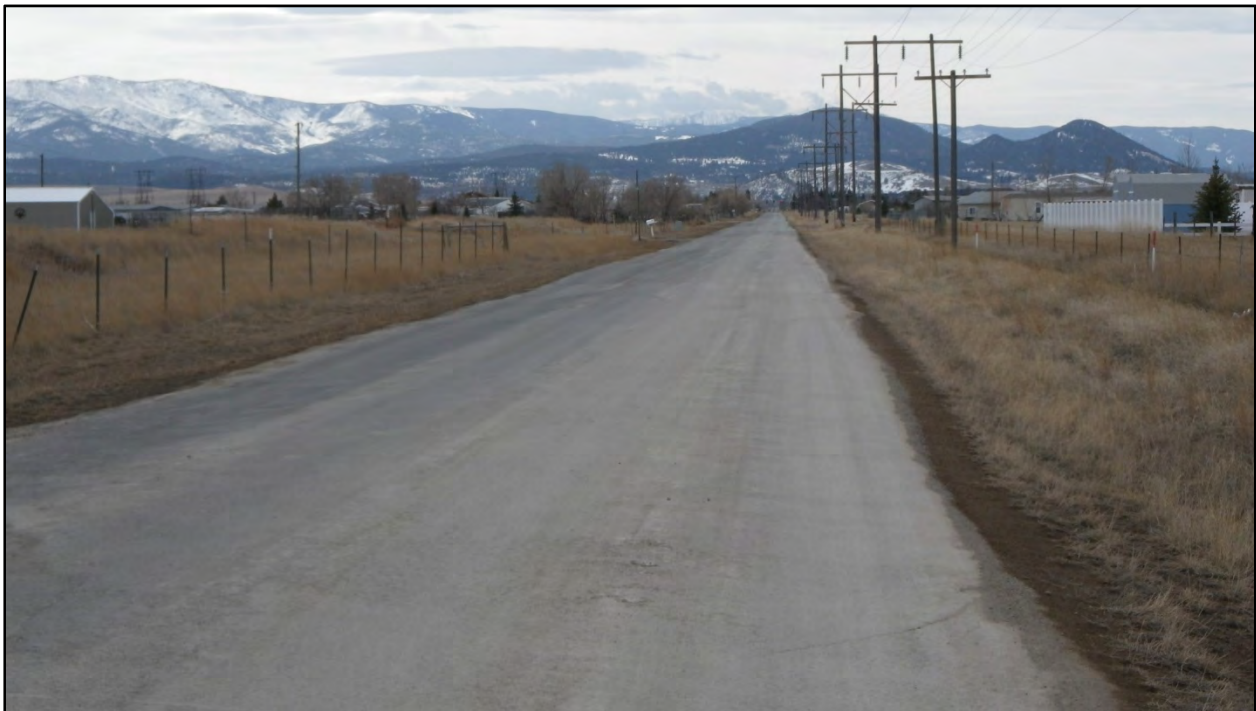
Photo 3.2: Existing Typical Section E.2 looking south.

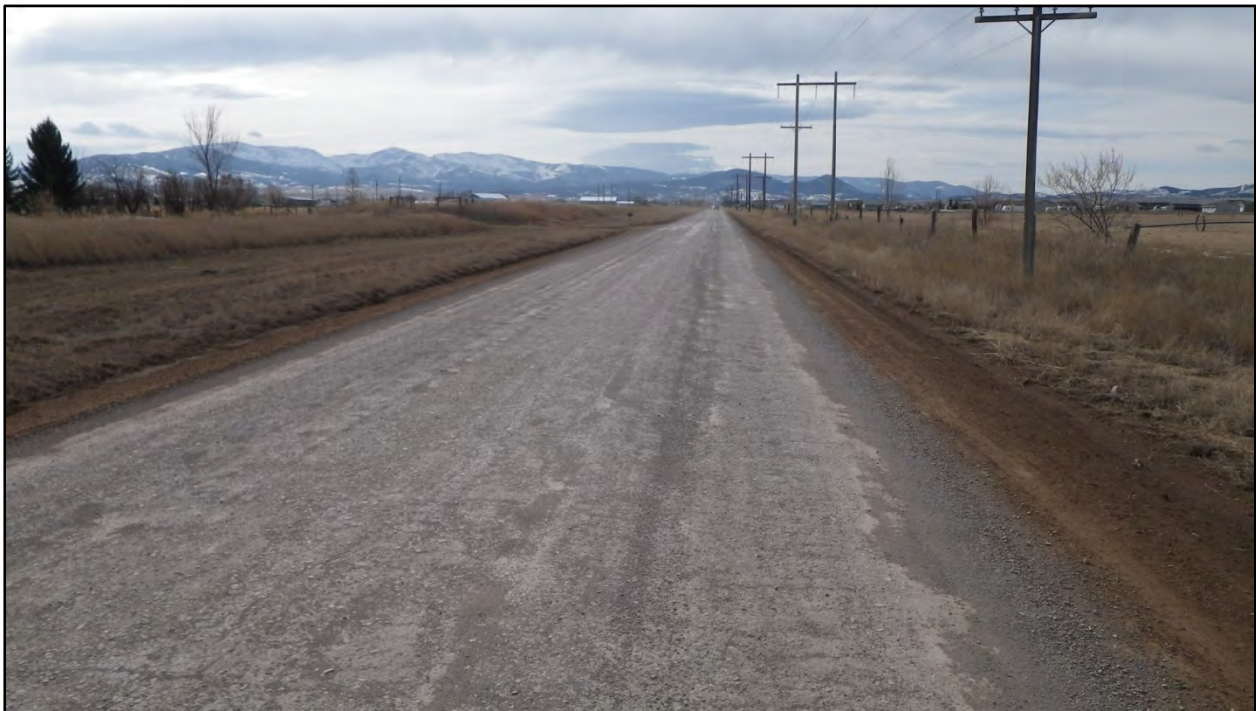
Photo 3.3: Existing Typical Section E.3 looking south.

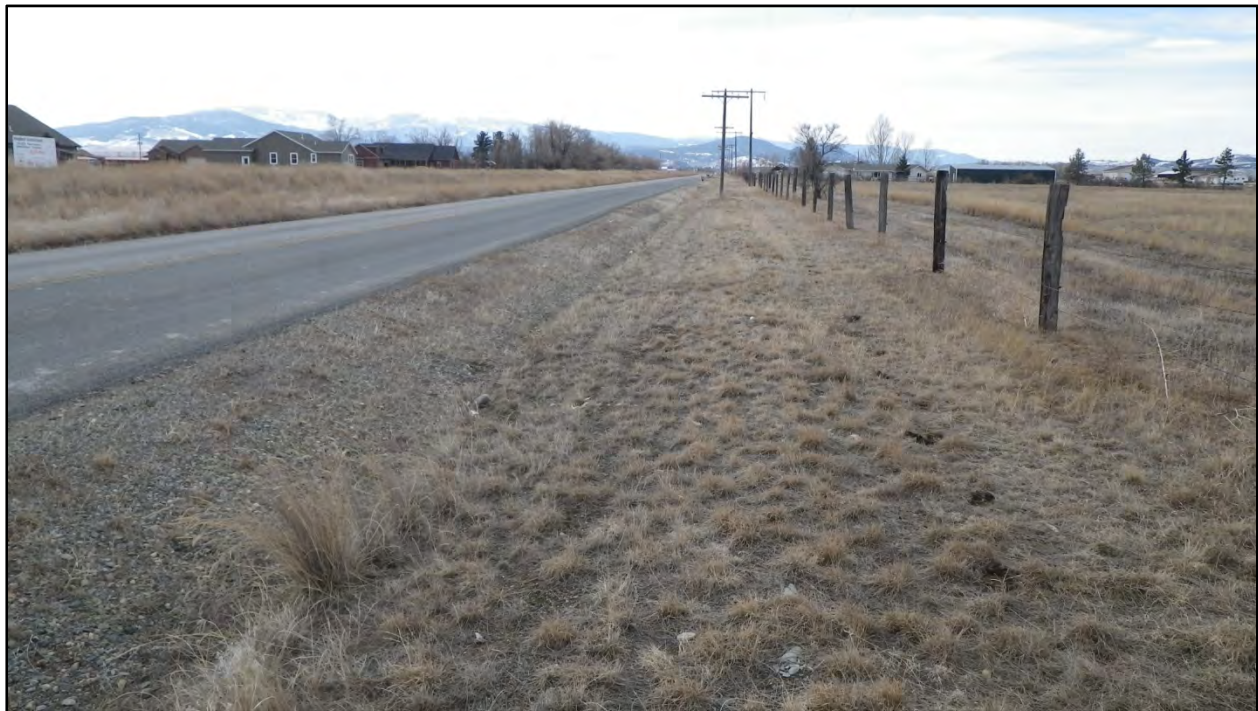
Photo 3.4: Existing Typical Section E.4 looking south.

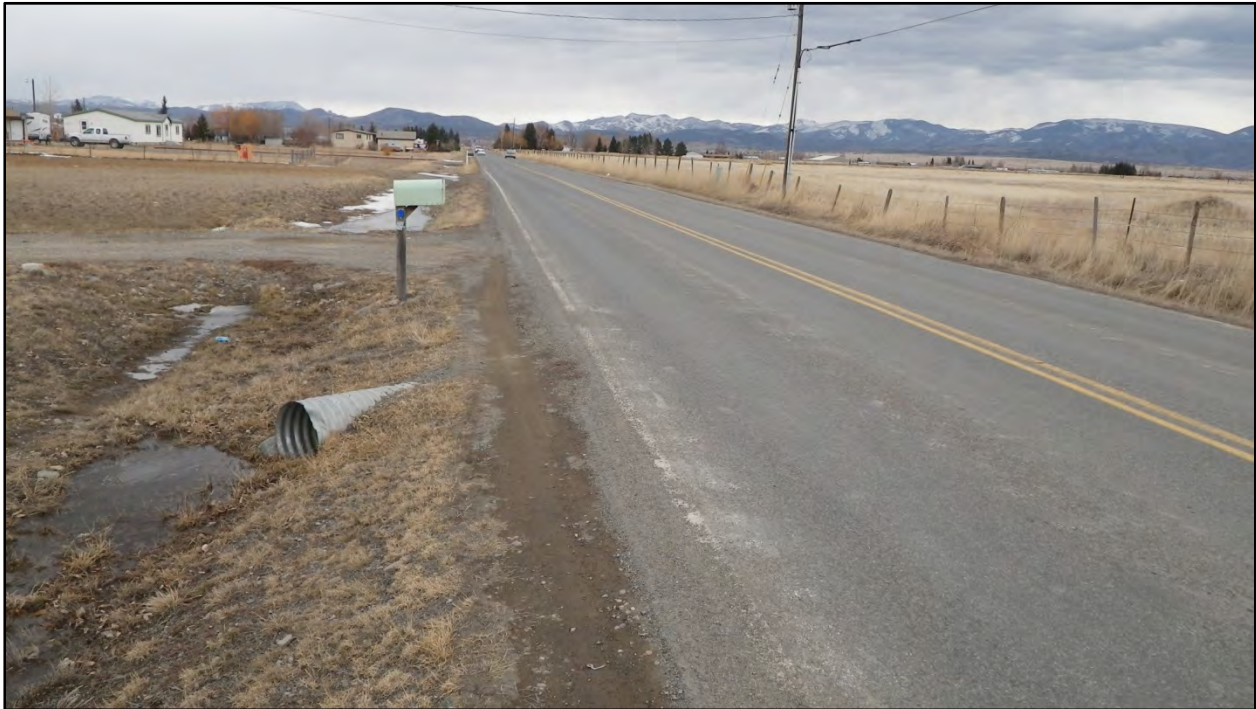
Photo 4.1: Existing cross drain located at MP 1.02.
