Preliminary Engineering Report

MCHUGH LANE—CITY LIMITS TO SIERRA ROAD

LEWIS AND CLARK COUNTY

RPA Project No. 10502.004

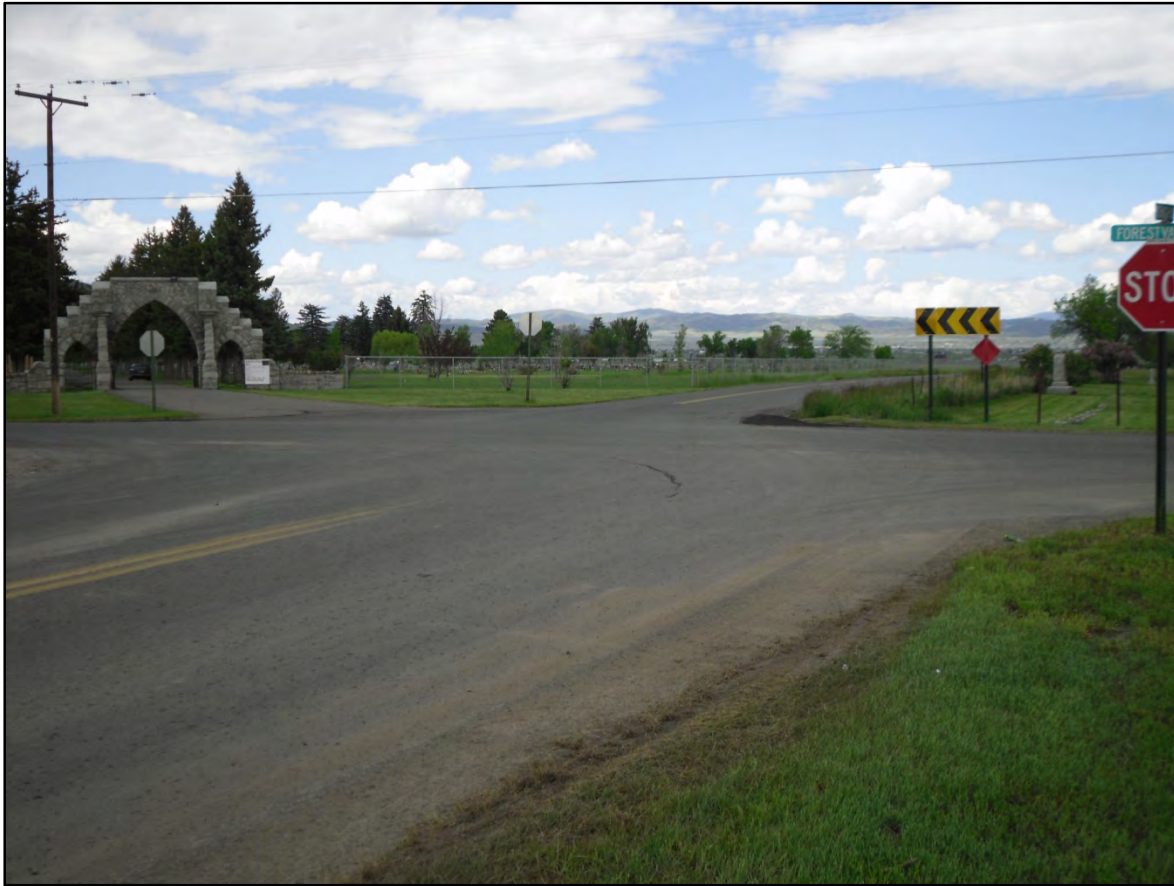
Photo 3.1: Skewed intersection alignment at Forestvale Road.

A single horizontal alignment issue was noted at the intersection of McHugh Lane with Forestvale Road (MP 1.80). At this intersection, the horizontal alignments for McHugh Lane do not match, as the alignment north of the intersection is shifted to the west (**Photo 3.1**). A shift in alignment at an

intersection is undesirable and the reconstruction of McHugh Lane would provide an opportunity to realign the intersection and improve traffic flow.

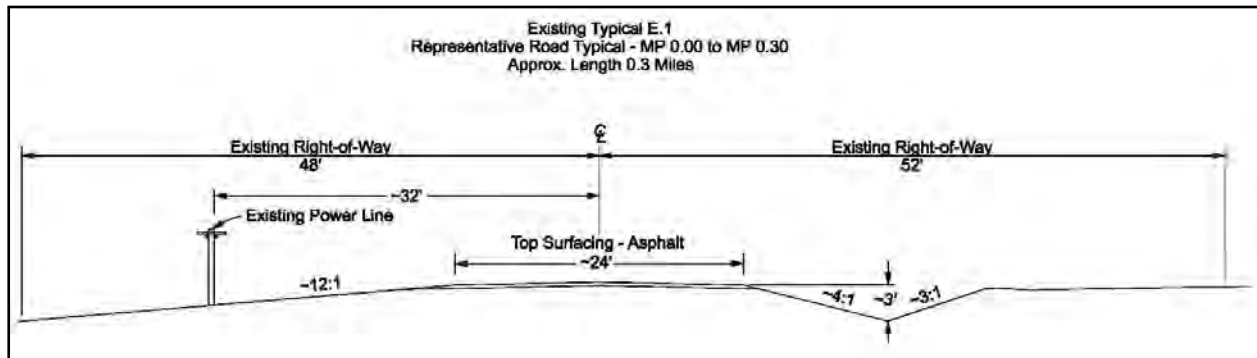
Figure 3.1: Existing Typical Section E.1 (MP 0.00 – MP 0.30) – Looking North.

The roadside ditch foreslopes were measured to be approximately 4:1 (horizontal : vertical, i.e. four feet horizontal distance for each one foot vertical drop) on the east side of the roadway and 12:1 on the west side where there is no ditch. The ditch backslope on the east side was measured to be approximately 3:1. The roadside ditch depth on the east side was approximately three feet deep and appears to meet

the County standards for ditch depths and slopes in most locations.

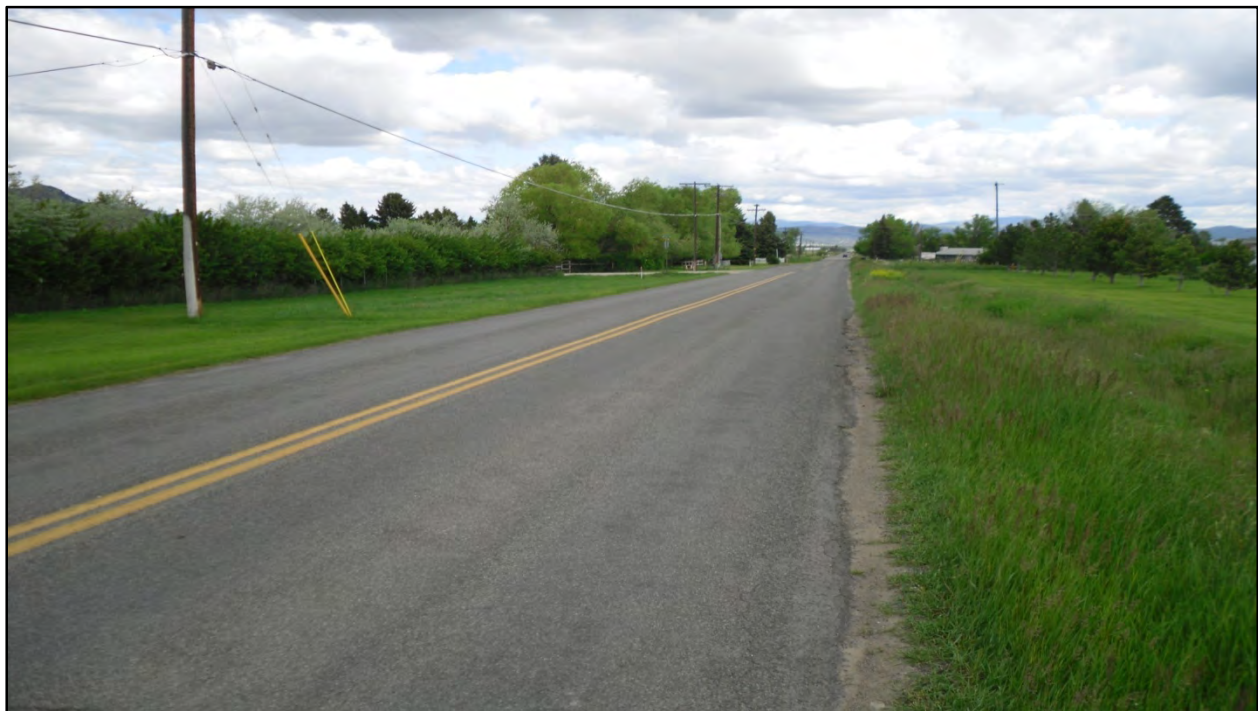
Photo 3.2: Existing Typical Section E.1 – Looking North.

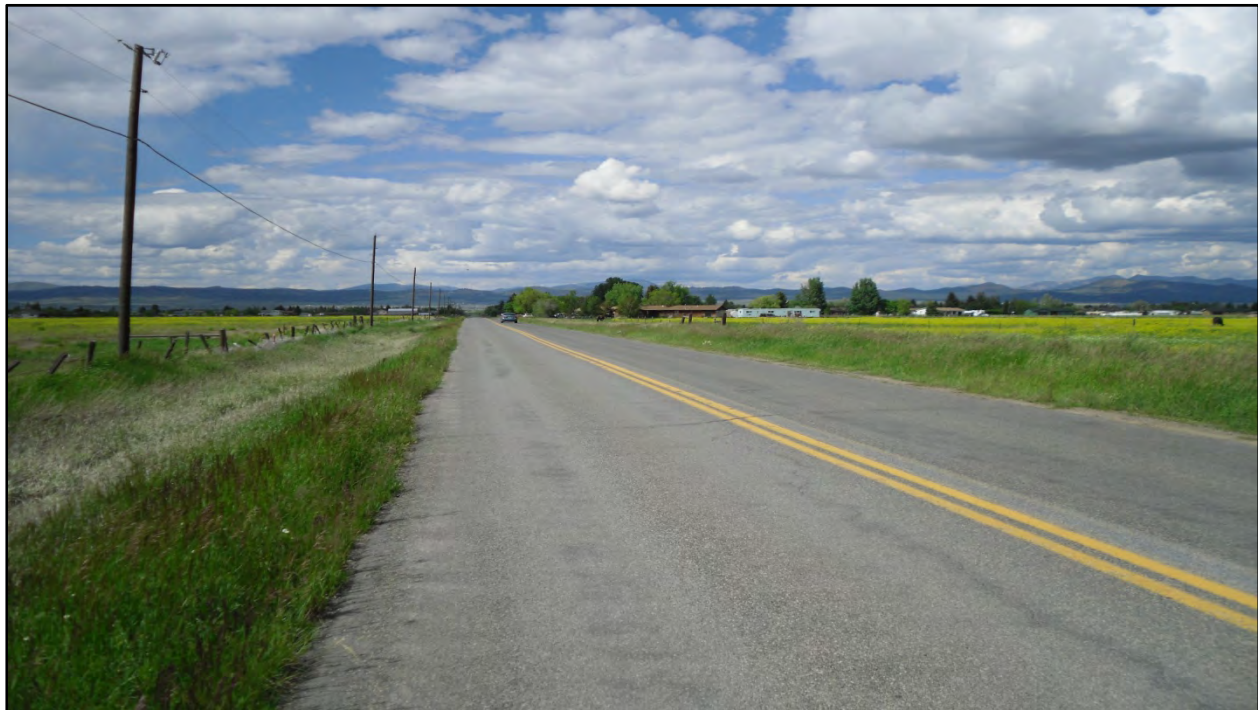
Photo 3.3: Existing Typical Section E.2 – Looking North.

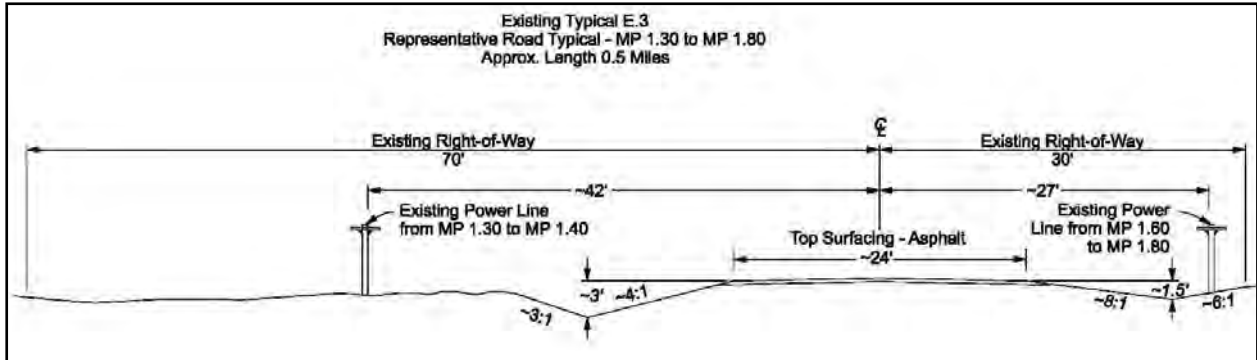
Figure 3.3: Existing Typical Section E.3 (MP 1.30 - MP 1.80) – Looking North.

Existing Typical Section E.3 runs from Mill Road to Forestvale Road (MP 1.30 to MP 1.80). The overall top surface of this section measured to be approximately 24 feet wide, with two 12-foot travel lanes and no distinguishable paved shoulders.

The roadside ditch foreslopes were measured to be approximately 4:1 on the west side and 8:1 on the east side of the roadway. The ditch backslopes were measured to be approximately 3:1 on the west side and 6:1 on the east side. An approximate 3-foot deep roadside ditch continues from the previous typical section along the west side, while a 1.5-foot deep ditch is on the east side. The ditch on the east side is shallow in comparison to the County standards and does not provide adequate cover over approach culverts.

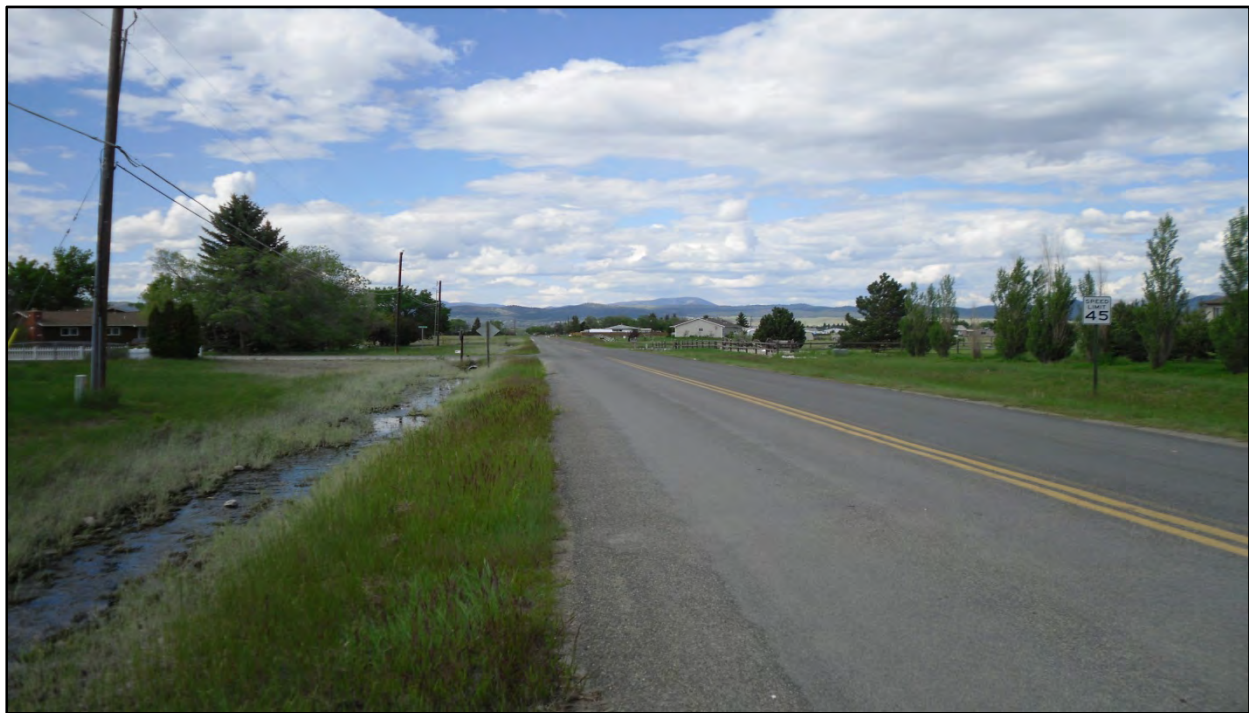
Photo 3.4: Existing Typical Section E.3 – Looking North.

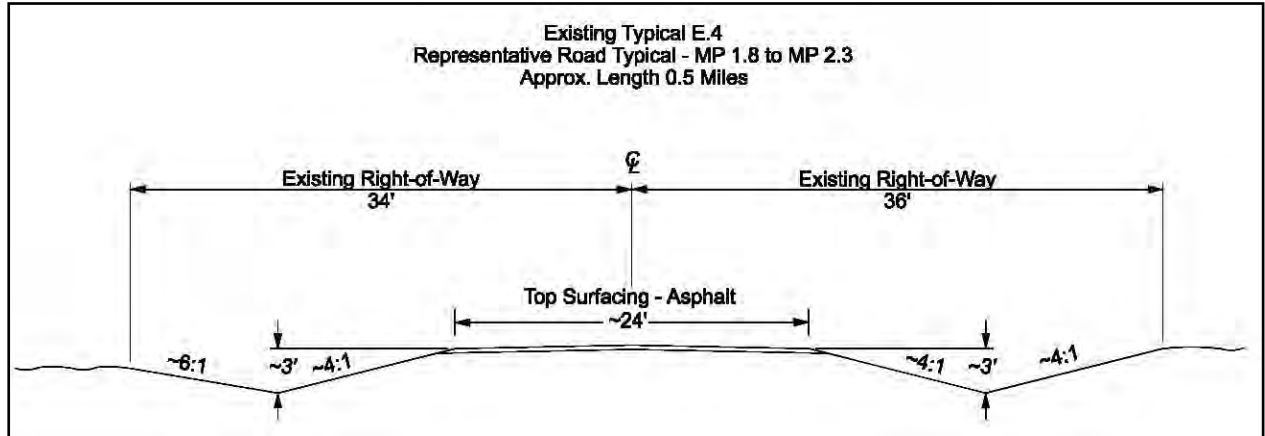
Figure 3.4: Existing Typical Section E.4 (MP 1.80 - MP 2.30) – Looking North.

Existing Typical Section E.4 runs from Forestvale Road to Sierra Road (MP 1.80 to MP 2.30). The overall top surface of this section measured to be approximately 24 feet wide, with two 12-foot travel lanes. There are no distinguishable paved shoulders.

The roadside ditch foreslopes were measured to be approximately 4:1 on both sides of the roadway. The ditch backslopes were measured to be approximately 6:1 on the west side and 4:1 on the east side. The roadside ditch depths were approximately 3 feet deep on both sides and appear to meet current County standards in most locations.

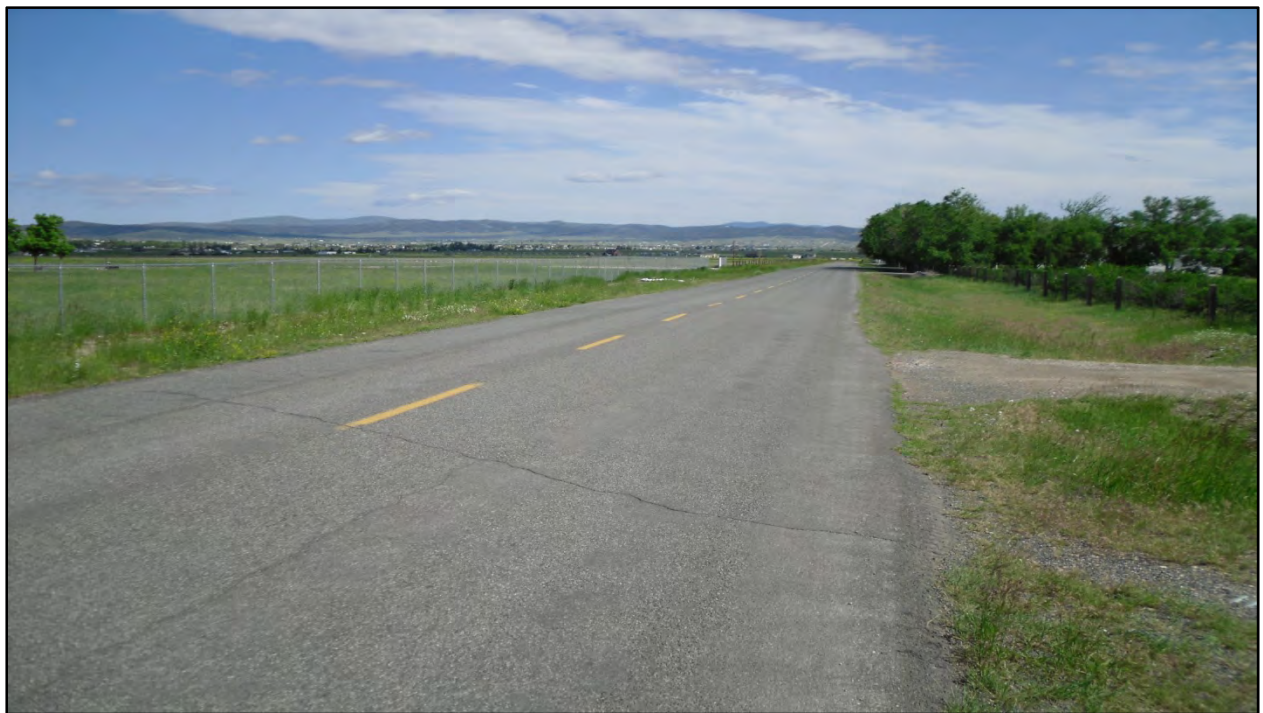
Photo 3.5: Existing Typical Section E.4 – Looking North.

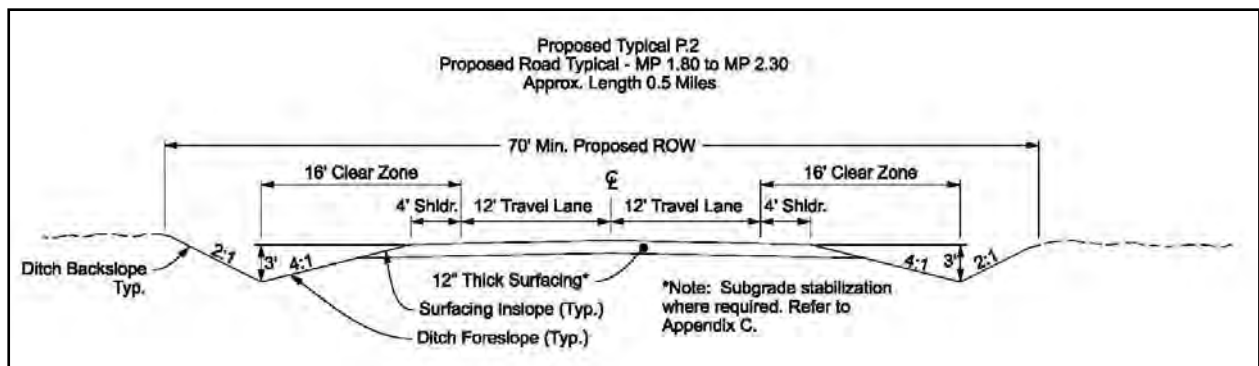
Figure 4.2: Proposed Typical Section P.2 (MP 1.80 - MP 2.30) – Looking North.

Proposed Typical Section P.2 (Figure 4.2) is for the portion of McHugh Lane between Forestvale Road and Sierra Road (MP 1.80 to MP 2.30). Projected future traffic forecast along this section is between 1000 and 1200 AADT, which according to AASHTO policy suggests a minimum clear zone of 16 feet. The minimum County standard for a Minor Collector is 80 feet of right-of-way. However, there are cemetery tracts on either side of McHugh Lane throughout this section. Impacting existing cemetery land would be a highly-sensitive issue, due to the historical and environmental issues involved as well as a generally negative public opinion of doing so. As a result, the recommended typical section for this section of McHugh Lane would fit the widened roadway into the existing 70 feet of right-of-way as not to impact any cemetery tracts.

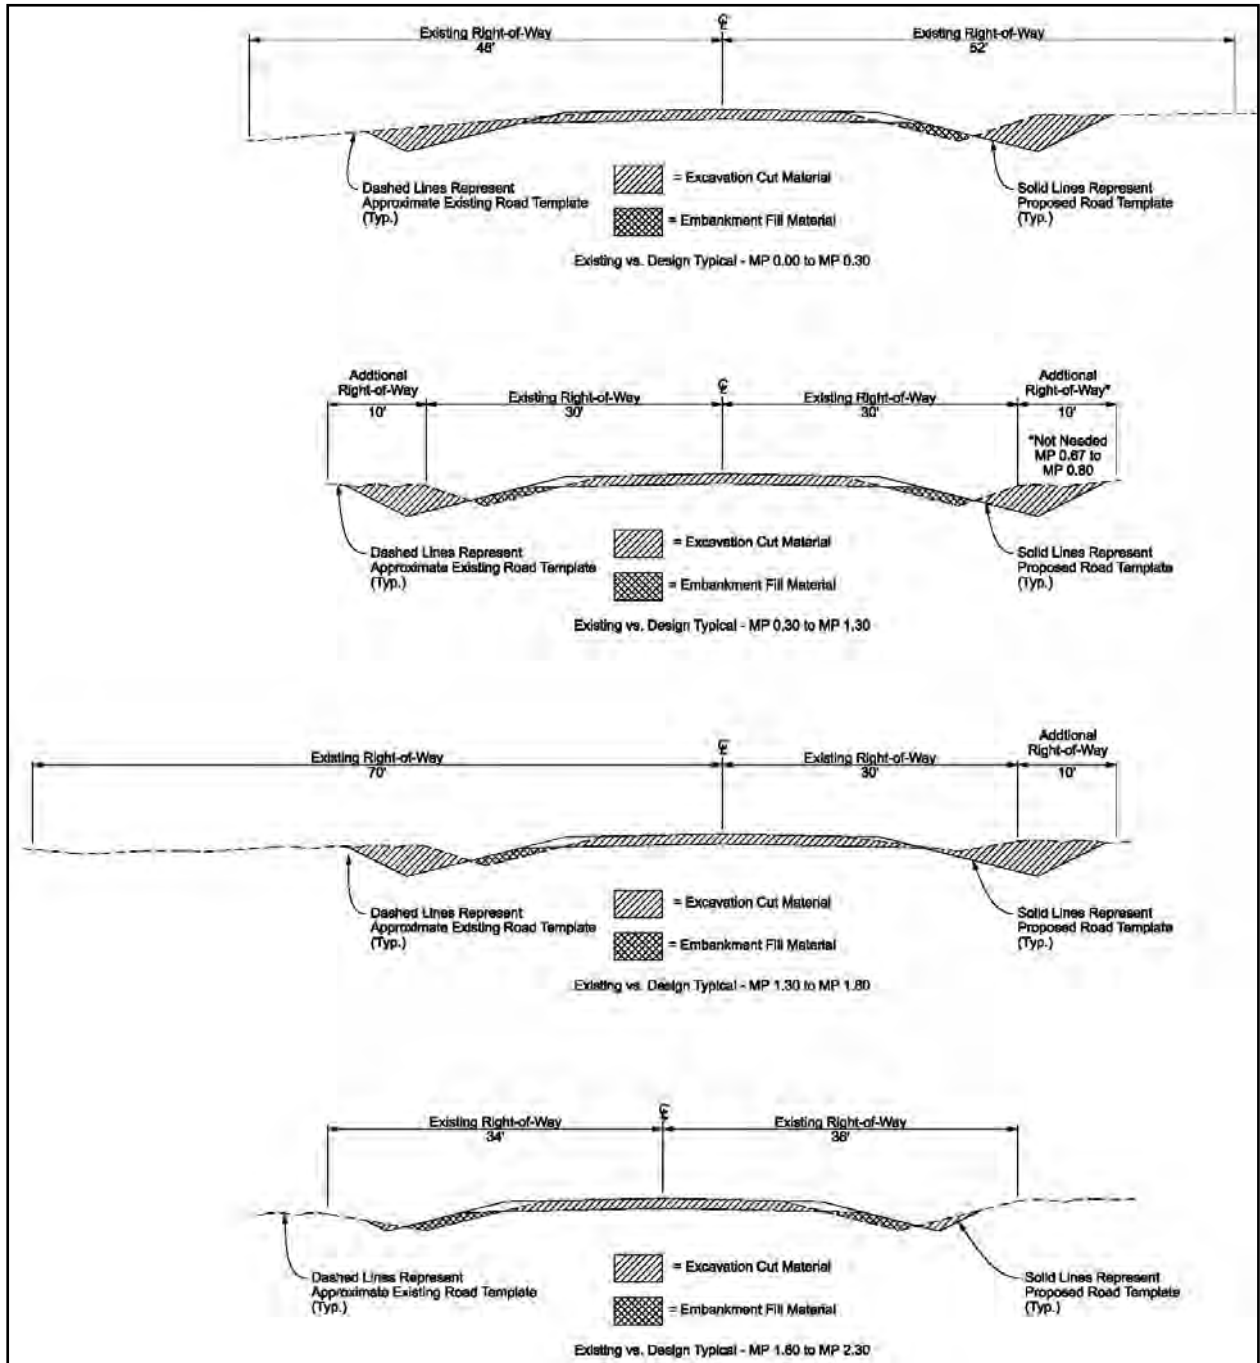
Figure 4.3: Estimated Reconstruction Cut / Fill Impacts

To estimate earthwork and miscellaneous other feature impacts to reconstruct the roadway in level terrain, we applied the design typical sections, shown in Figures 4.1 through 4.2 over the existing road templates estimated from field measurements, Figures 3.1 through 3.4. The estimate is based on proposed roadway centerlines following existing centerlines from Helena city limits to south of

Forestvale Road, then shifting to the west to line up the Forestvale Road intersection, and then following the existing roadway centerline from Forestvale Road to Sierra Road. The superimposed typical sections are shown in **Figure 4.3**.

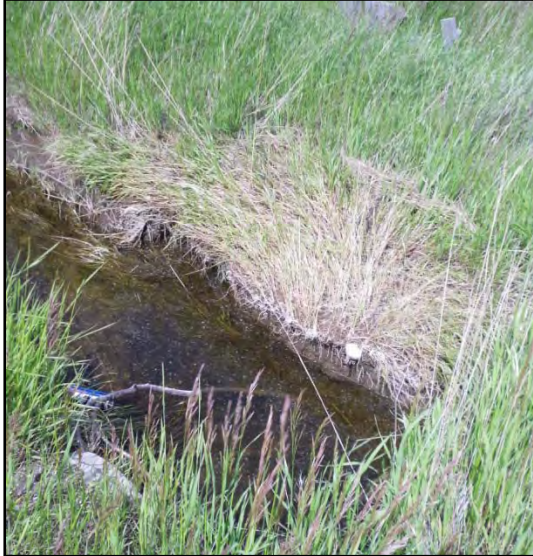
Photo 4.1: Existing cross drain with scour hole located at MP 0.67.

The second cross drain, located at MP 0.67, serves an existing 500-year Zone B floodplain. Surface runoff and overflow from Tenmile Creek west of the road are conveyed by the cross drain to the roadside ditch on the east side of the road. The cross drain is a concrete pipe 24 inches in diameter. During the recent June 2011 flooding, the cross drain was inundated with overflow from Tenmile Creek and water did not overtop the roadway. However, a large scour hole (**Photo 4.1**) developed on the downstream side of the

pipe and it was observed that much of the runoff was bypassing the drain and continuing along the west side of McHugh Lane. A hydraulic analysis should be completed before McHugh Lane is reconstructed to determine if a larger pipe diameter and skew angle would improve drainage. It was assumed for this report that the pipe would be replaced with a 36-inch diameter pipe.

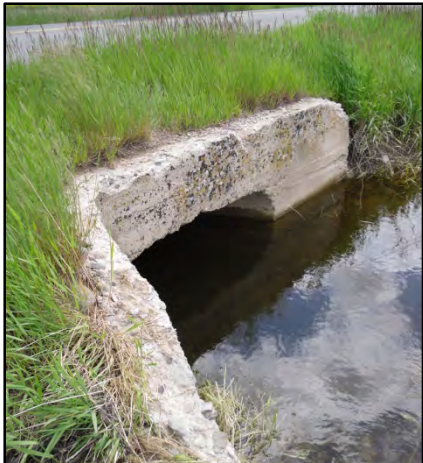
Photo 4.2: Existing drainage structure at MP 0.78.

The third cross drain on the McHugh Lane corridor is located at MP 0.78 and is an existing concrete structure (**Photo 4.2**). The structure was full of floodwater during the field review, but is estimated to be approximately 7 feet wide by 3 feet deep. This structure appears to serve an existing overflow channel of Tenmile Creek and is in a 500-year flood hazard area. The structure was inundated with runoff during the recent June 2011 flooding and the road was not overtopped in this location. Runoff was also, however, bypassing the structure and continuing in roadside ditches along the west side of McHugh Lane. A detailed hydraulic analysis should be completed before the road is reconstructed to assess if the current size of drainage structure is adequate. It was assumed for this report that the structure would be upgraded to a double box culvert with a 7-foot span and 3-foot rise.

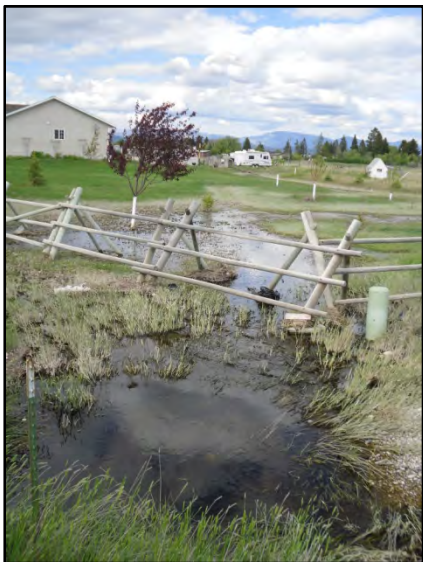
Photo 4.3: Shallow drainage channel downstream of existing cross drain at MP 1.47.

The fourth cross drain on the McHugh Lane corridor is located at MP 1.47 and is an existing 24-inch concrete pipe. This pipe serves to convey surface runoff and Tenmile Creek overflow to a shallow drainage channel on the east side of the road. The pipe is in a 500-year flood hazard area. The structure was inundated with runoff during the recent June 2011 flooding and the road was overtopped, and subsequently closed, in this location. Overtopping of McHugh Lane from runoff in the west roadside ditches began near Motsiff Road (MP 1.2). A detailed hydraulic analysis should be completed before the road is reconstructed to determine the size of pipe necessary to minimize flooding impacts at this location. It was assumed for this report that the pipe would be replaced with a 36-inch diameter pipe.

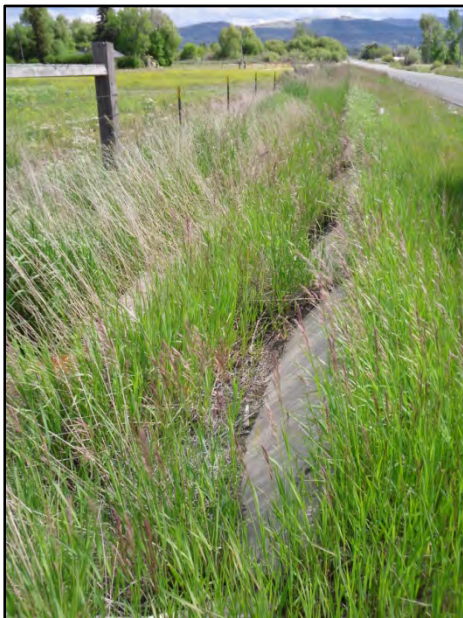
Photo 4.4: Concrete irrigation channel at MP 0.67.

An existing concrete irrigation structure is installed between approximately MP 0.55 and MP 0.67. The structure appears to be an above-ground irrigation channel (**Photo 4.4**). The channel is about 10 feet off the edge of McHugh Lane in the existing right-of-way and originates from private property. It was assumed for this report that the irrigation channel would be removed and replaced with the standard County road ditch for a Minor Collector.

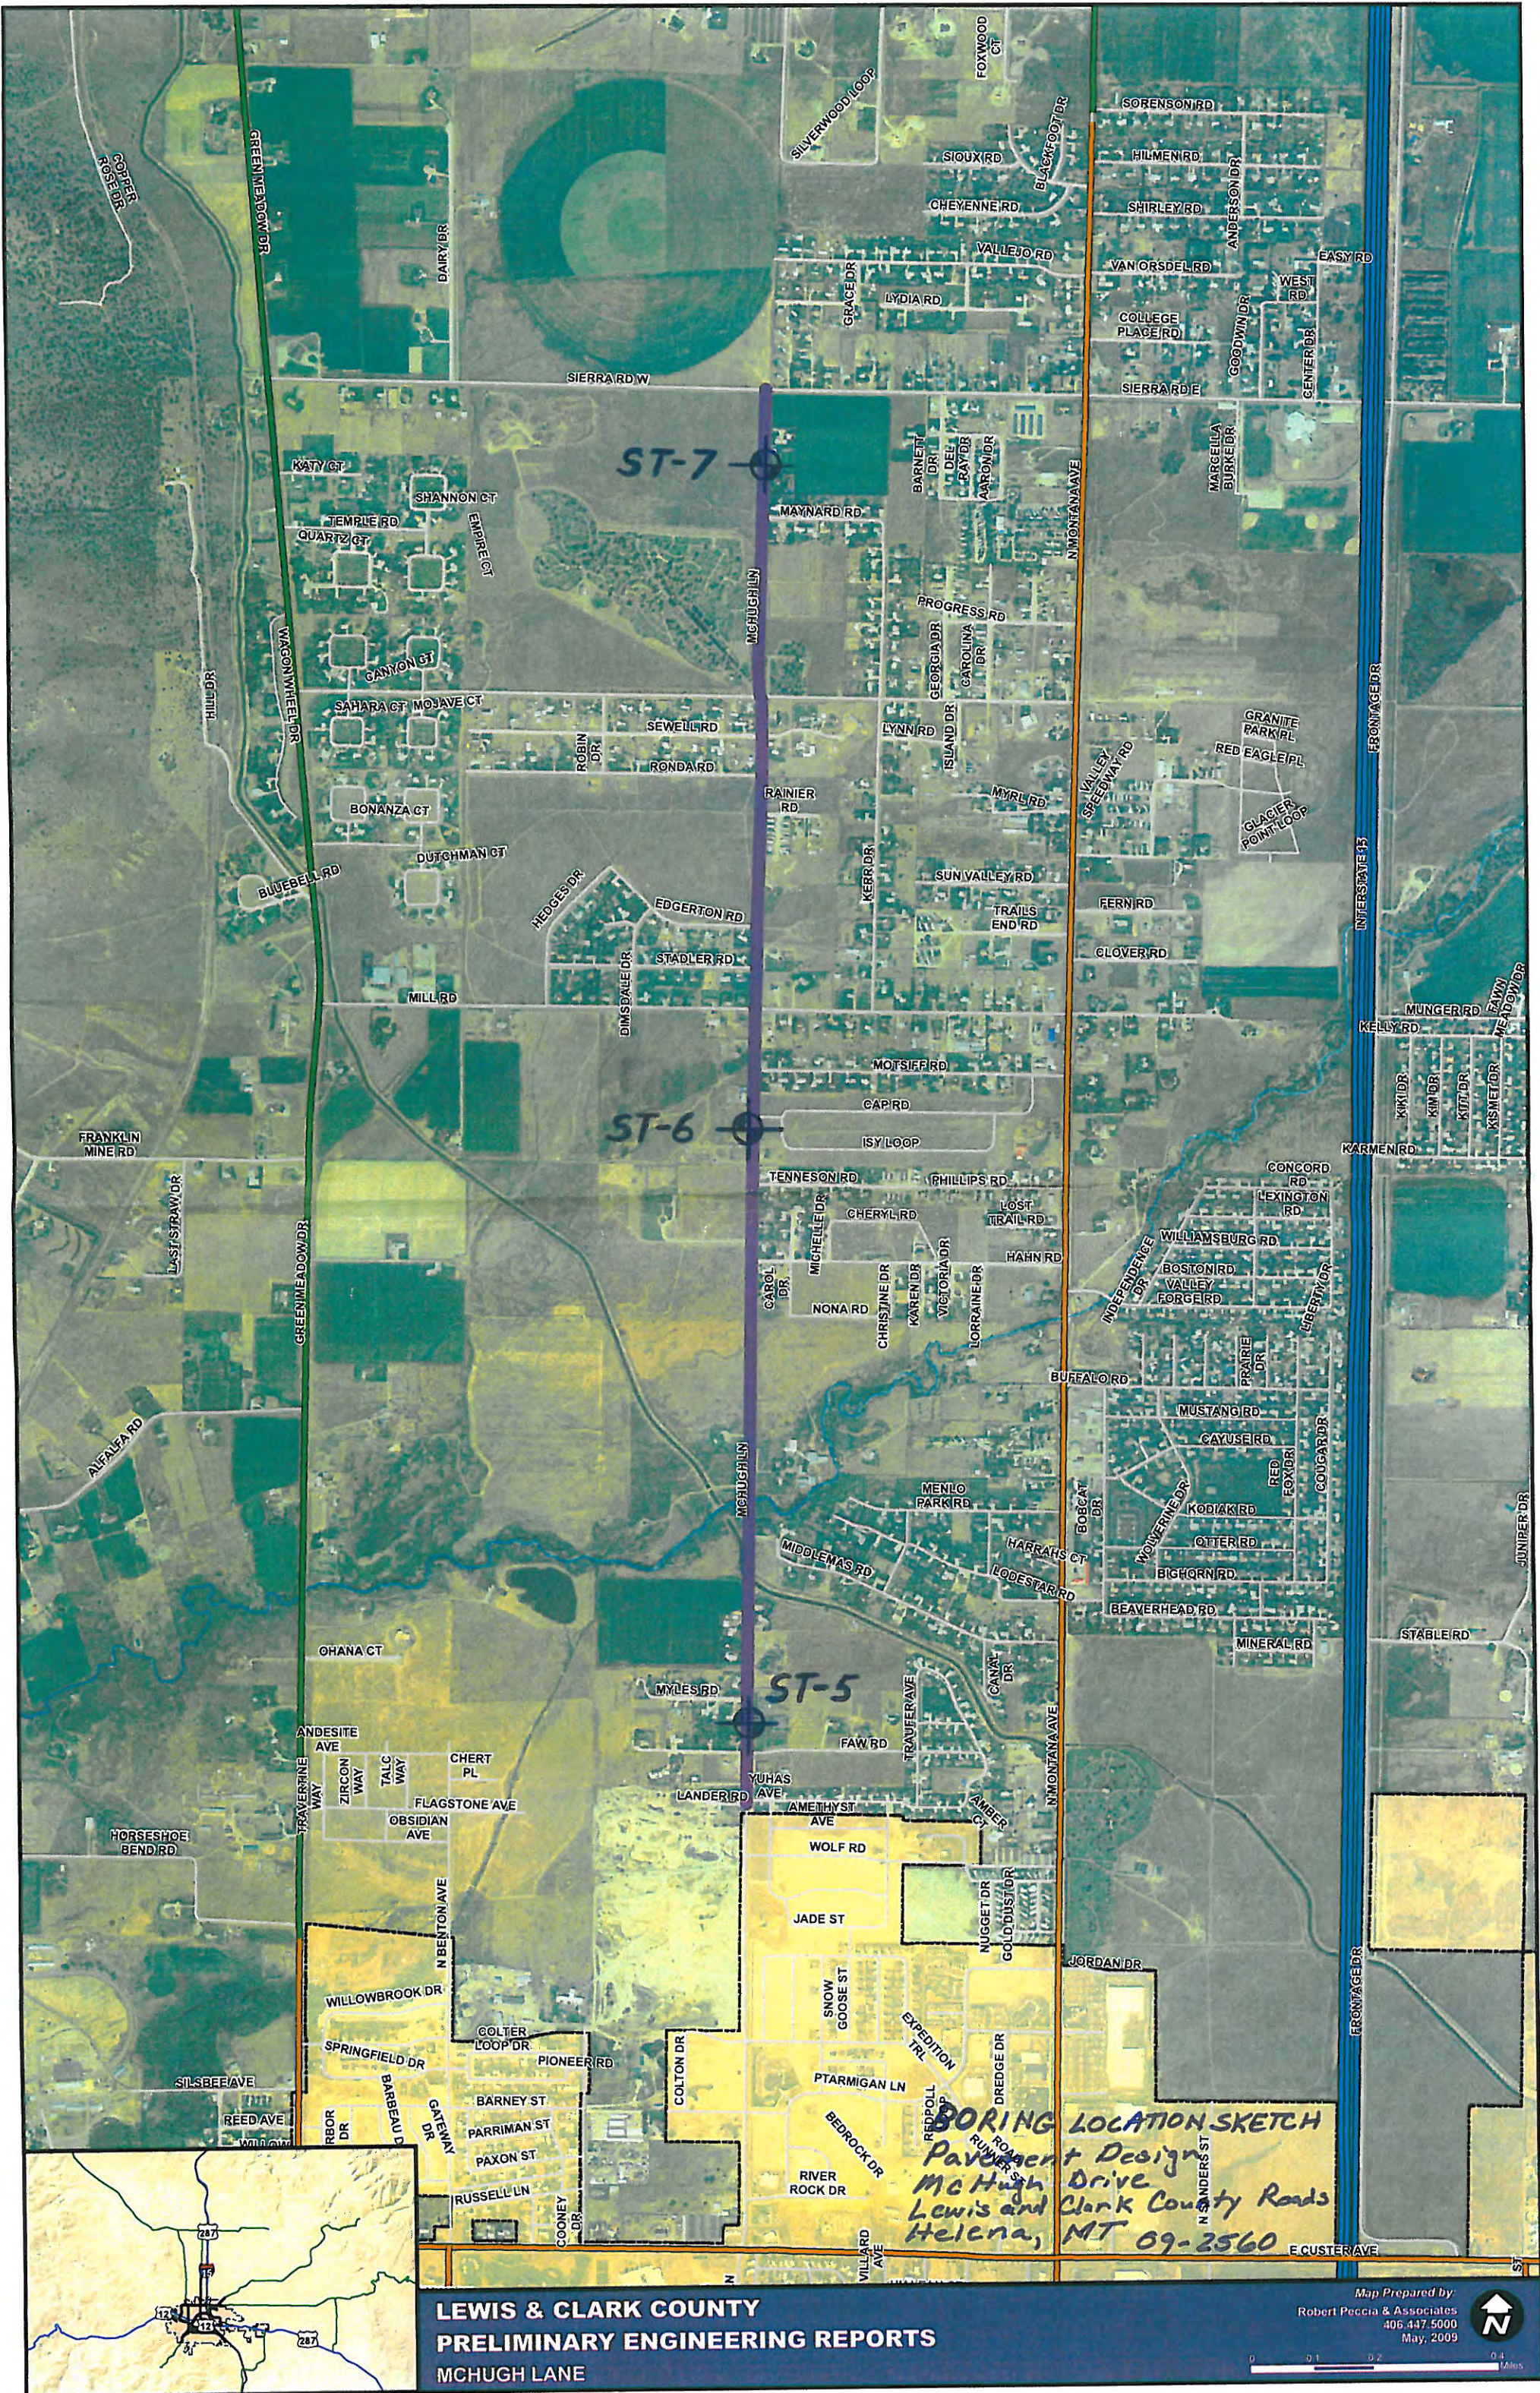
BORING LOCATION SKETCH
 Pavement Design
 McHugh Drive
 Lewis and Clark County Roads
 Helena, MT 09-2560

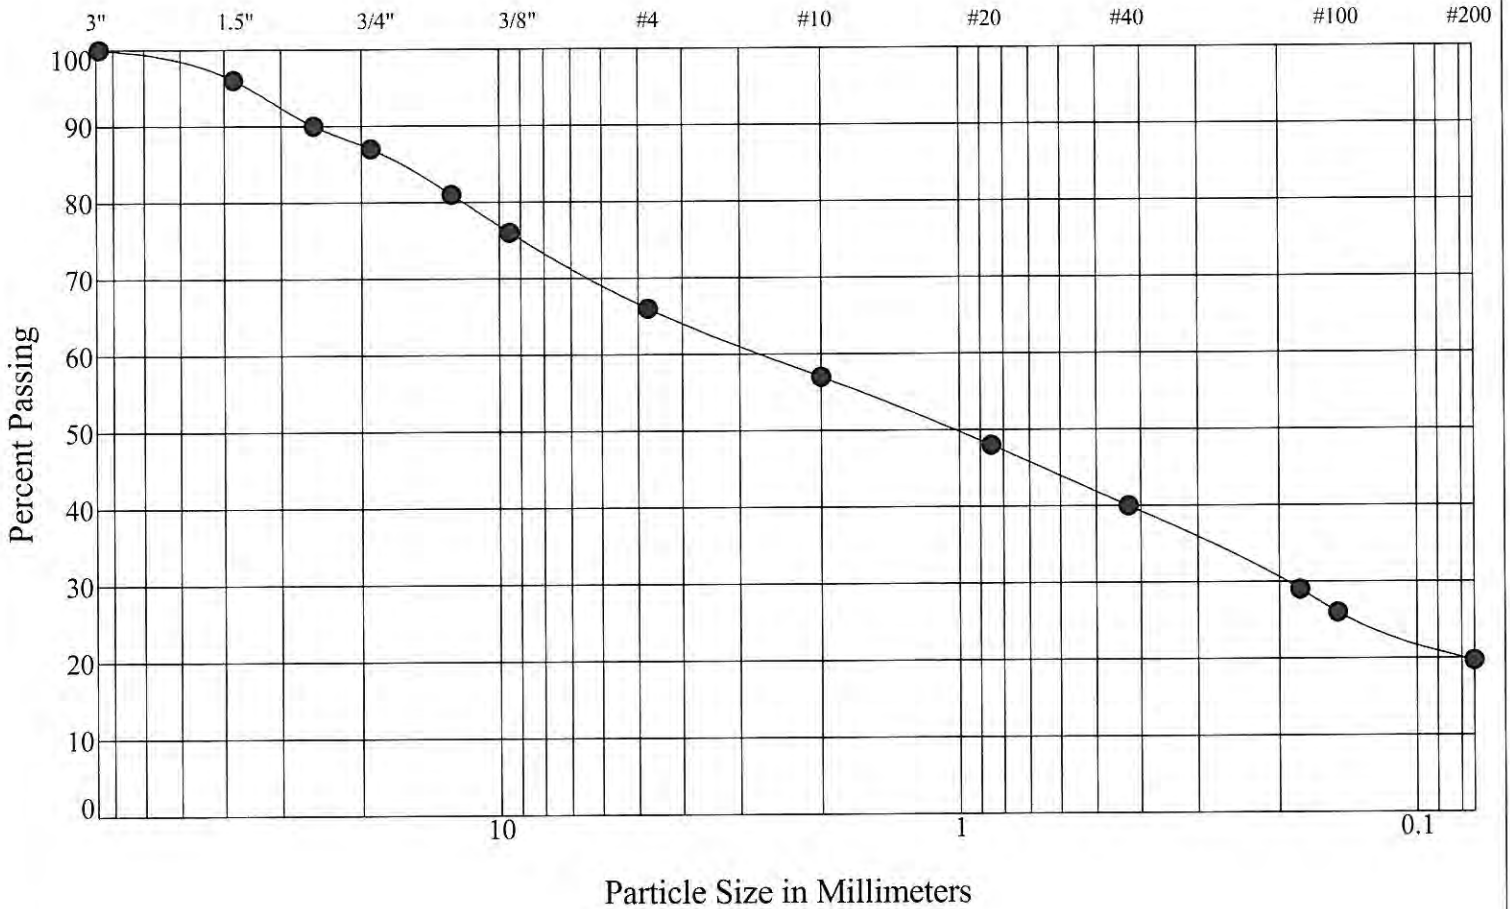
Sieve Analysis
 Project Number: 09-2560
 Lewis and Clark County Roads
 Helena, Montana

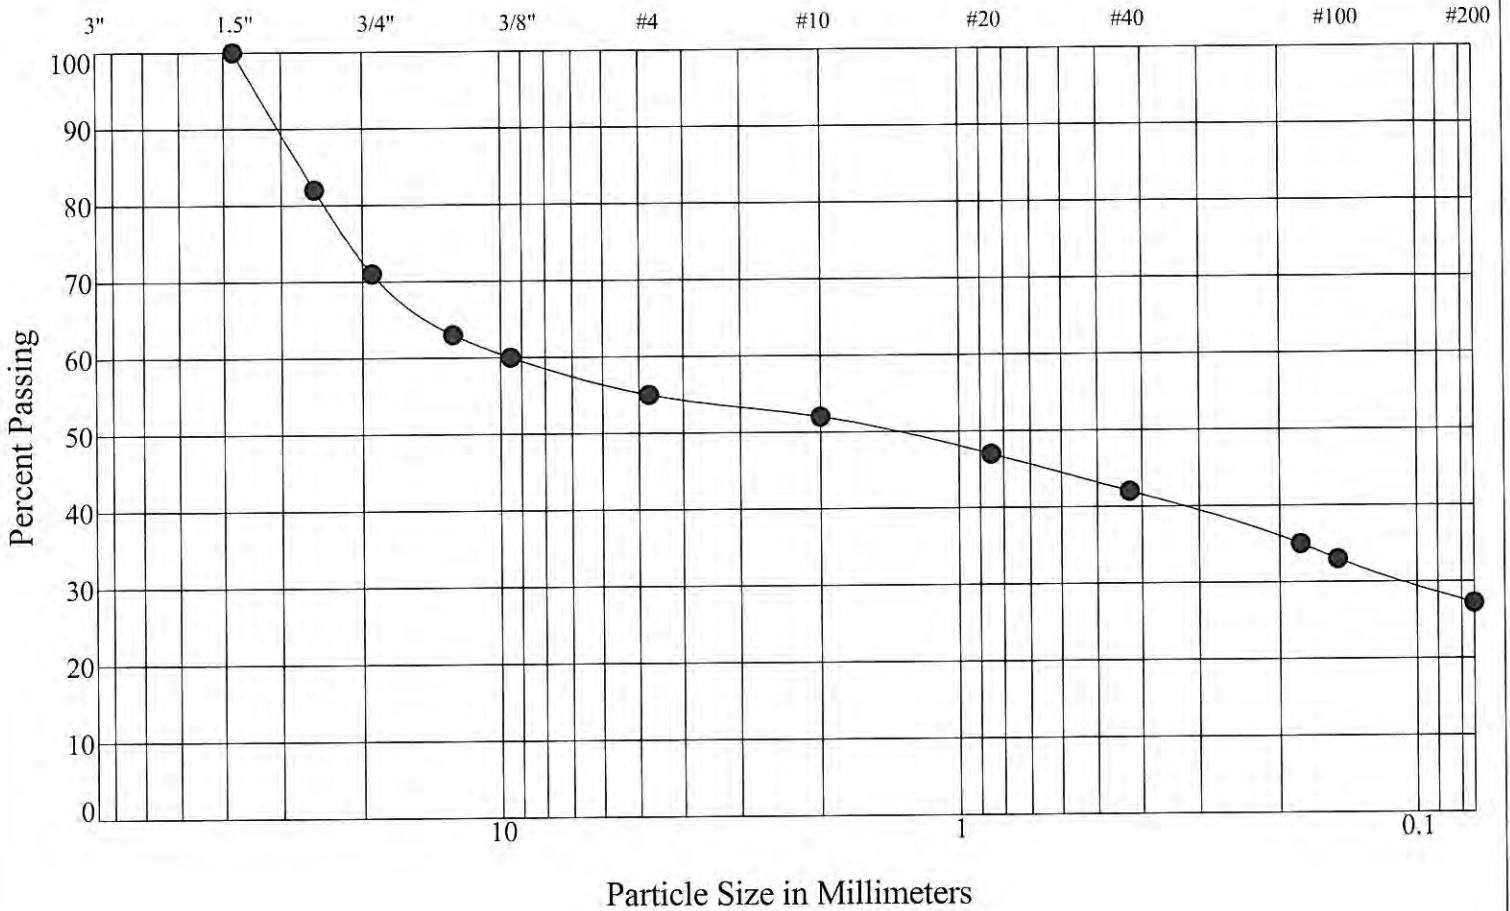
Sieve Analysis
 Project Number: 09-2560
 Lewis and Clark County Roads
 Helena, Montana

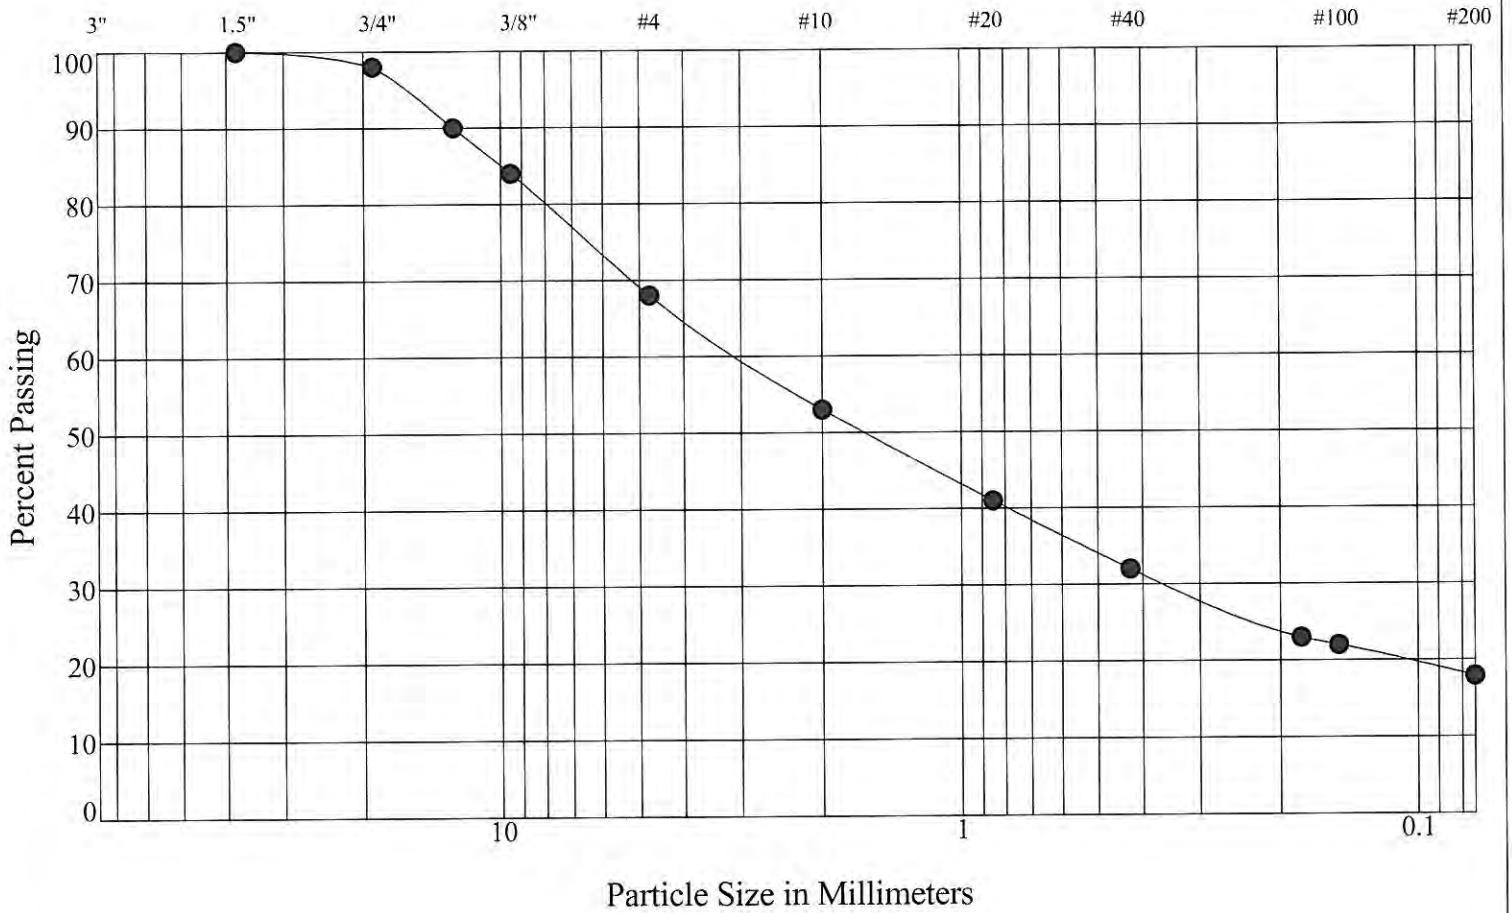
Sieve Analysis
 Project Number: 09-2560
 Lewis and Clark County Roads
 Helena, Montana

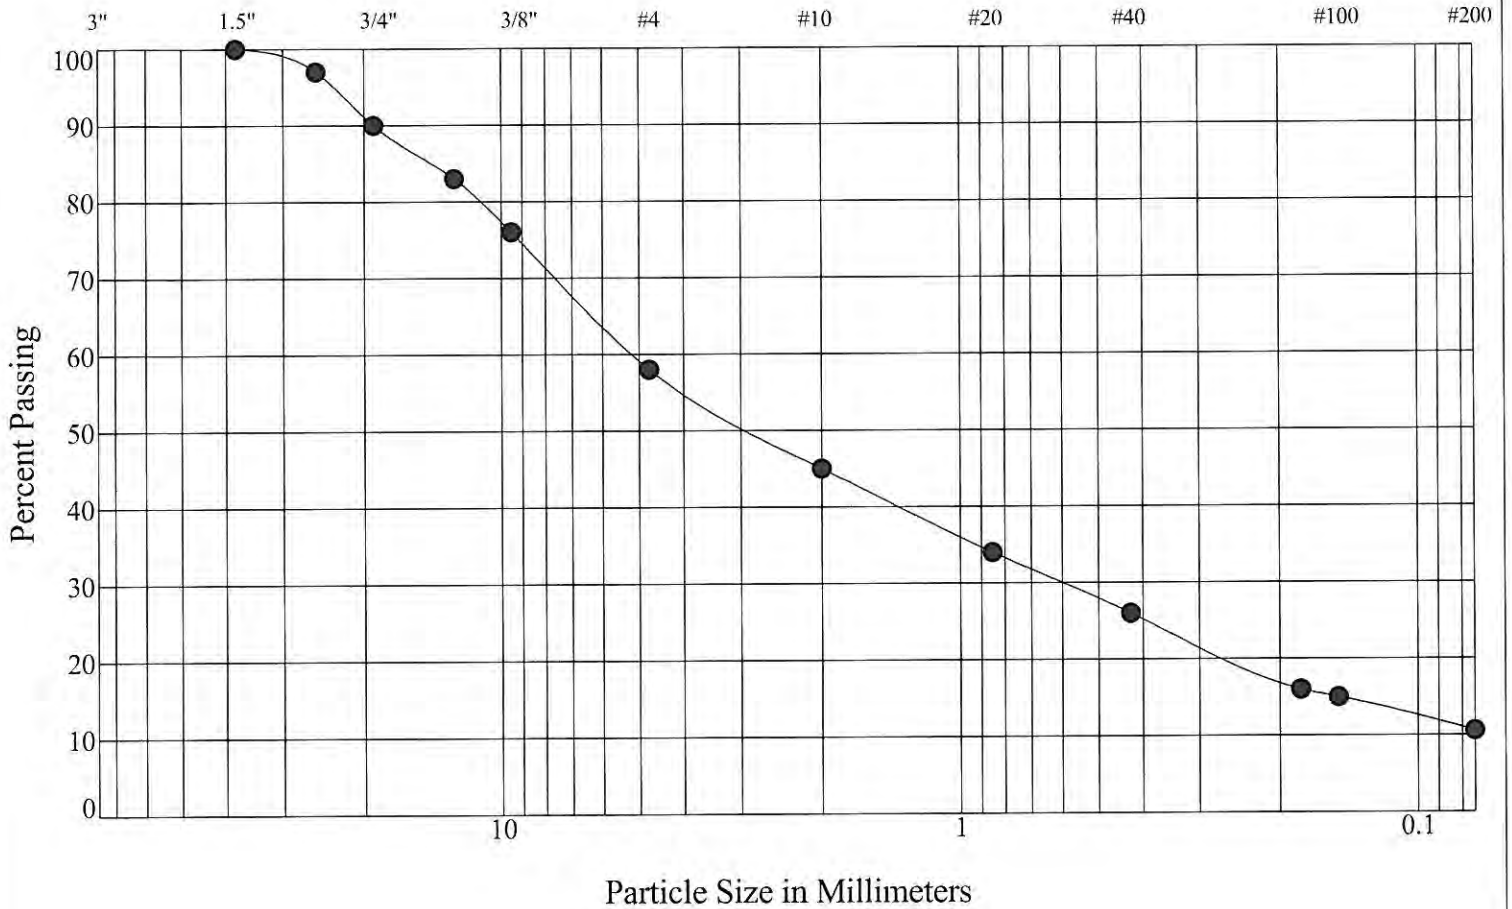
Sieve Analysis
