Preliminary Engineering Report

APPLEGATE DRIVE

LEWIS AND CLARK COUNTY

RPA Project No. 11502.000

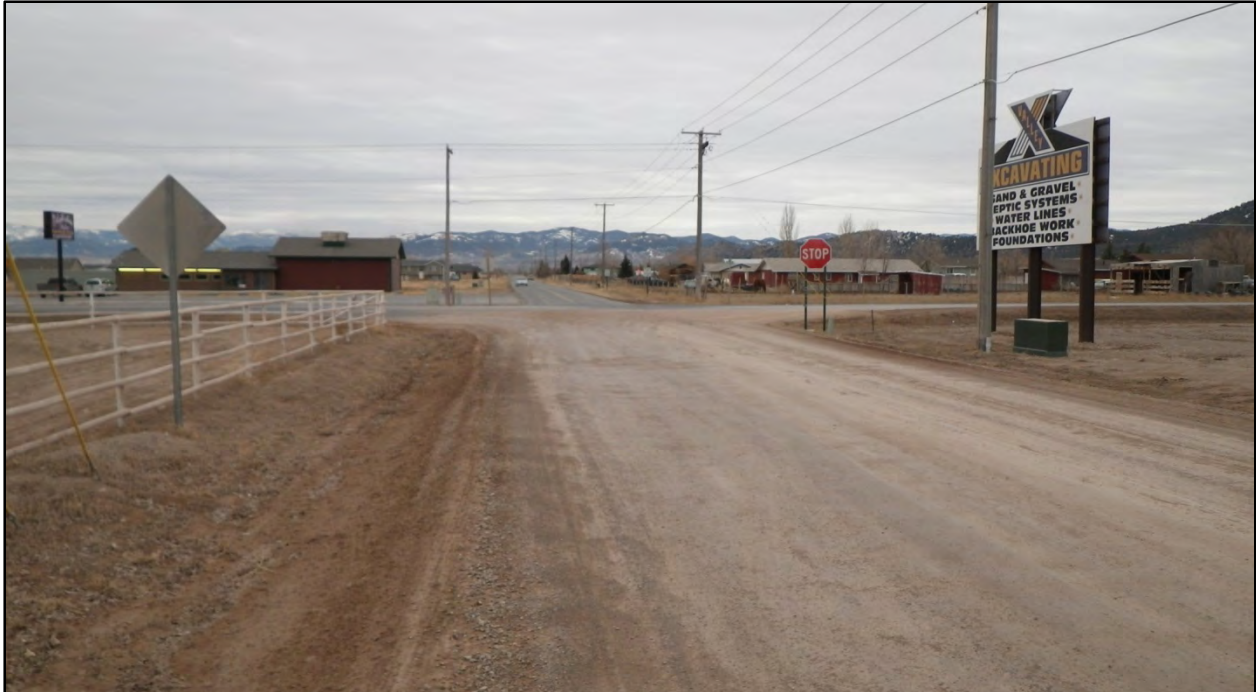
Photo 3.1: Existing Typical Section E.1 looking south.

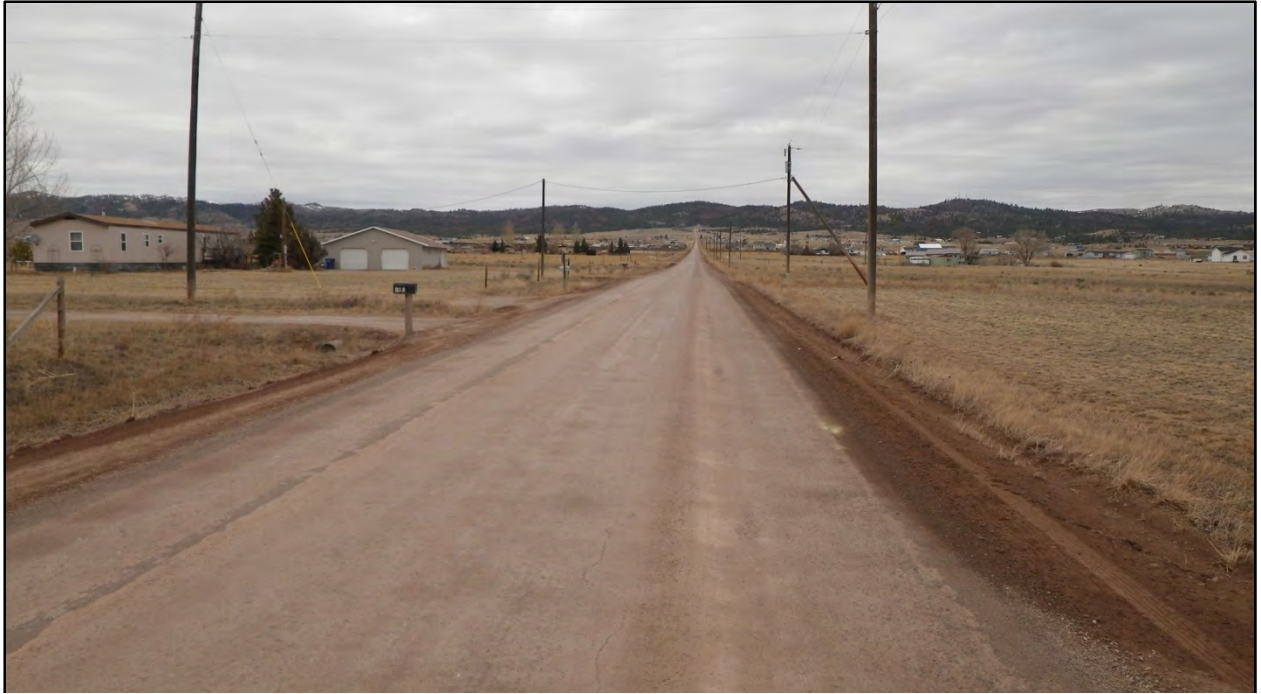
Photo 3.2: Existing Typical Section E.2 looking north.

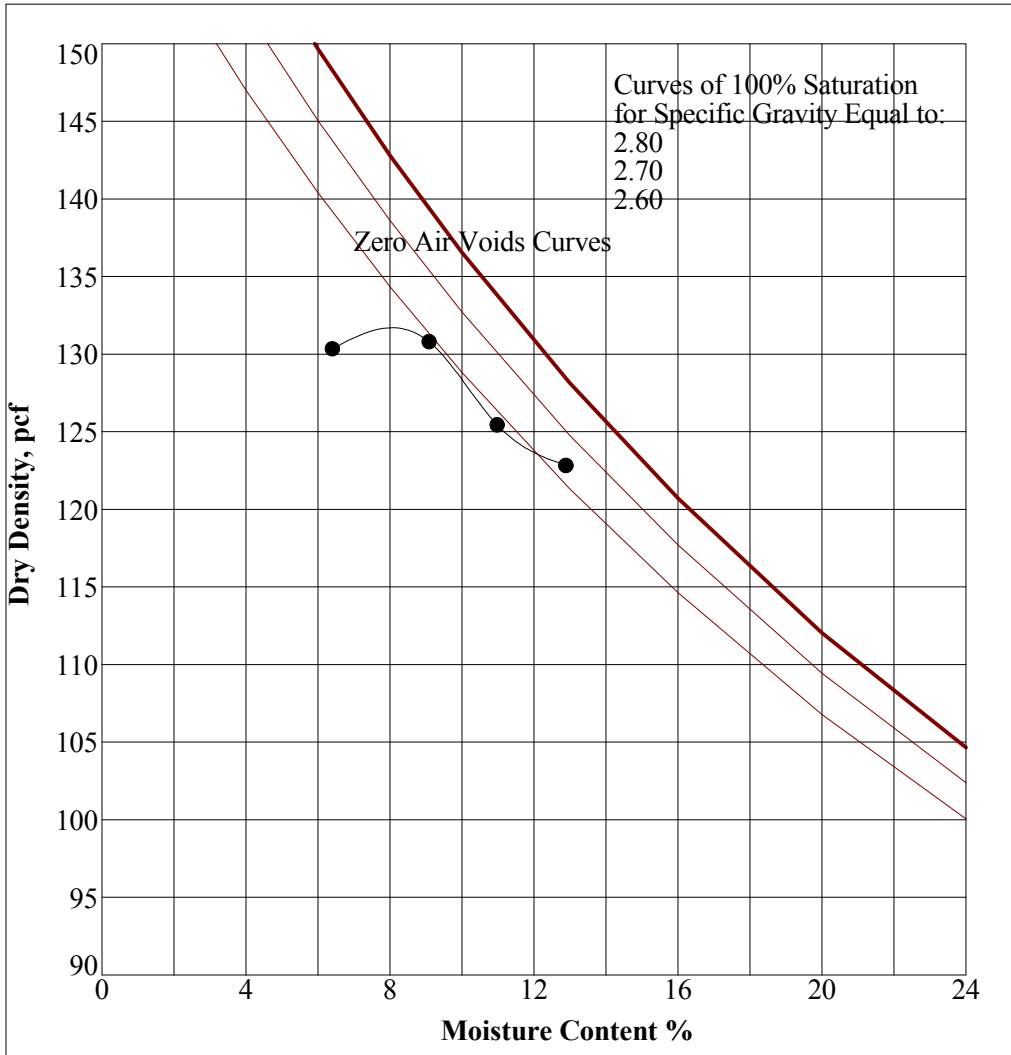
ASTM D 698 Method C

Maximum Dry Density, pcf	Optimum Moisture Content %
131.1	8.4

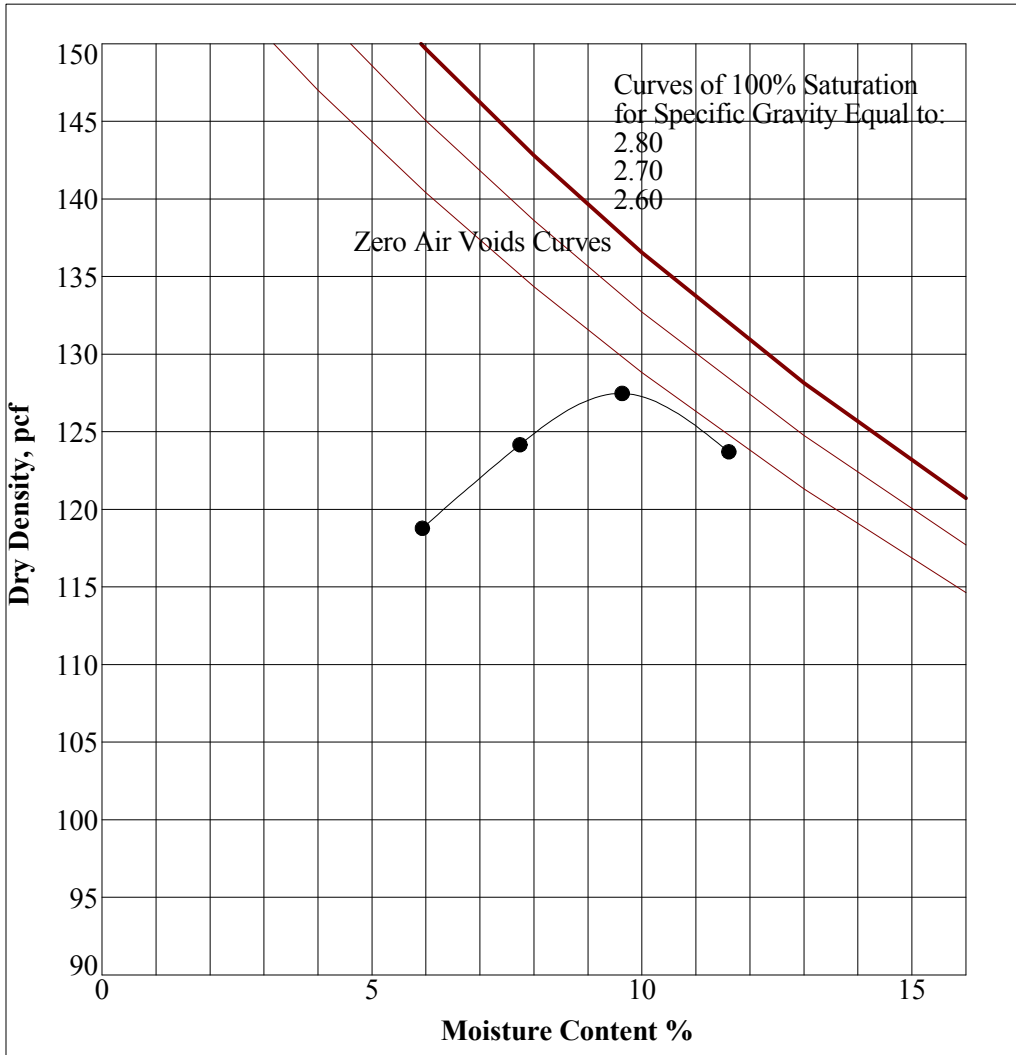
ASTM D 698 Method C

Maximum Dry Density, pcf	Optimum Moisture Content %
127.5	9.6
